**Report Title:** Site C Reservoir Shoreline Stability Assessment

**Issuer:** Thurber Consultants Ltd.

**Date:** April 1978

**A report to  
B.C. HYDRO & POWER AUTHORITY**

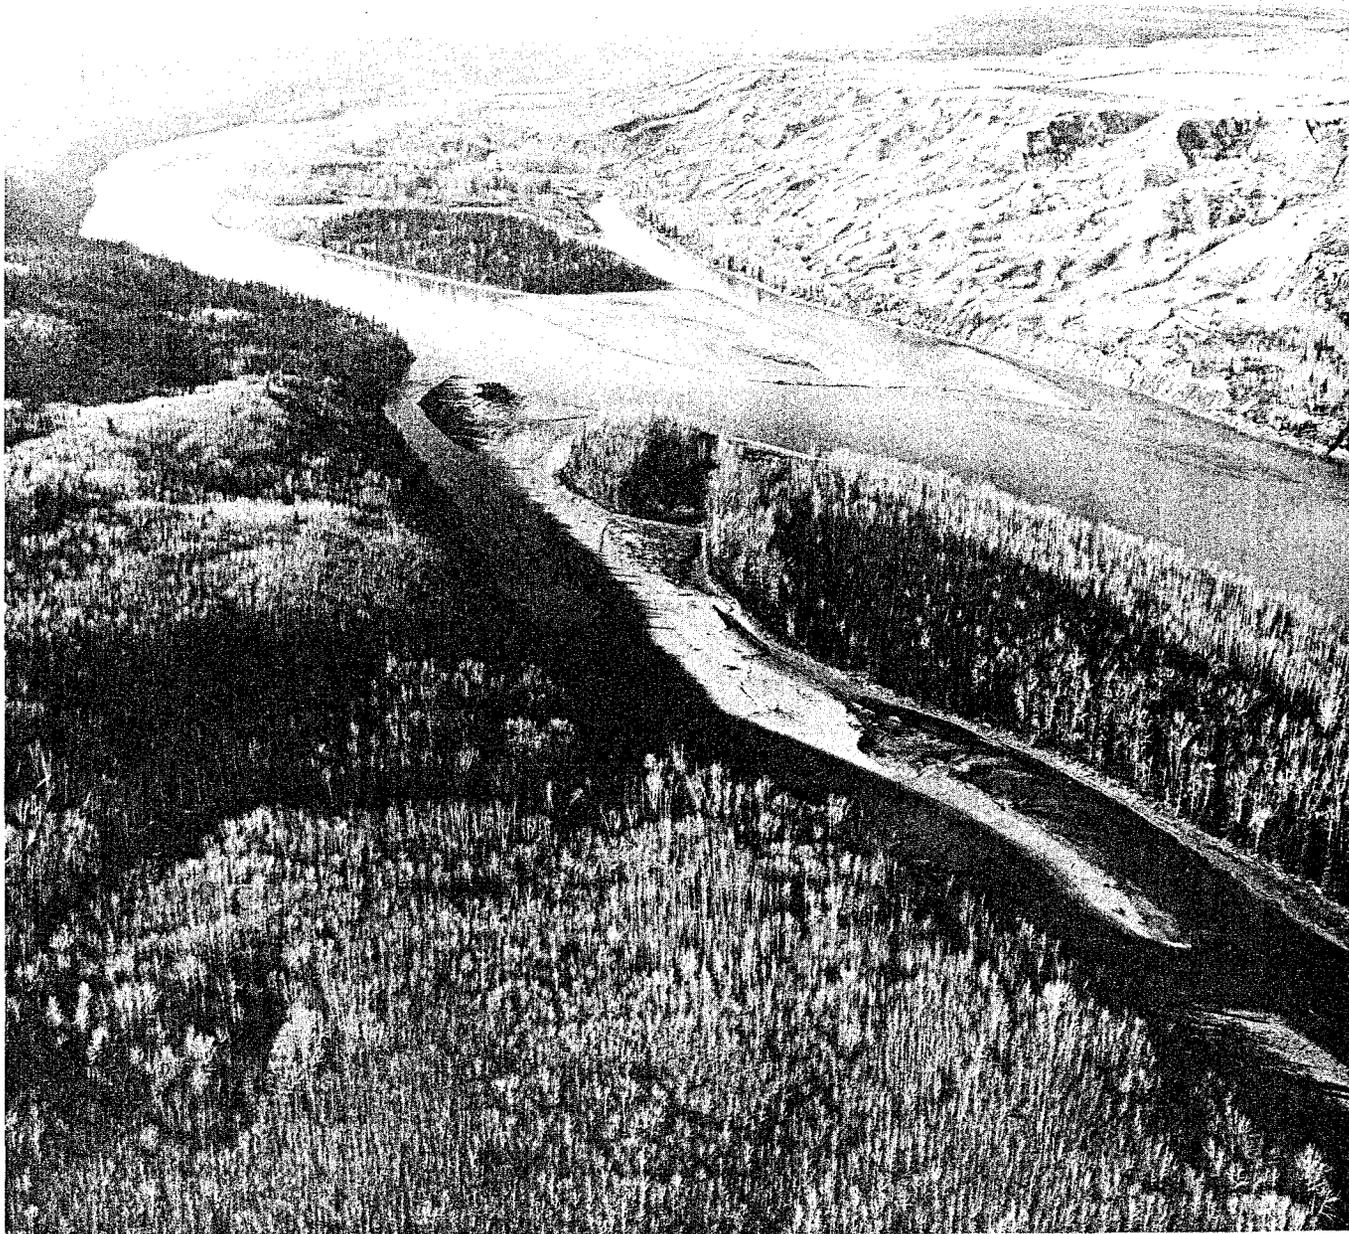
Fig. 2

Looking upstream from Mile 42. Tea Creek is off the right side of the photograph. Note the typical slump topography in silts and clays on the 700 feet high valley slope. The thickness of the slumped material is often quite shallow and relatively minor disturbance (e.g. road cuts and fills) can reactivate movement.

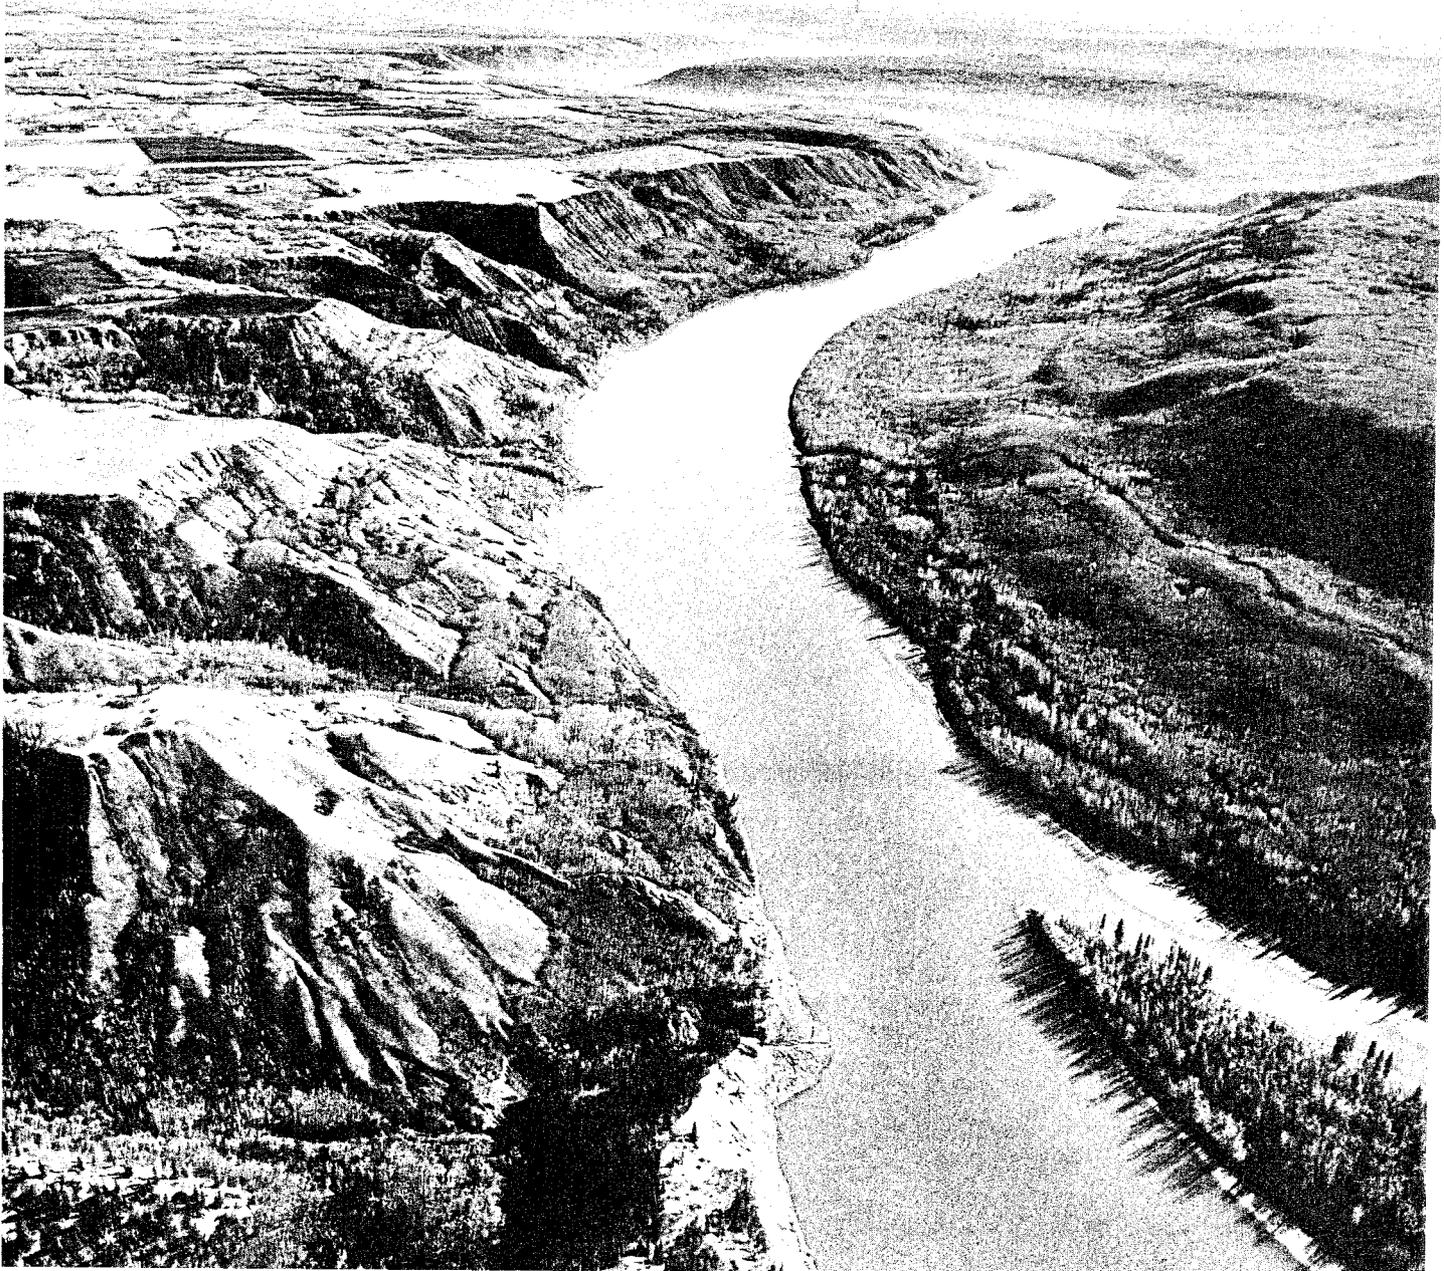
Fig. 3

Looking downstream from Tea Creek (Mile 42) towards Site C. Note the difference in the topography and vegetation of the valley slopes. The left bank shows more evidence of relatively recent slumping. Both slopes are in bedrock.

The valley downstream of Mile 42 (Fig.3) exhibits a steep north slope of 2:1 and a much flatter south slope of 4:1. Both slopes are in shale bedrock and there is no evidence of any change in the nature of the shales from one side of the river to the other. It can only be concluded that the groundwater conditions have been more adverse on the south side and has resulted in flattening of the slope by sliding.

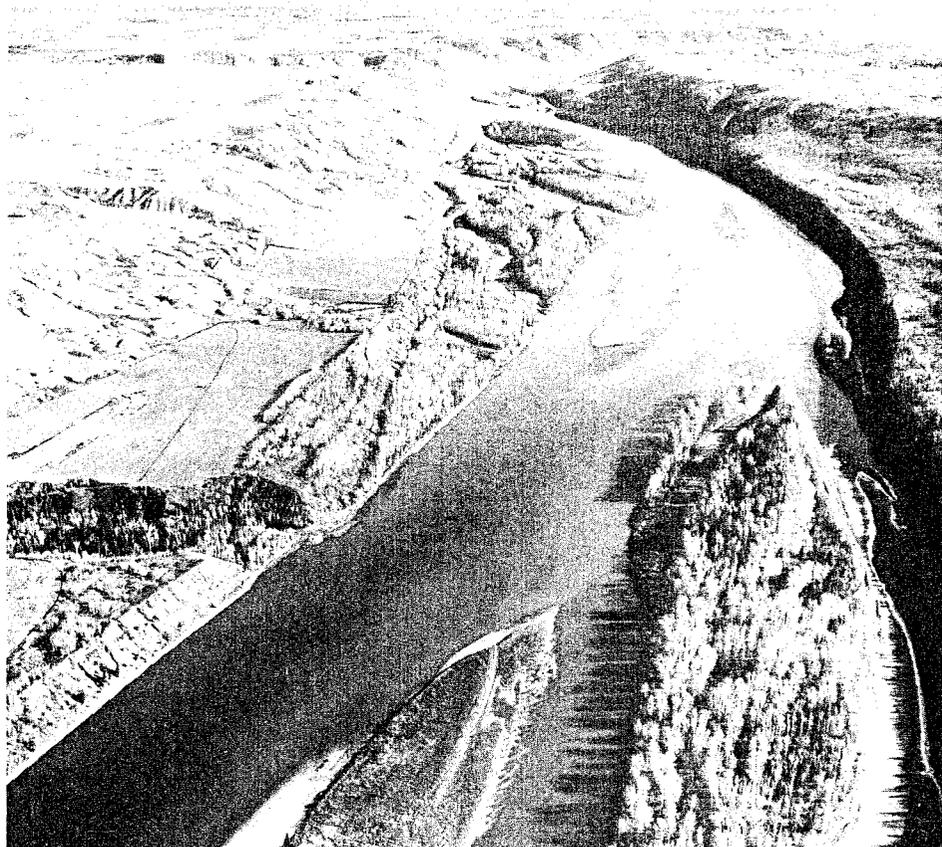
Fig. 4

A view downstream from Mile 46 looking towards the bedrock 'canyon' beginning at Tea Creek. (see Fig. 3).

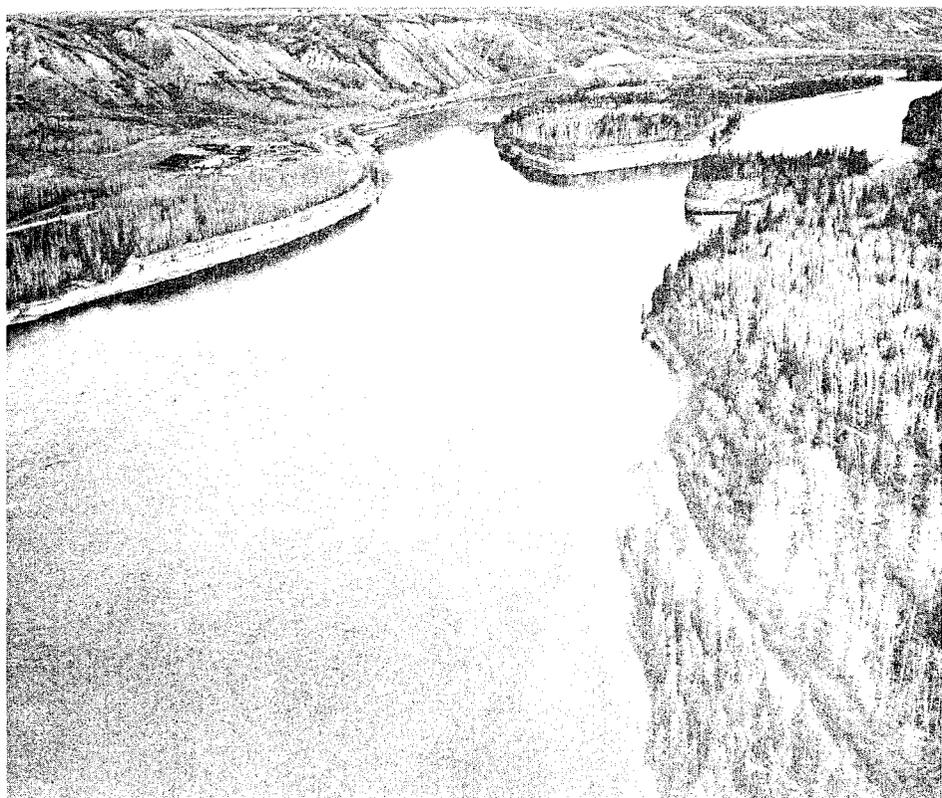
Fig. 5

Sandstone islands at Mile 77, marking the furthest downstream point of exposed Gates Sandstone. Beyond this point Ft. St. John Shales are found at river level.

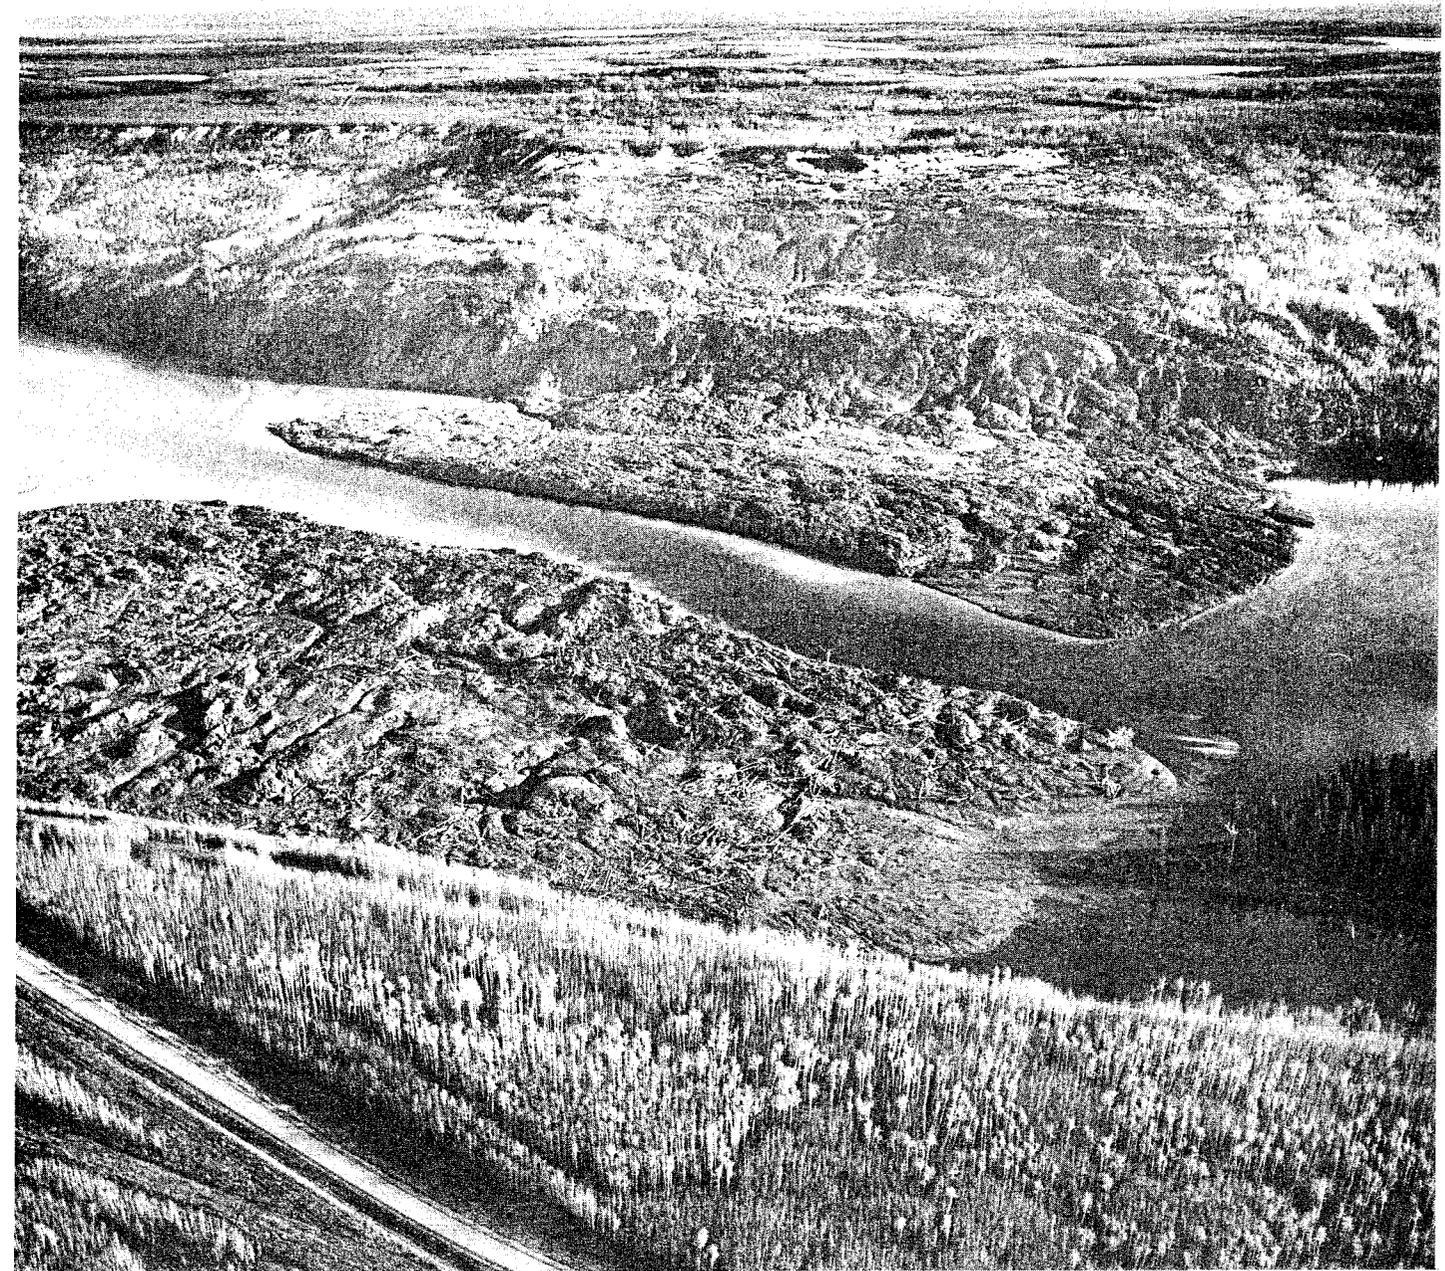
Fig. 6

A view of the Attachie Slide which occurred on May 26, 1972 blocking the river for several hours. The slide developed on the south bank of the Peace River at Mile 62. The bank extends up approximately 700 feet above river level.

The slide occurred suddenly and rapidly on the night of May 26, 1973. It blocked the river for ten hours. By May 28 a well defined channel with a minimum width of 250 feet had been eroded through the slide debris. Prior to overflow, it is estimated that the slide caused the river to pond 23 to 24 feet above river level.

The slope prior to failure was 3.3:1, and the top of the slope regressed 200 to 250 feet as a result of the slide.

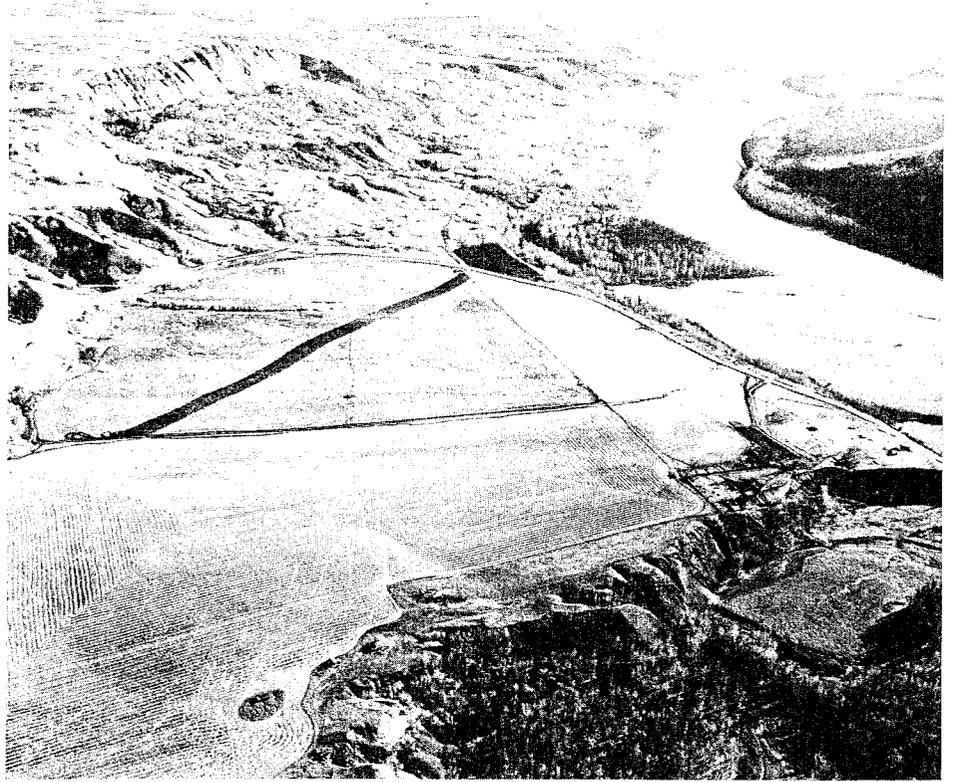
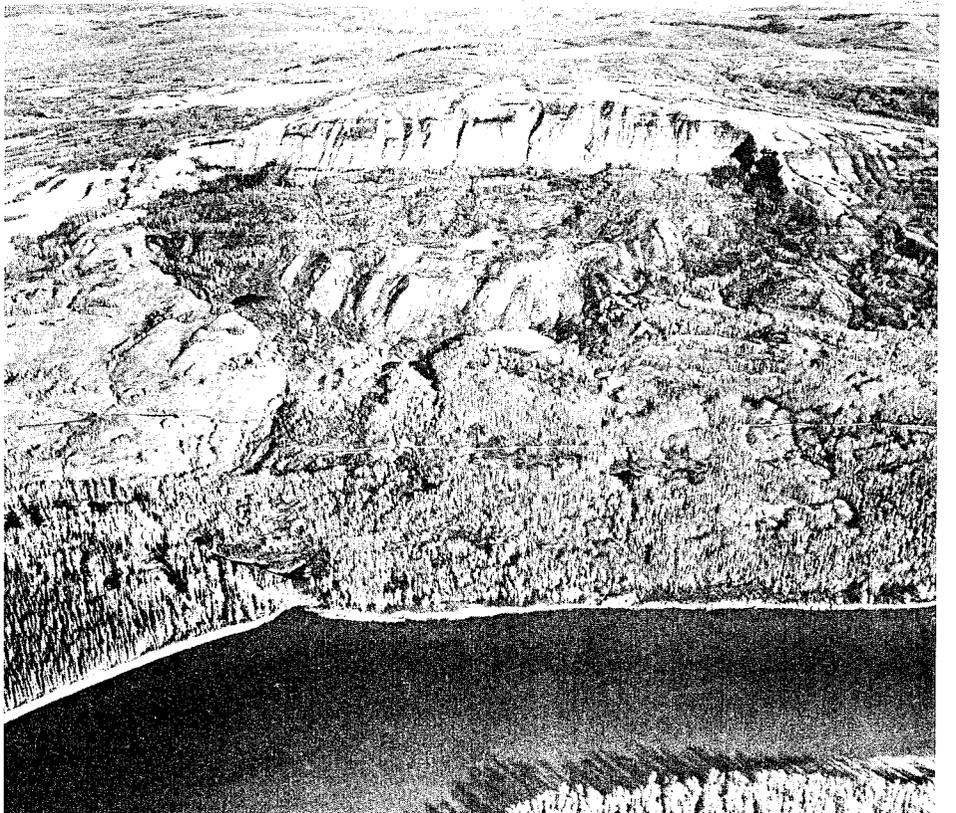
Figs. 7 and 8

The Cache Creek Slide area at Mile 51 on the north bank. This massive slide occurred in shale and sandstone bedrock. Partial movements occurred at the beginning of this century. The slide, almost 1500 feet high and 1.5 miles across, has affected the entire slope.

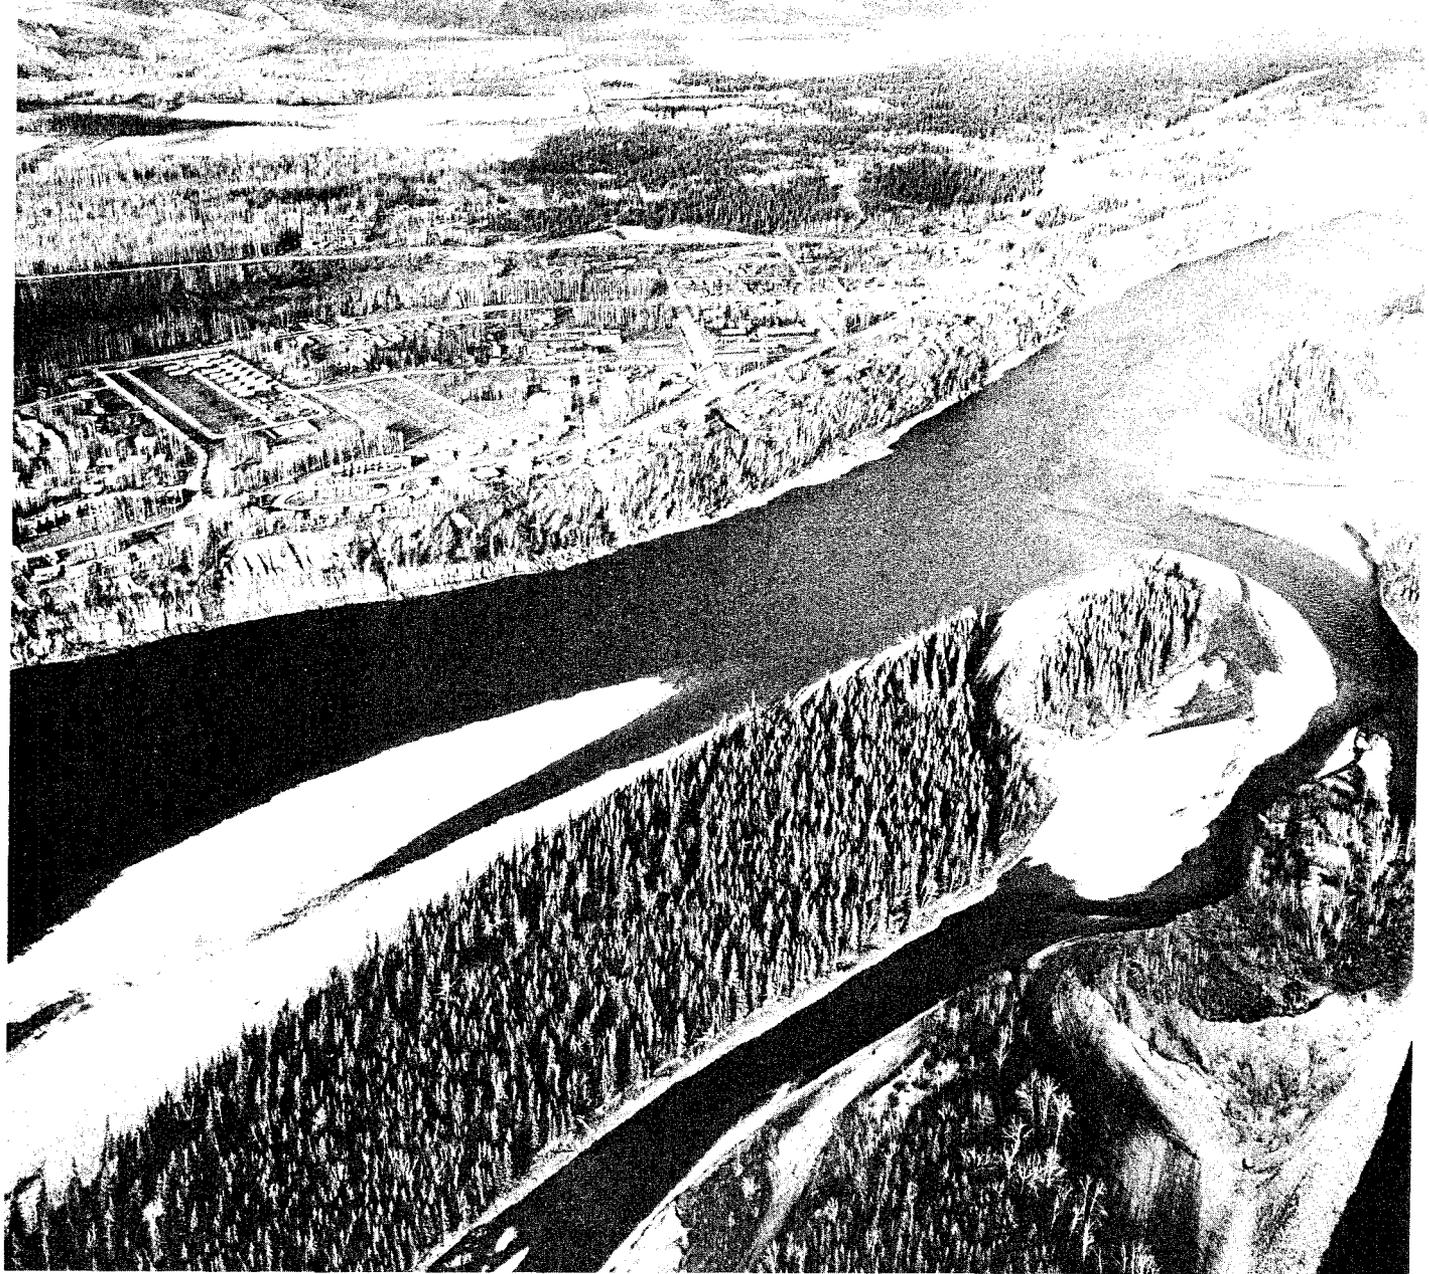
Fig. 9

The village of Hudson Hope on the north bank at Mile 84 is located on a terrace of gravel overlying clay silts. Bedrock dips well below river level at this point.

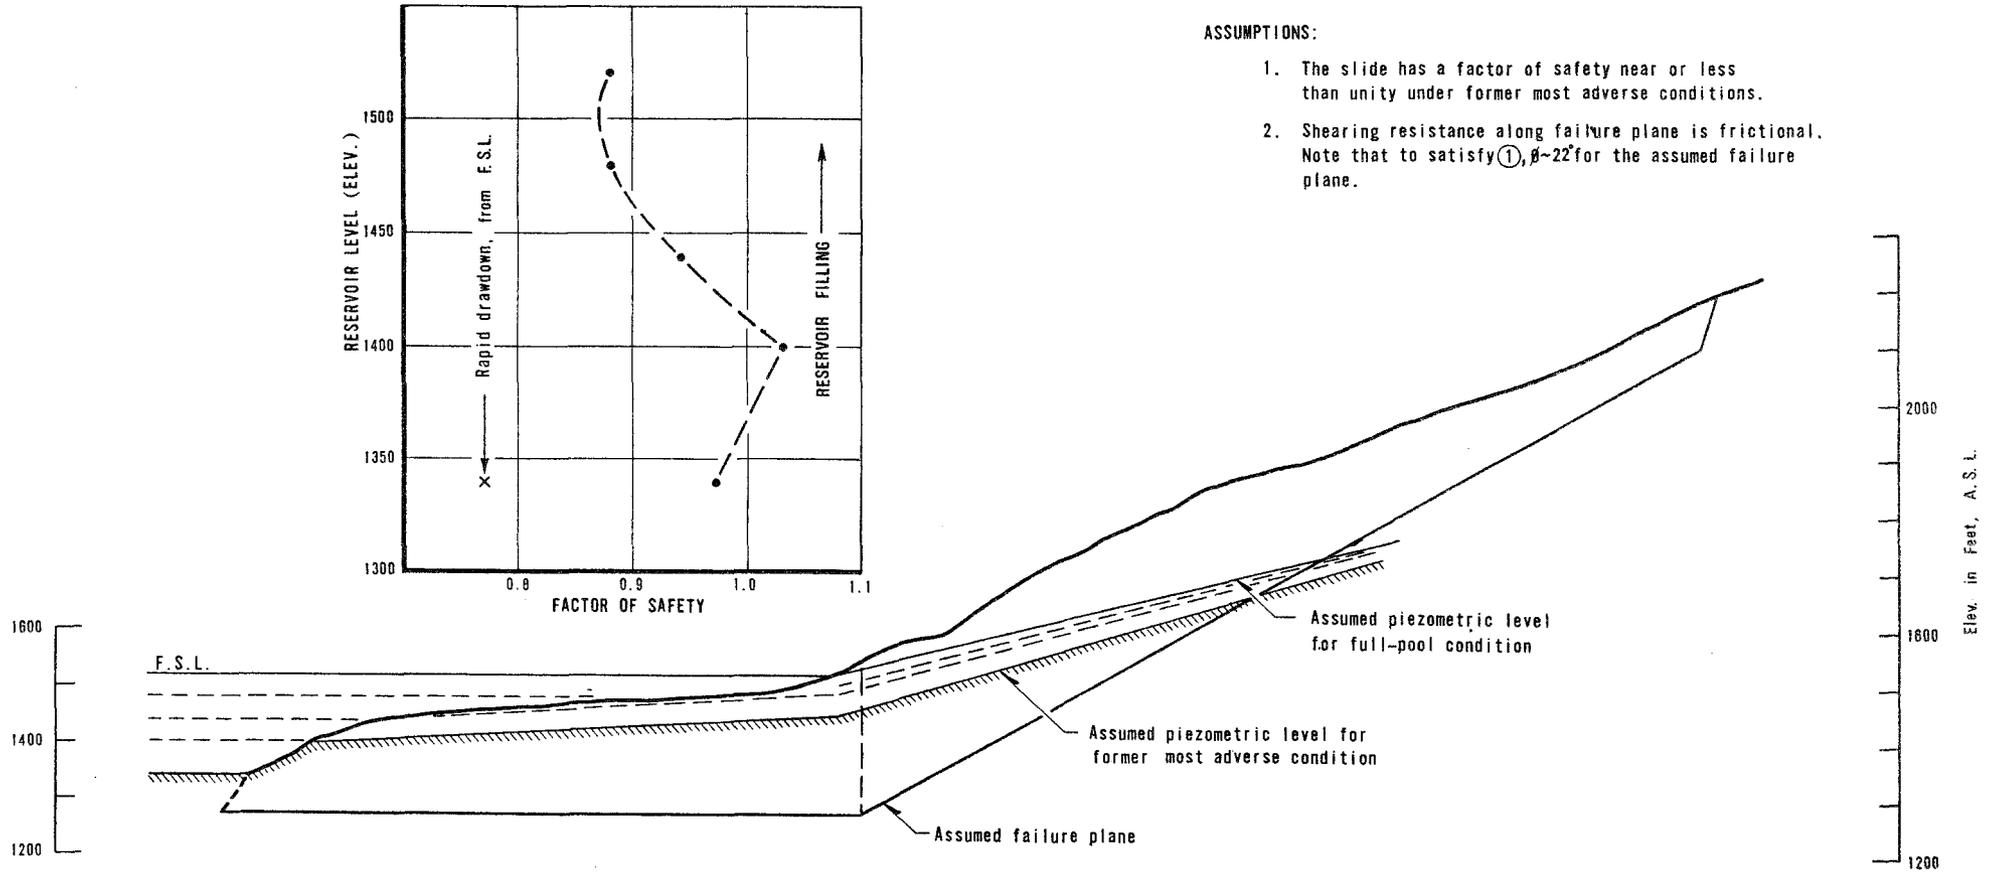
Fig. 11 portrays a homogeneous material with the existing groundwater table above the present river level, but below the final reservoir level. It is important to note that raising the reservoir level initially increases the factor of safety until the reservoir level is a little above the height of the existing groundwater. Any further rise in the reservoir level decreases the factor of safety. Very slow drawdown tends to increase the stability to that before filling, while rapid drawdown can decrease the stability. Although Fig. 11 shows the case of a block slide along a pre-existing failure surface, colluvial, slumped or slide debris material overlying intact material are similar situations.

1. The slide has a factor of safety near or less than unity under former most adverse conditions.
2. Shearing resistance along failure plane is frictional. Note that to satisfy ①,  $\beta \sim 22^\circ$  for the assumed failure plane.

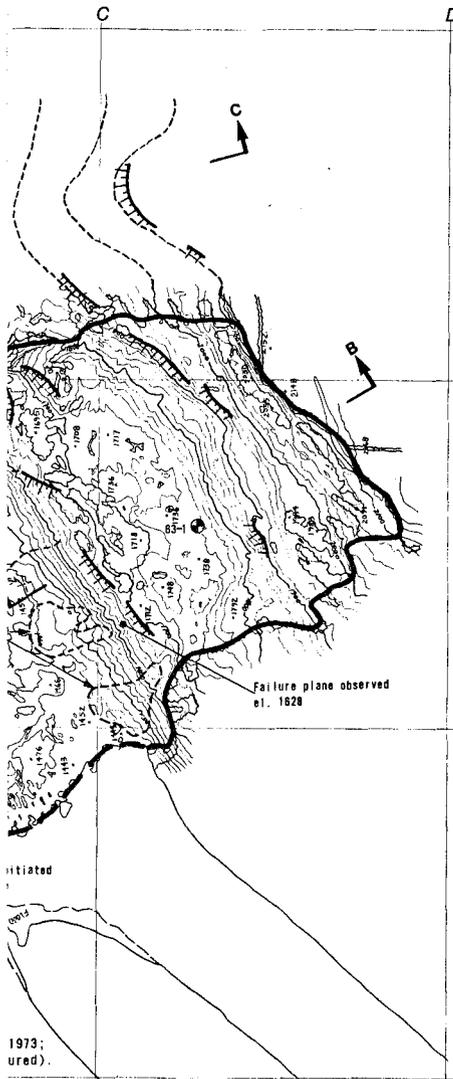
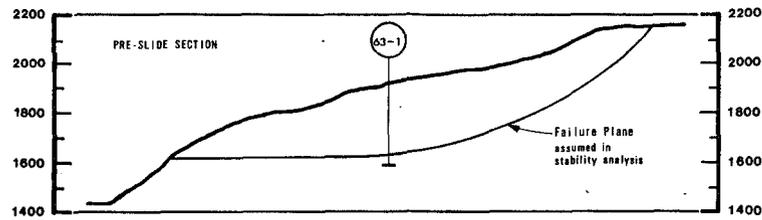
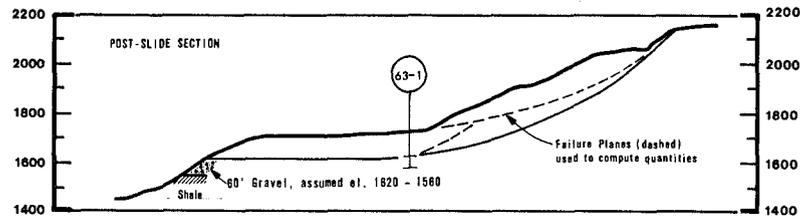
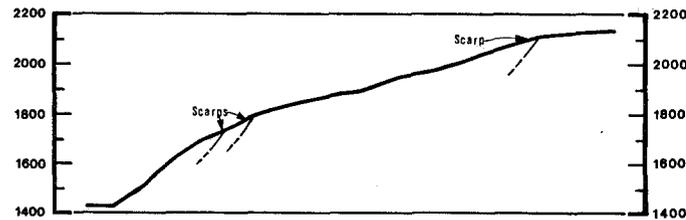
The slide probably failed progressively up the slope. The last phase of the slide may well have involved failure of the oversteepened back slope over the slide debris. This is portrayed by the dashed failure surfaces shown on Sections A-A and B-B of Dwg. 9. The depth of overburden over the gravel may have been sufficiently reduced by the slide to allow uplift and venting of groundwater from the gravel through the overlying clay and slide debris. This would have immediately reduced the water pressure downhill of the location of the venting and stopped the slide.

The area immediately downstream of the slide (Section C) is traversed by a large number of fresh cracks and scarps. The probability of this area failing within the next few years is high. Should such a failure occur it could be of the same order of magnitude as the recent slide.

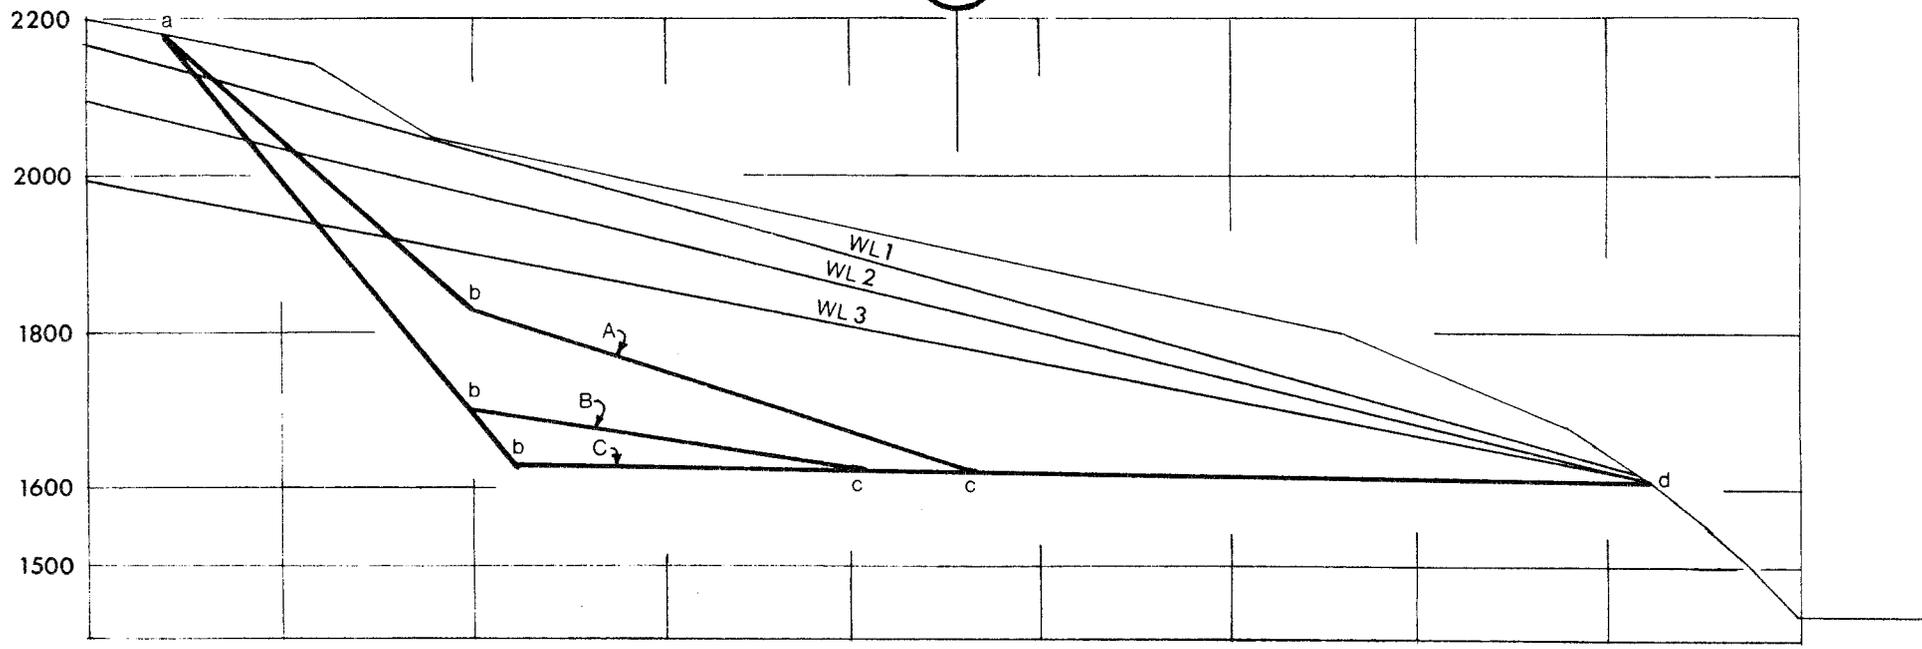
STABILITY ANALYSIS OF ATTACHIE SLIDE (SECTION A-A)

A stability analysis was carried out to estimate the groundwater conditions in the gravel and overlying clay. A range of shear strength parameters was used, and a summary of the results are given in Appendix B. Air photos taken prior to the slide show evidence of movement and thus it is reasonable to assume different shear strength parameters acting along different segments of the failure plane immediately prior to failure. These would likely range from cross-bedding peak value to parallel bedding residual value. The analysis indicates that very high piezometric levels were probably acting at the time of failure. For example, referring to Figure B.1 strength parameters of  $c' = 0$  and

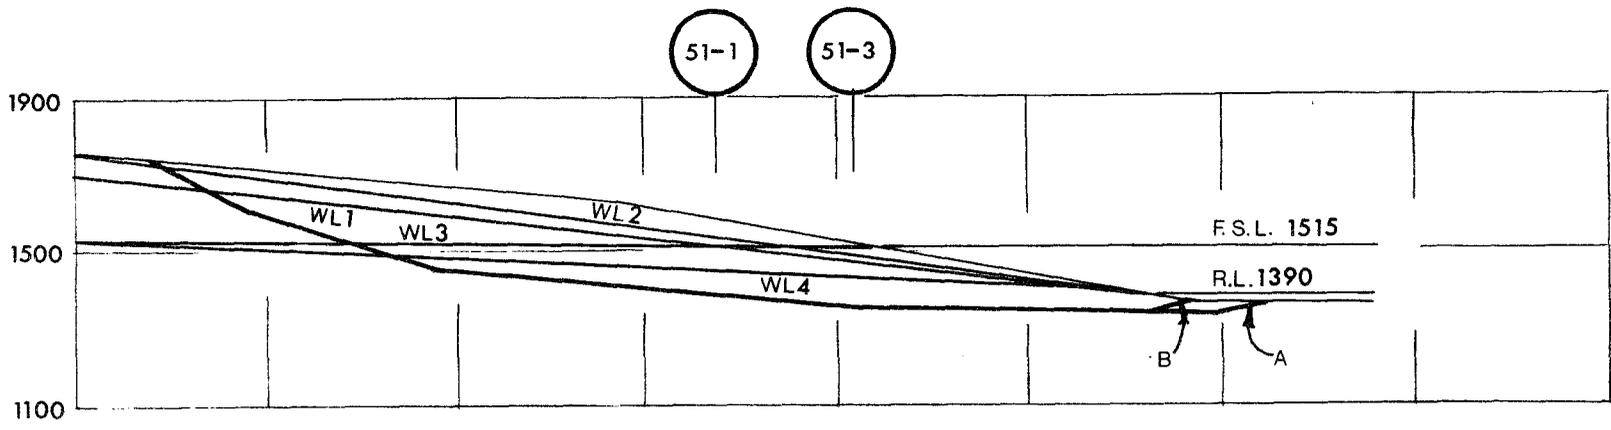
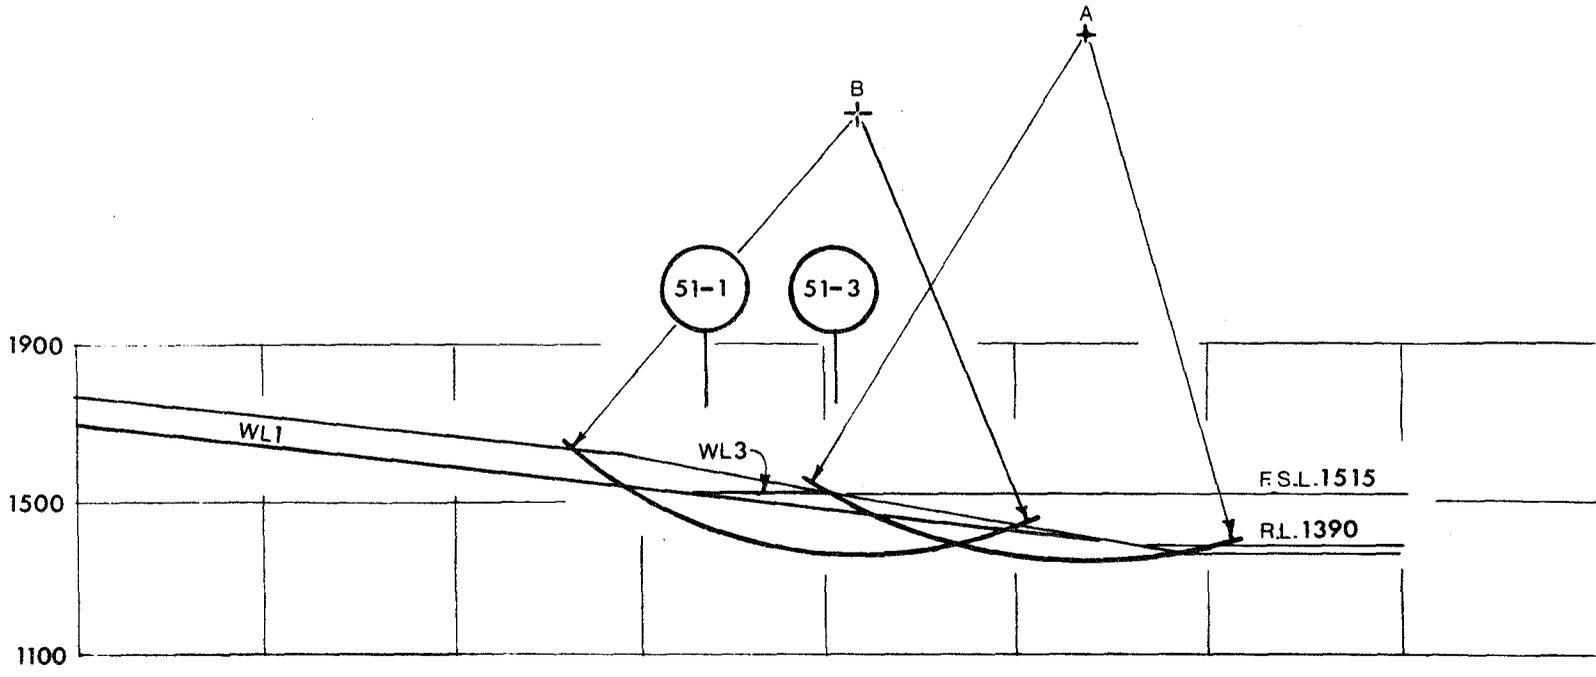
FIGURE B2

The analysis for the lower area, again assuming reasonable residual strength values and piezometric levels compatible with those observed to date, indicates a more stable condition. The lowest factor of safety was obtained for assumed reactivation of the slide debris over the old slide plane assuming a residual  $\phi$  value ( $13^\circ$ ). It should be noted that an increase in piezometric level as much as 100 feet at the location of hole 51-1 would be required to lower the factor of safety to unity

STABILITY ANALYSIS OF CACHE CREEK LOWER SLIDE (SECTION A-A)

<u>Strength Parameters(<math>\phi</math>)*</u> (c=0 throughout)				<u>Factor of Safety</u>	
$\phi_{a-b}$	$\phi_{b-c}$	$\phi_{c-d}$	$\phi_{d-e}$	Plane A	Plane B
40	13	13	13	0.83	0.82
40	22	13	13	-	0.96
40	22	22	13	1.29	1.27
40	22	22	22	1.39	1.37
40	40	13	13	1.32	1.31
40	40	22	22	1.64	1.62
40	28	22	13	1.40	1.38

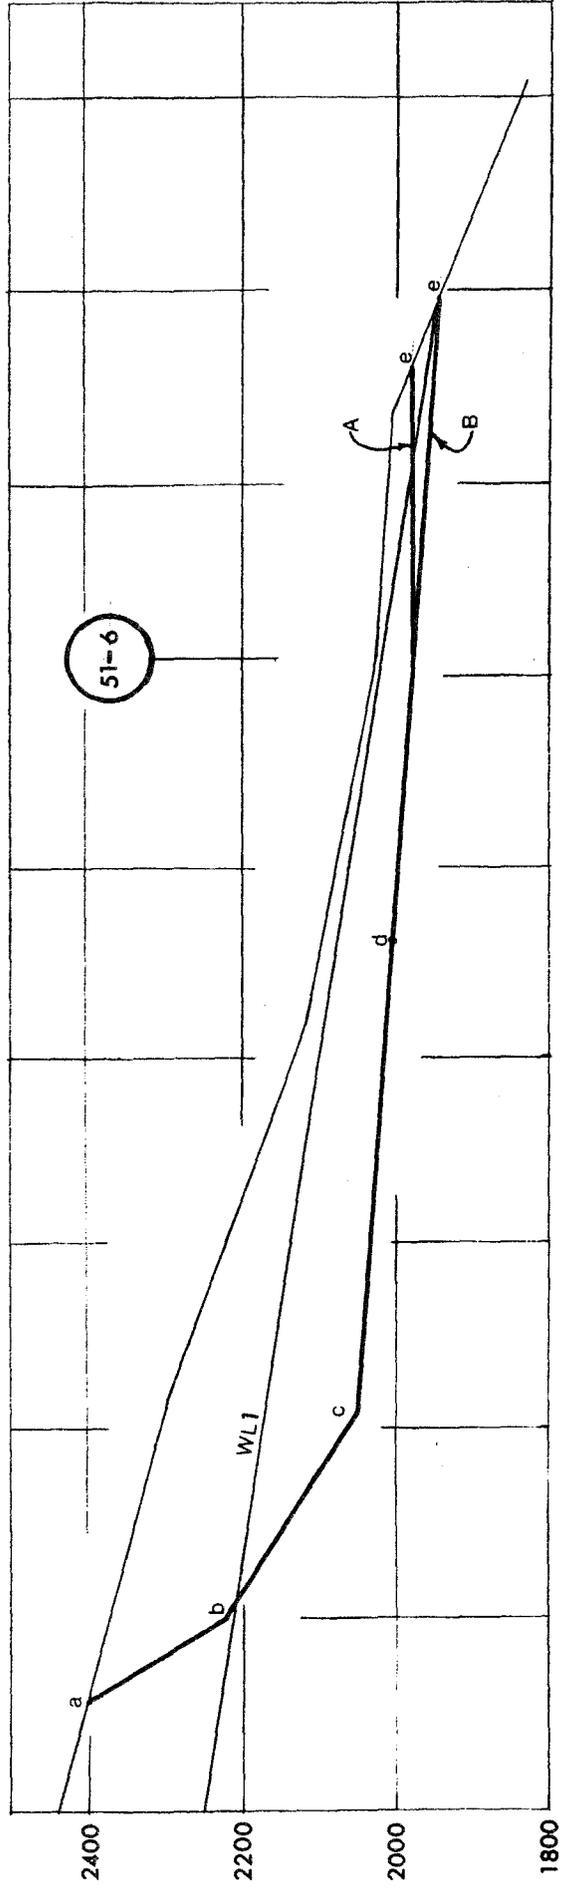
FIGURE B3

STABILITY ANALYSIS OF CACHE CREEK UPPER SLIDE (SECTION A-A)
