Site C Clean Energy Project

Temporary Upstream Fish Passage Facility Operations Report

Reporting Period: April 1 to 30, 2024

Prepared by BC Hydro

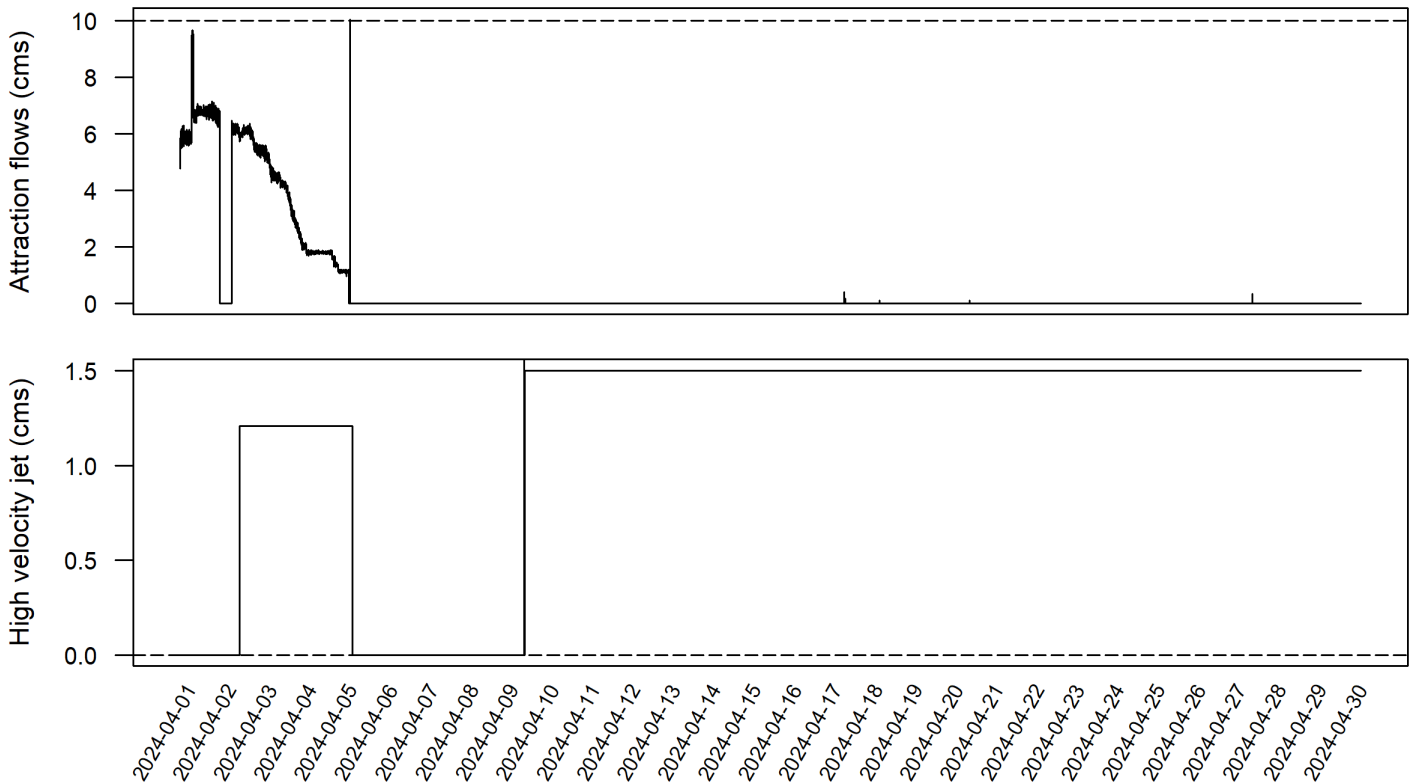
Figure 5. Operation of the attraction flows and high velocity jet during the reporting period.

In 2024, BC Hydro intended to operate the attraction flows and high velocity jet at 10 cms and 0 cms, respectively (horizontal dashed lines in Figure 5). However, within the first week of operations, the attraction flows steadily declined and system alarms indicated electrical faults with the horizontal propeller pumps. BC Hydro 'turned off' the horizontal propeller pumps on April 5, 2024 (top panel) and removed them from the pump station for a detailed inspection on April 15, 2024 (Photo 2). As such, the high velocity jet was operated at 1.5 cms for the remainder of the reporting period (bottom panel).

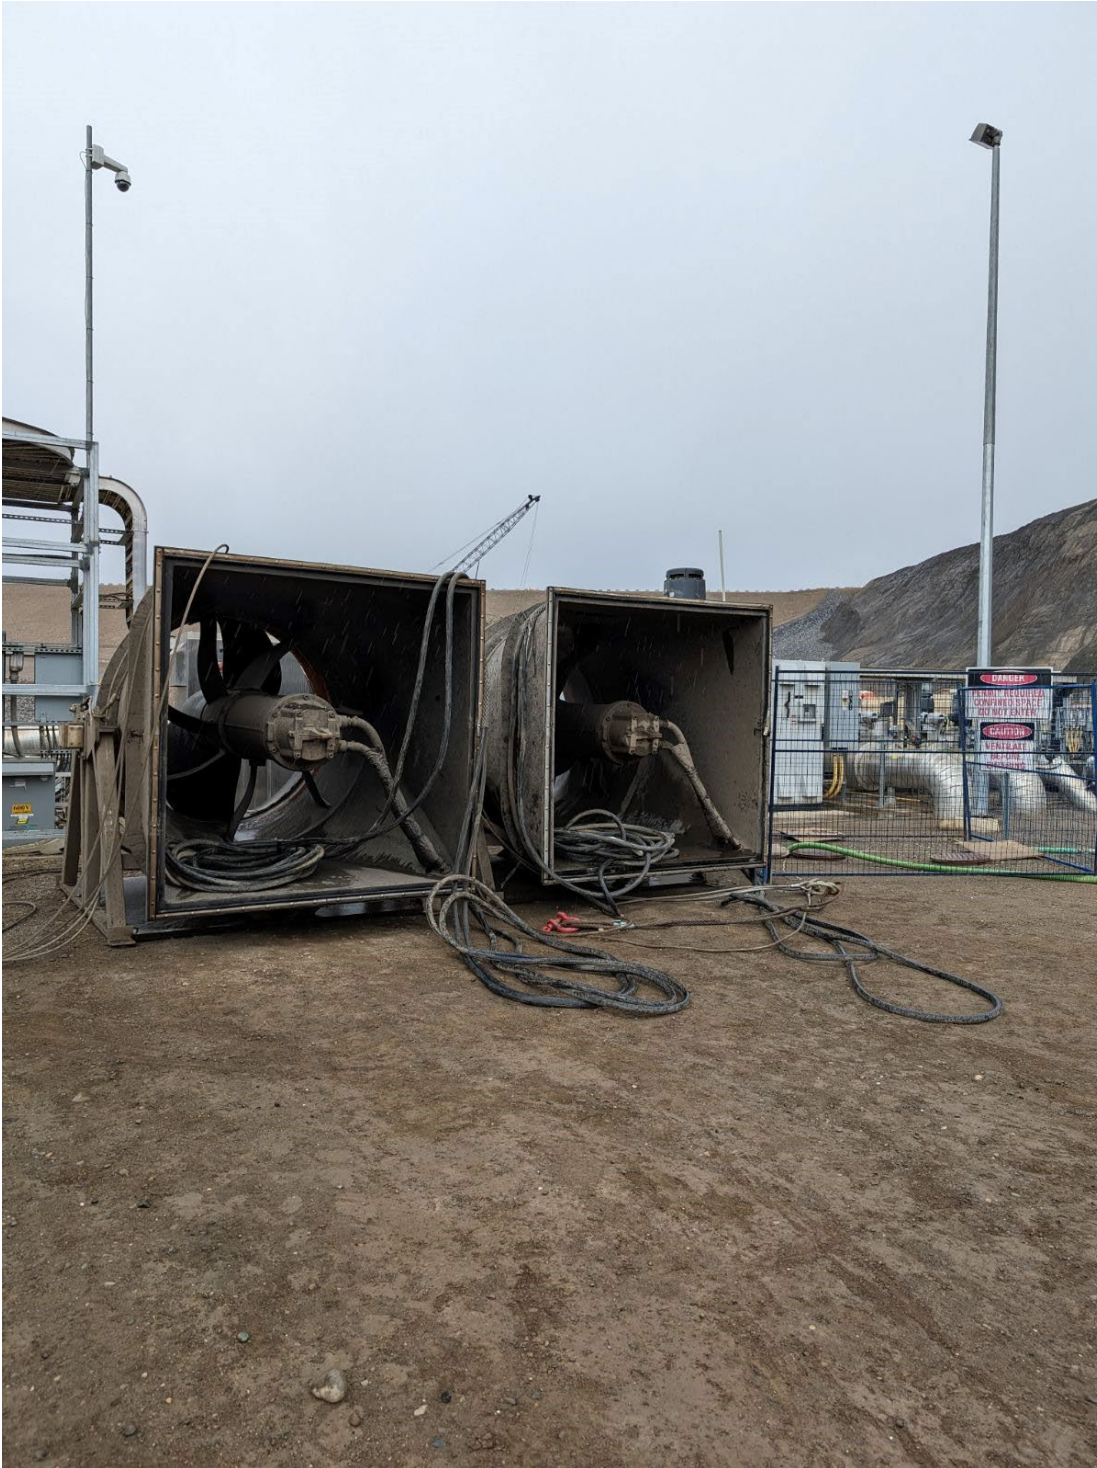
Attraction flows steadily declined during the first week of the reporting period and system alarms indicated electrical faults with the horizontal propeller pumps. On April 15, the horizontal propeller pumps were removed from the pump station for detailed inspection (Photo 2). Both pumps had sustained extensive damage from operation in previous years and were prepared to be shipped to the manufacturer for repair. As such, the temporary facility did not provide attraction flows during the reporting period.

Date	Standby or shutdown	Rationale
2024-04-15 10:11 to 2024-04-15 13:54	Shutdown	Facility shutdown for 3.5 hours to remove the horizontal propeller pumps from the pump station and perform a detailed inspection (Photo 2).

Photo 2. Horizontal propeller pumps – which provide the attraction flows at the temporary facility – were pulled from the pump station for inspection and repair (April 15, 2024).

Component	Adjustment
Mechanical operation	Due to the faulting and removal of the horizontal propeller pumps (Photo 2), the operator turned on the high velocity jet on April 9 to provide some level of attraction to the temporary facility. The HVJ was left on for the remainder of the reporting period.
