**Report Title:** Peace River Site C Development – Fisheries Habitat and Tributary Surveys  
1989 Studies

**Issuer:** Tim Slaney, Aquatic Resources Ltd

**Date:** July, 1991

**PEACE RIVER SITE C DEVELOPMENT:  
FISHERIES HABITAT AND  
TRIBUTARY SURVEYS**

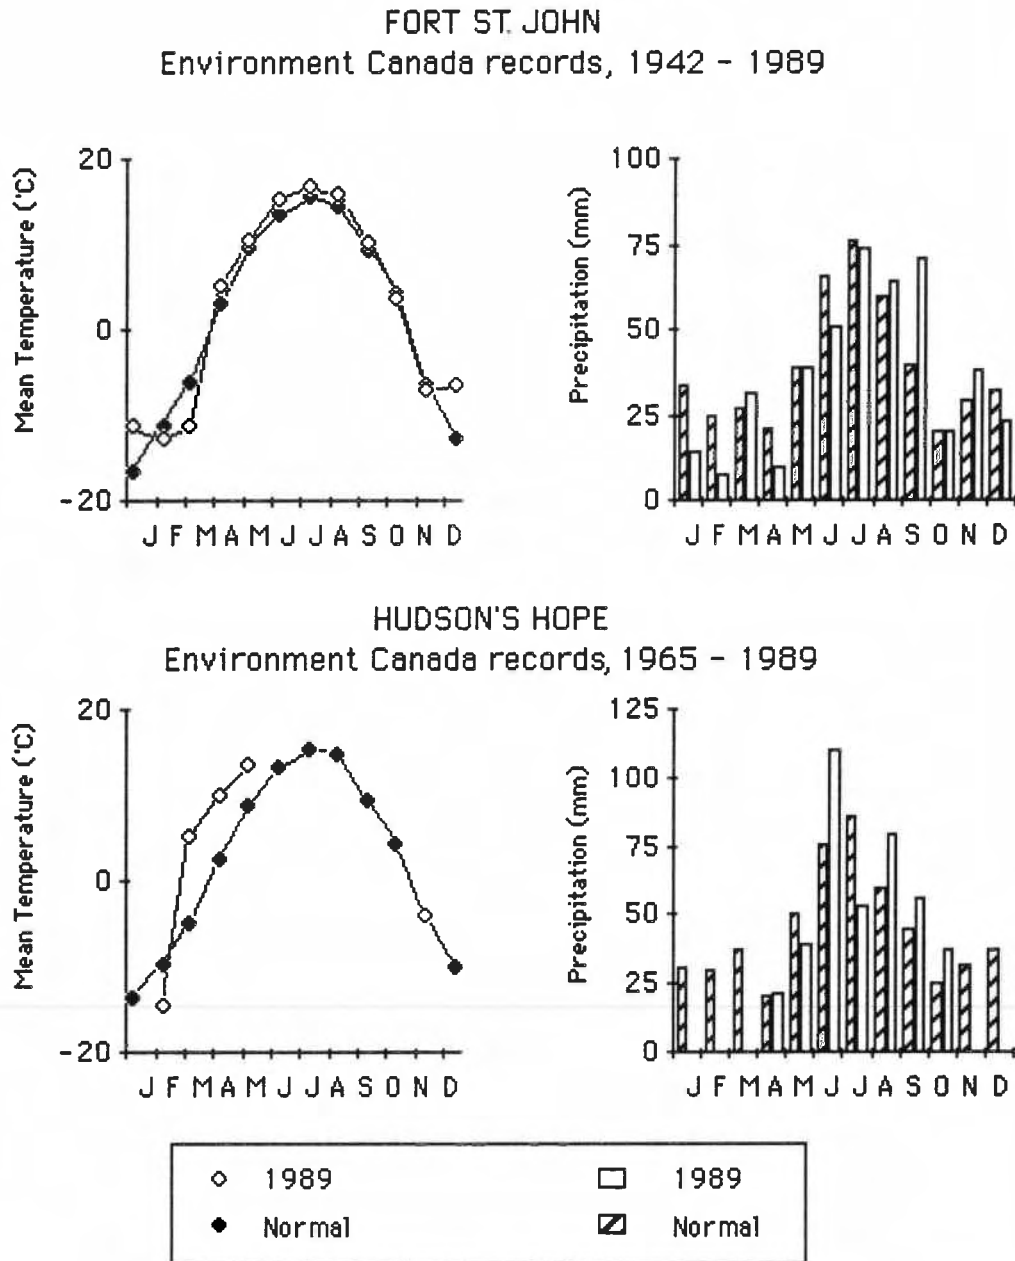
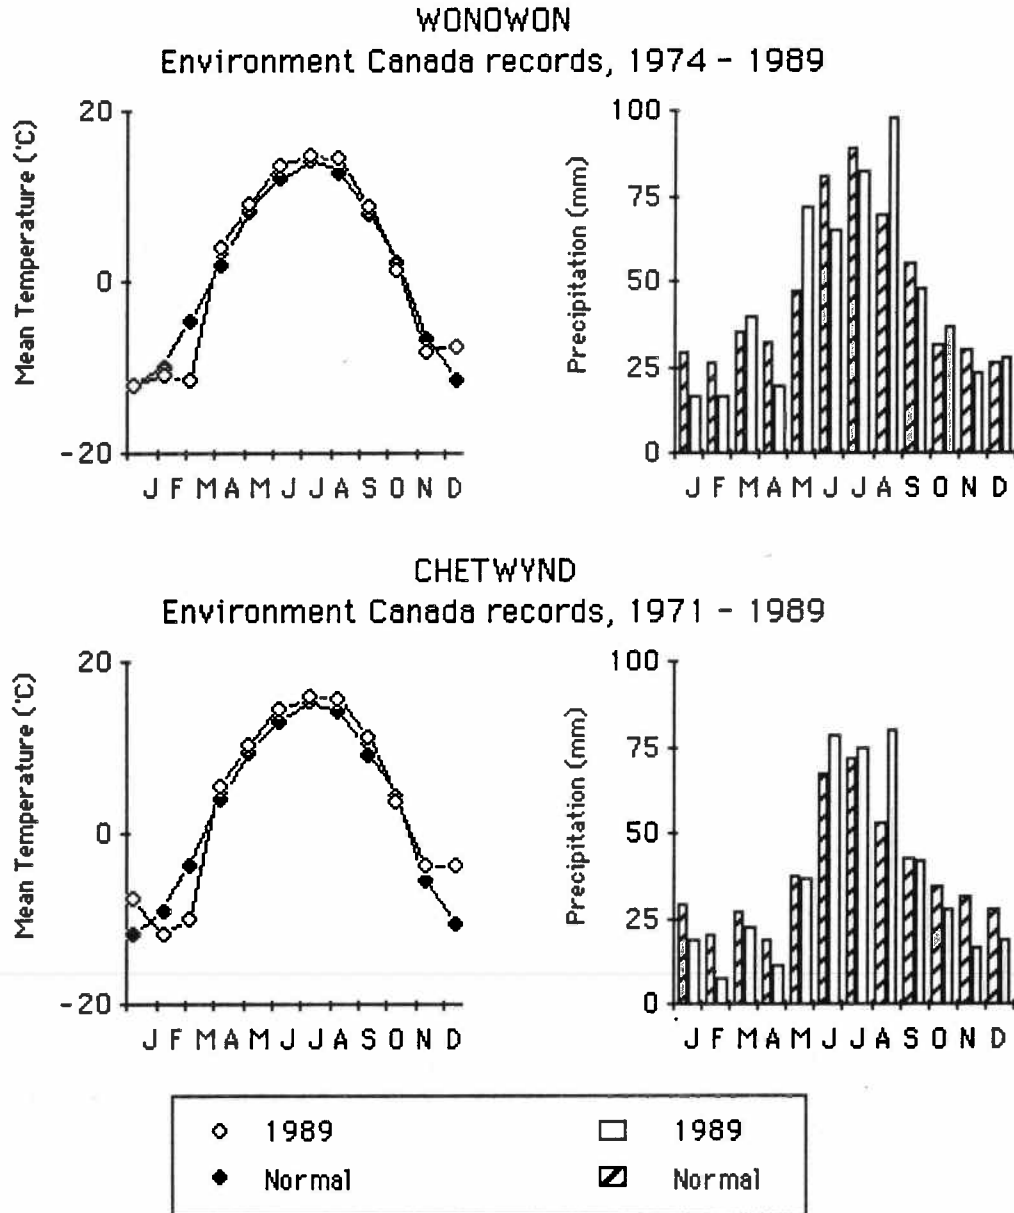
Figure 10.  
Temperature and precipitation in  
the Site C area, 1989.

All stations were slightly cooler than usual during the late winter of 1988/89 and slightly warmer over the summer months (Figure 10). The biggest deviation from this pattern was at Hudson Hope where, although records are not complete, March through May temperatures appear to have been 5 - 10°C above normal. During September, when the bulk of the biophysical survey was completed, temperatures were very close to the long term averages at all stations.

Figure 10 (continued)  
Temperature and precipitation in  
the Site C area, 1989.

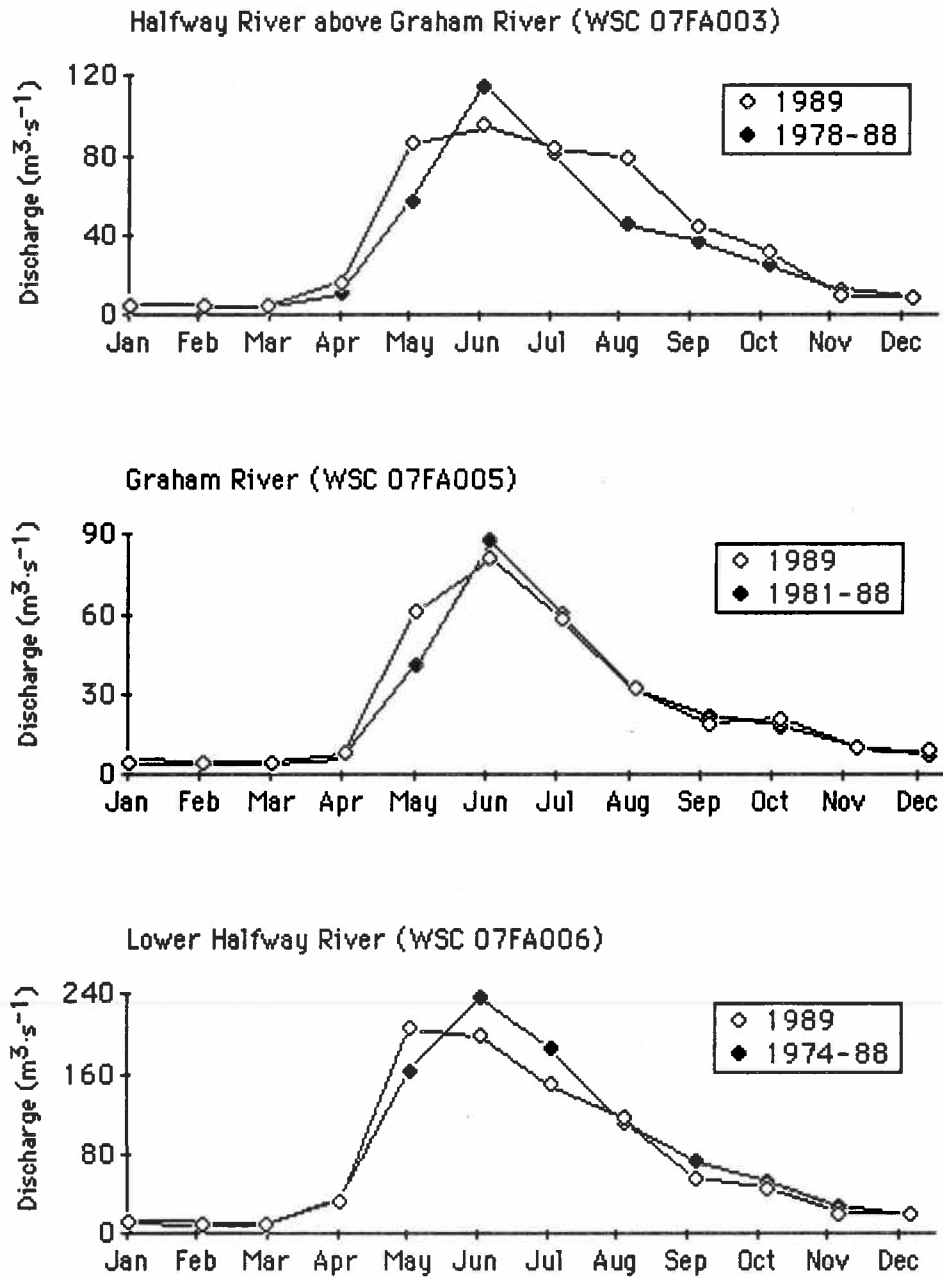
Figure 11.  
Discharge at stations in the Halfway system.

May through August (Figure 11) and were 22% above the 1978-88 normal by September.

The Halfway River discharge is typically at its annual mean during September (Figure 11, WSC 1989). However, during February and March the flows usually

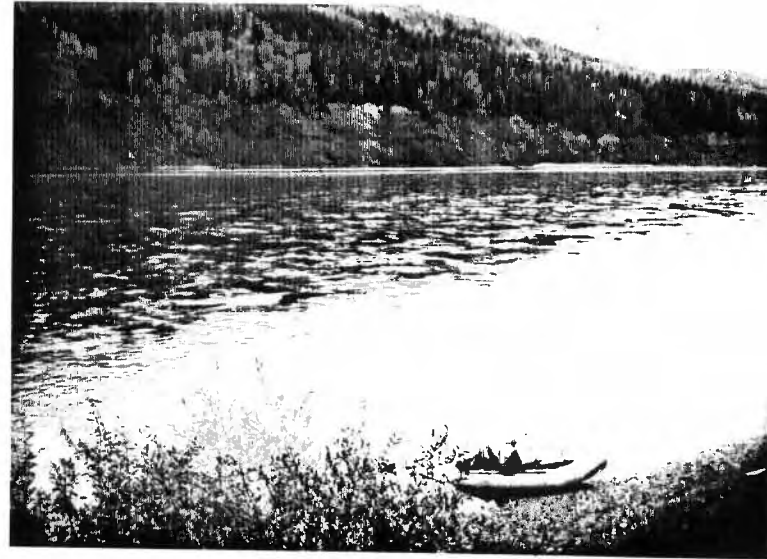
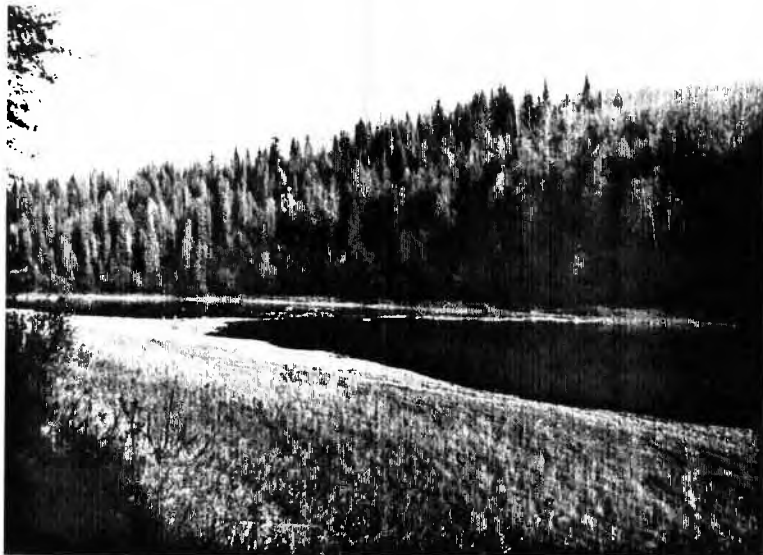
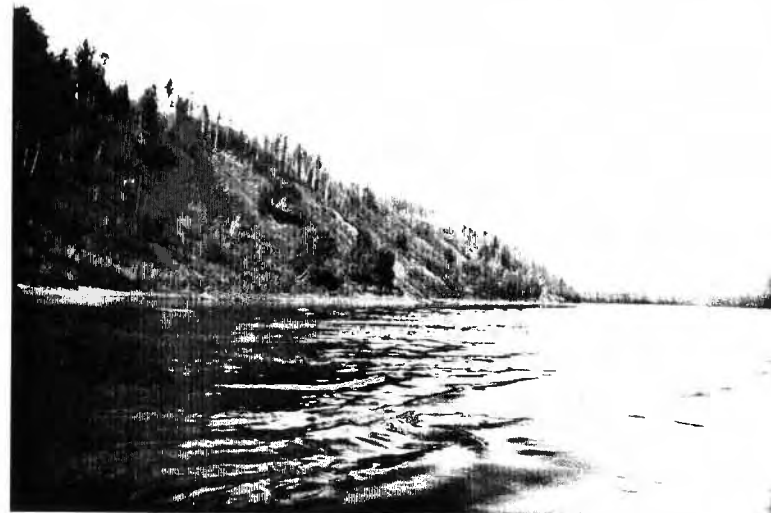
Deep glide habitats predominate in Reach 1 of the Peace River (upper right) which is bounded on the north side by steep silt and shale slopes. Reach 2 (lower right) is mainly a single channel although sloughs and secondary channels (below) are found in both reaches.

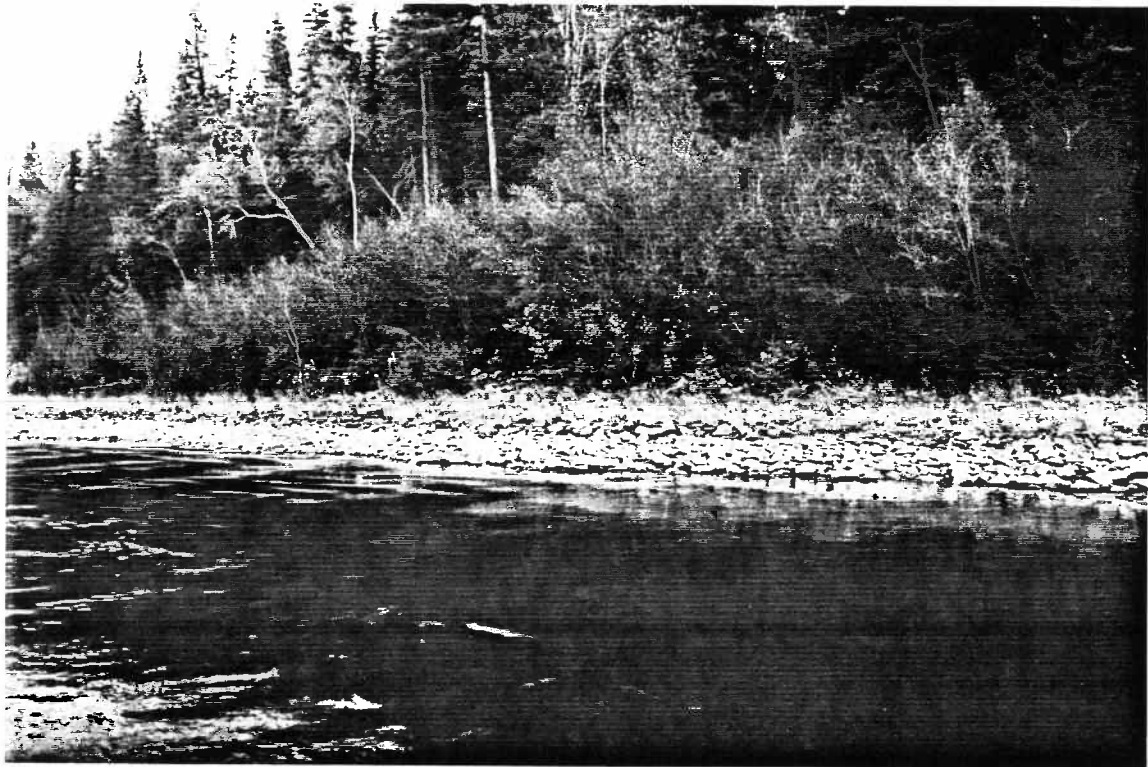
Plate 2.

Peace River Reach 3 extends 12 km upstream from sandstone outcrops at 'the Gates' (above). Turbulence in the foreground is caused by a series of stone sills. Cobble and boulder is common on the islands and bars of this reach and increased stability is evident in the succession of riparian vegetation (below).

Reach 3 extends from the Gates (km 66, Plate 2) upstream to the mouth of Maurice Creek (km 78). The area was examined September 26 - 27, 1989 when discharge ranged from 1,170 - 1,050 m<sup>3</sup>·s<sup>-1</sup>. Water velocity was near 0.8 m·s<sup>-1</sup> in most of the thalweg glide although it increased to 1.8 m·s<sup>-1</sup> near km 73. Overall gradient (0.059%) is slightly higher than Reach 2 particularly near km 74 where velocities of 2 m·s<sup>-1</sup> were observed. Channel form is again simpler than in the preceding reach although there is a large island and side channel complex along the south shore just downstream from Maurice Creek. Deep glide was again most common (79%) while riffle (16%) was a larger proportion than in Reach 2 (Table 5). Banks on both shores are steep and largely composed of silt with varying proportions of gravel, and boulder. The absence of vegetation in many areas suggests constant erosion.

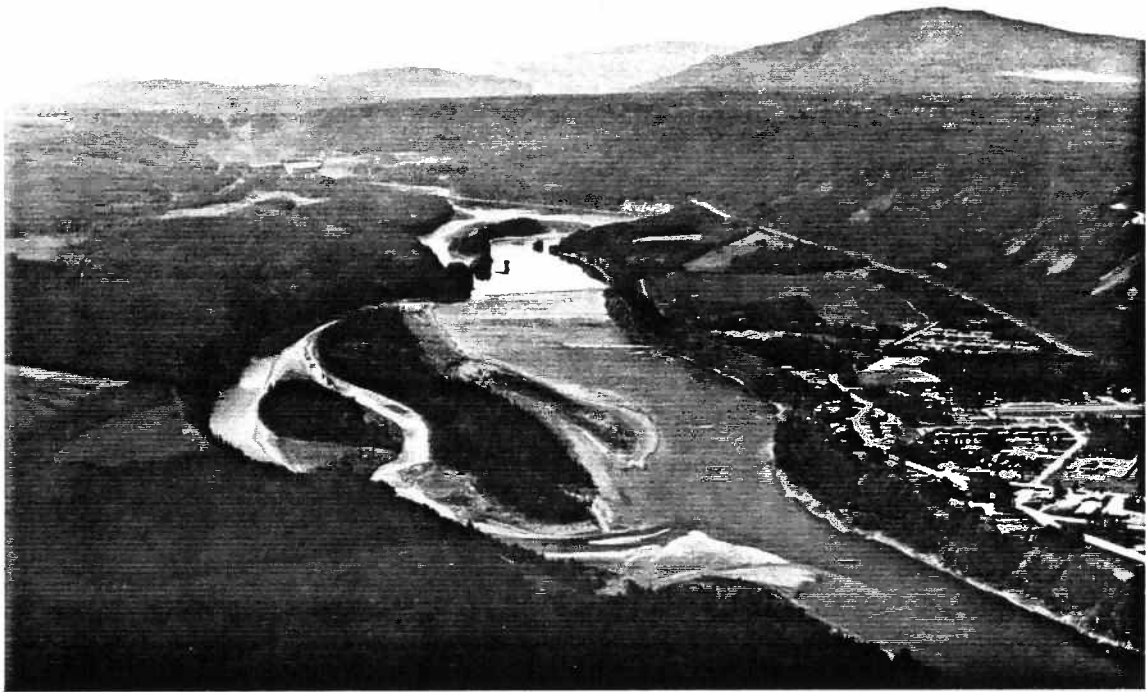
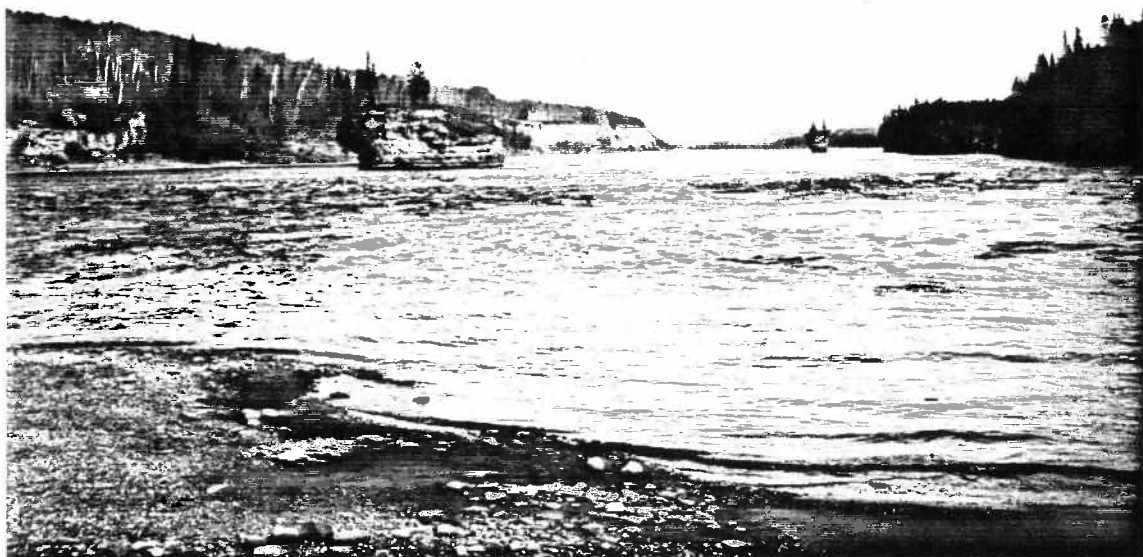
Plate 3.

Peace River Reach 4 is confined by vertical sandstone walls over most of its length (upper) and a series of sills extends out across the mainstem. At the 'Coffee Pot' outcrops, deep holes, and large gyres result in productive fish habitats (lower).

Reach 4 extends from Maurice Creek (km 78) upstream to the Peace Canyon Dam. The reach is quite distinct from those below due to an increased gradient (0.11%) and large areas of sandstone and siltstone in both bank and channel substrates (Plate 3). Dominant habitat type is riffle (1.03 km<sup>2</sup>, 54%) with deep glide comprising 41% of the reach's total area. The north shore is confined by near vertical sandstone walls 30 - 40 m in height which extend almost the whole length of the reach. On the south shore, steeply cut silt and shale banks approximately 30 m in height extend from the mouth of Maurice Creek upstream to km 80. Above km 80, the south bank is vertical sandstone similar to that of the north shore. The thalweg lies along the north shore through most of this reach and steps down over a series of sandstone ledges which extend out from the north shore. The ledges and numerous rock outcrops result in numerous small but deep holes and pools. The area was surveyed September 27, 1989 when the Peace River discharge was 1,050 m<sup>3</sup>s<sup>-1</sup>. Water velocities exceeded 2.5 m·s<sup>-1</sup> throughout most of the main channel areas but there were low or negative water velocities in many of the deep holes, pools and gyres. At the downstream end of the reach, water depth over the ledges was generally <1 m increasing to 2 m in the channels between them. Further upstream, water depth increased to 3.5 - 5 m in between the ledges.

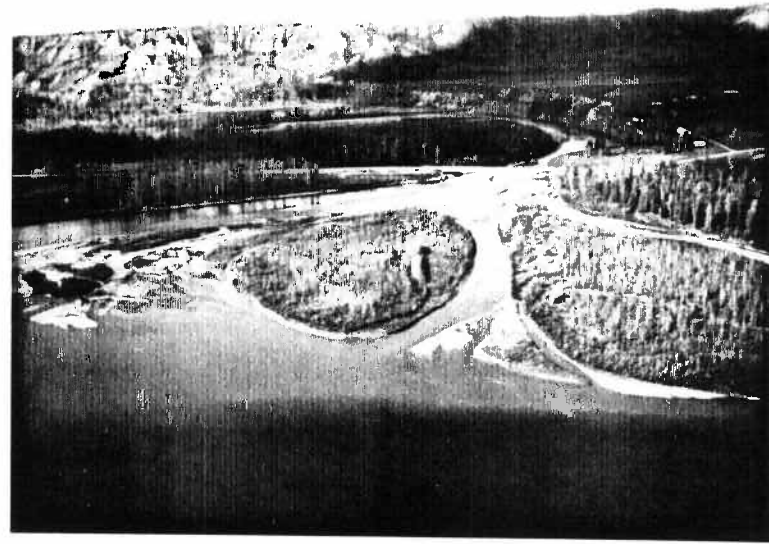
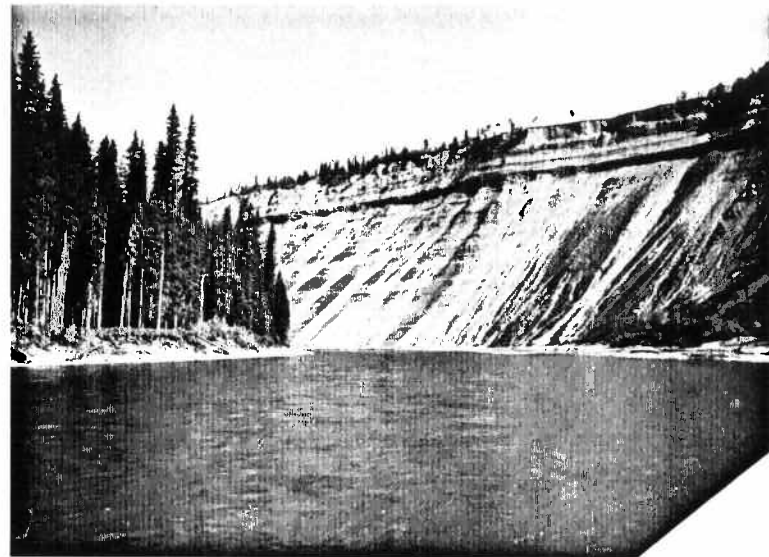
The Halfway River discharges into the Peace River through a shallow delta (upper right). Further upstream, Reach 1 is confined by cut banks up to 220 m in height (lower right). In Reach 2, the valley opens out and the river becomes braided.

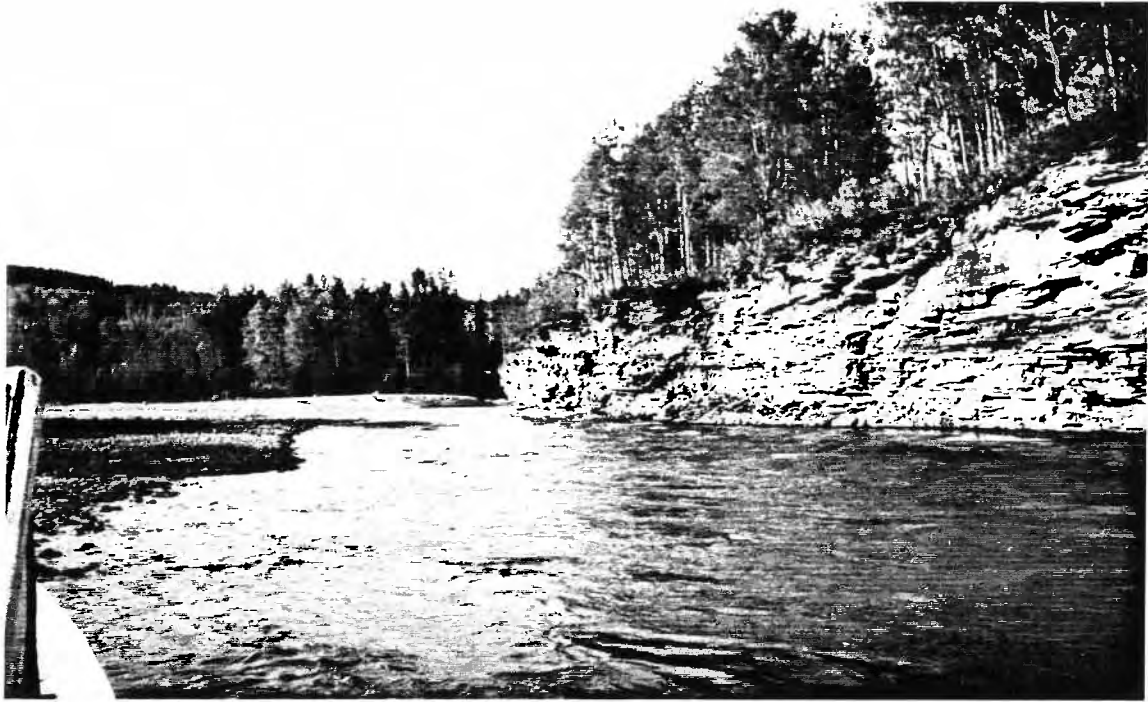
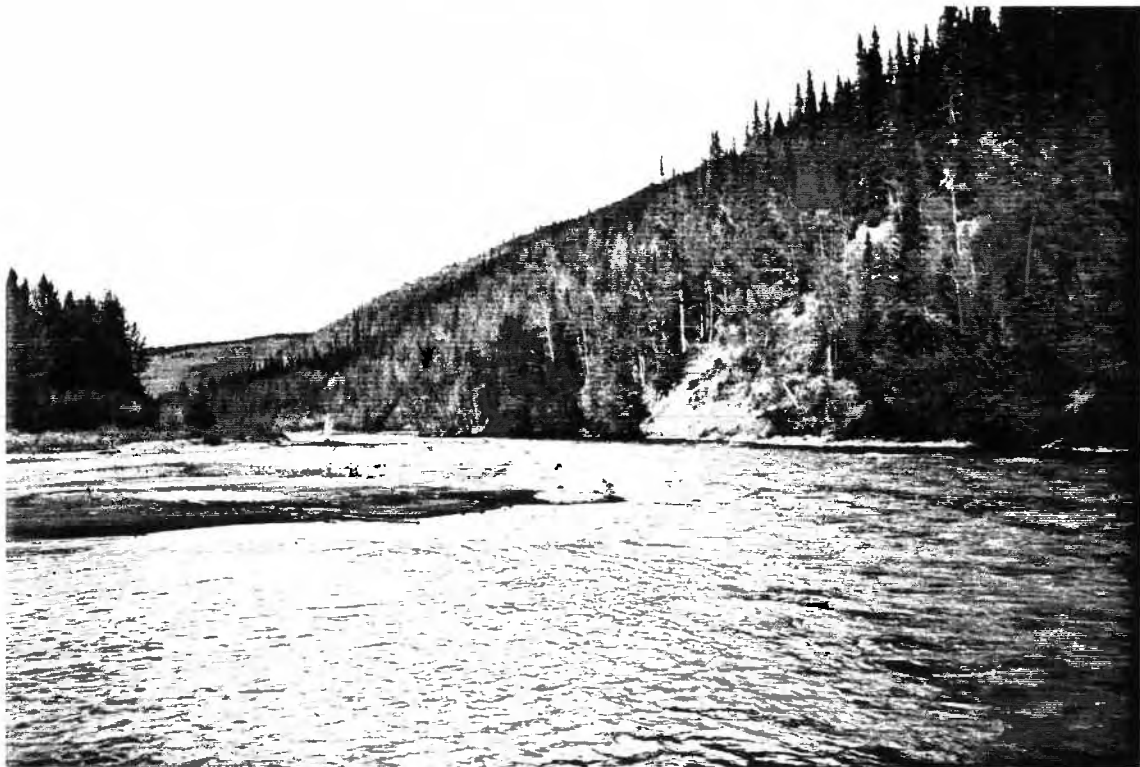
Plate 5.

Reach 3 of the Halfway River (upper) passes over a series of sandstone sills including this one at the confluence of the Graham River. Further upstream, Reach 4 has a braided character although occasionally confined by the valley's eastern side (lower).

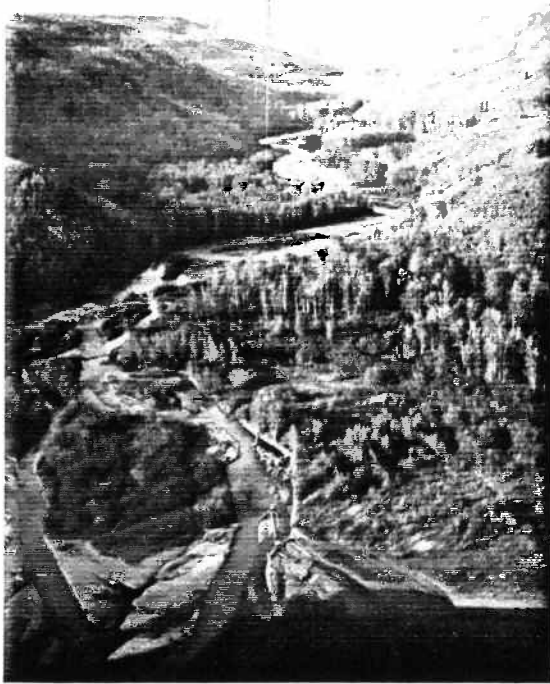
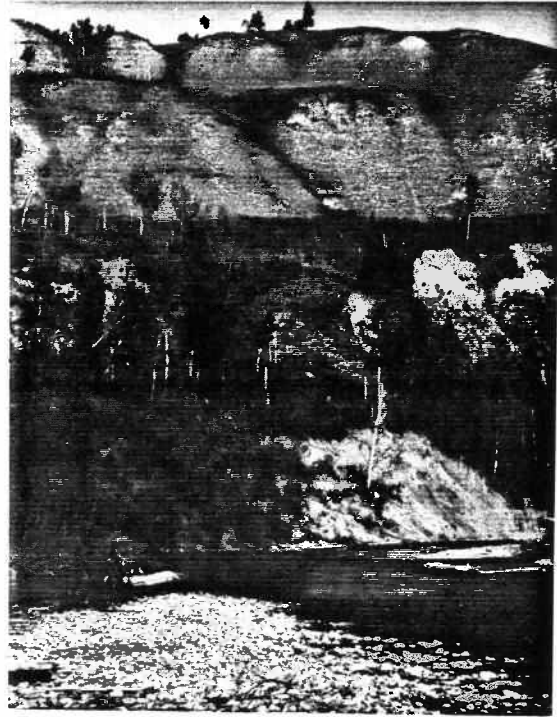
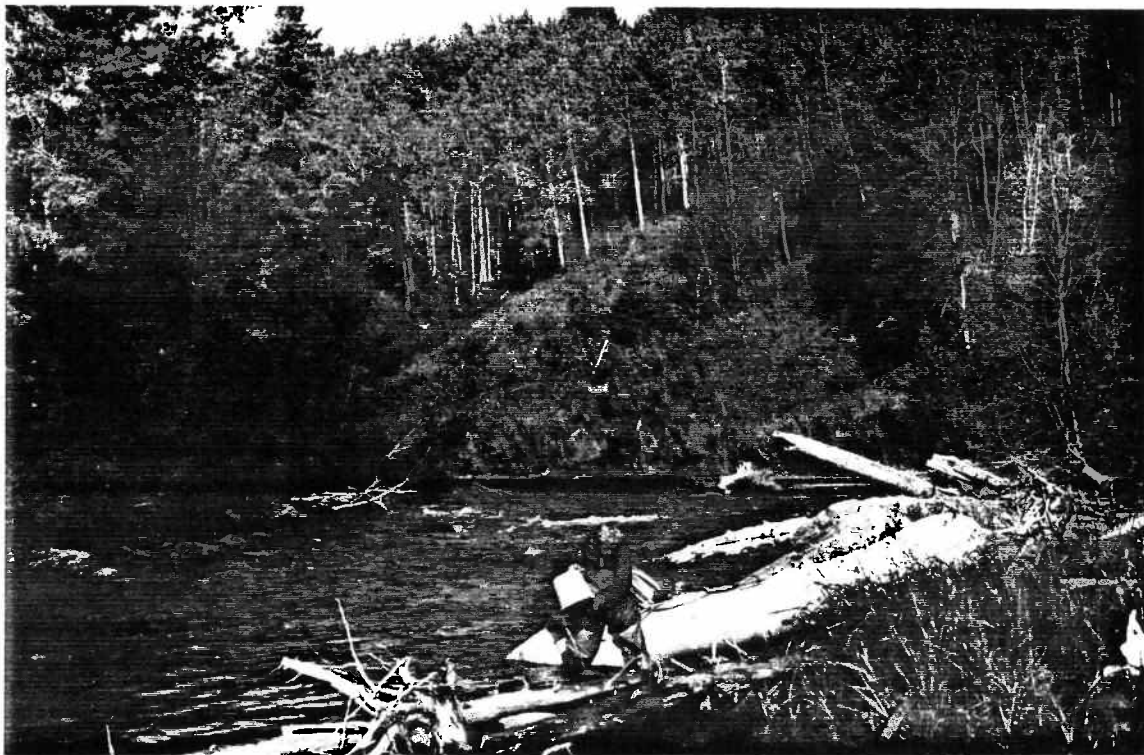
Plate 6.

Moberly River Reach 1 (above) is fast flowing and braided with large amounts of organic debris and other evidence of recent channel changes. Reach 2 (below) has a single channel and much greater confinement.

The 130 km of river between Moberly Lake and the Peace River consists of five reaches (Figure 3). Reach 1 extends from the mouth at the Peace River to a point approximately 25 km upstream. The channel along this section is unstable, braided and has an abundance of organic debris (Plate 6). The banks are eroding in many places causing trees to fall into the channel. In other places, aggradation is evident. The habitat consists largely of riffle (42%) and shallow, fast flowing glide up to 1 m deep (37%) (Table 8). Mean gradient is 0.5% and there is little pool habitat. The channel is occasionally confined and has an average width of 33 m. The Site C reservoir would flood 298,000 m<sup>2</sup> or about 46% of Reach 1 (Table 8). This includes all of the deep glide/riffle complex and shallow pool habitat but is otherwise similar to the unaffected portion

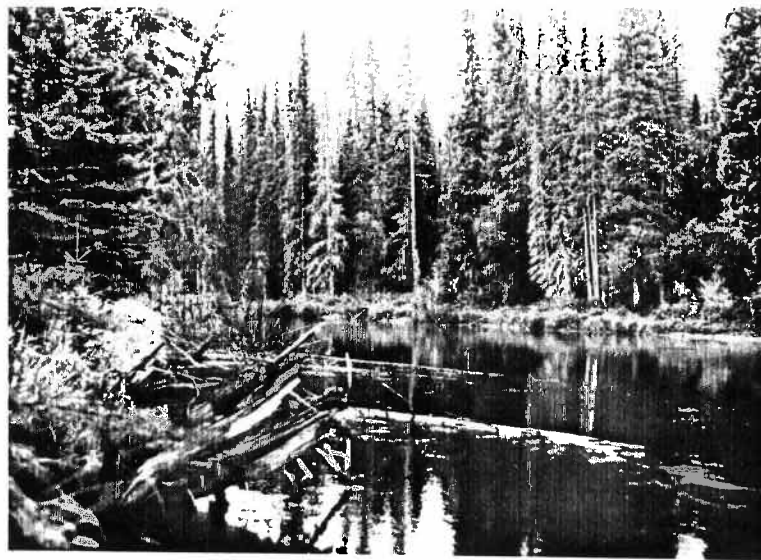
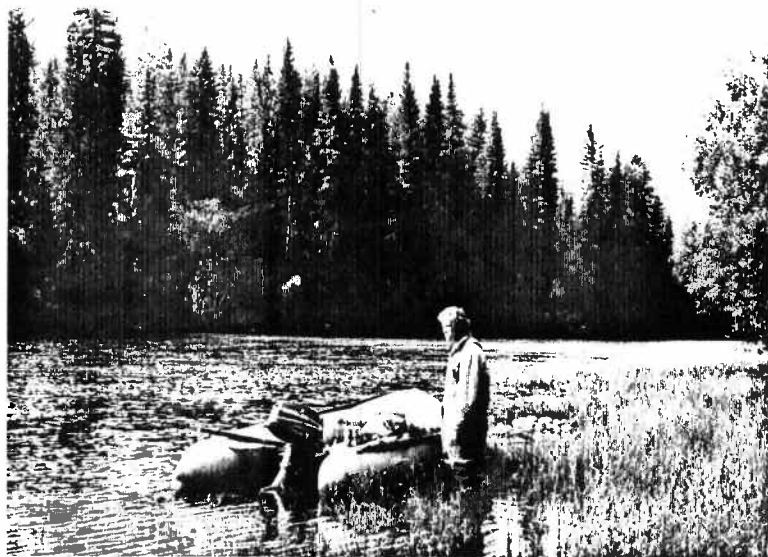
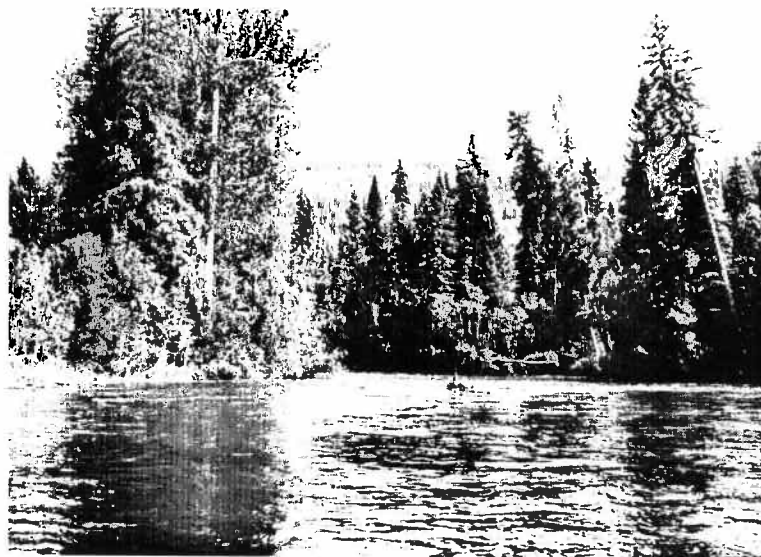
The gradient of the Moberly River declines in Reach 3 (right) and the system meanders through a series of glides. It becomes slightly steeper in Reach 4 (lower right) with about 20% riffle. Reach 5 regains the slow glide character with large areas of submergent vegetation and moderate numbers of northern pike.

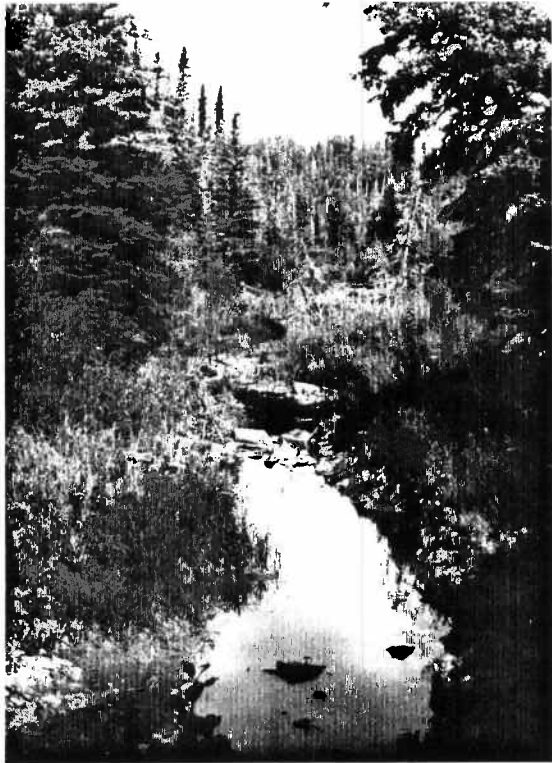
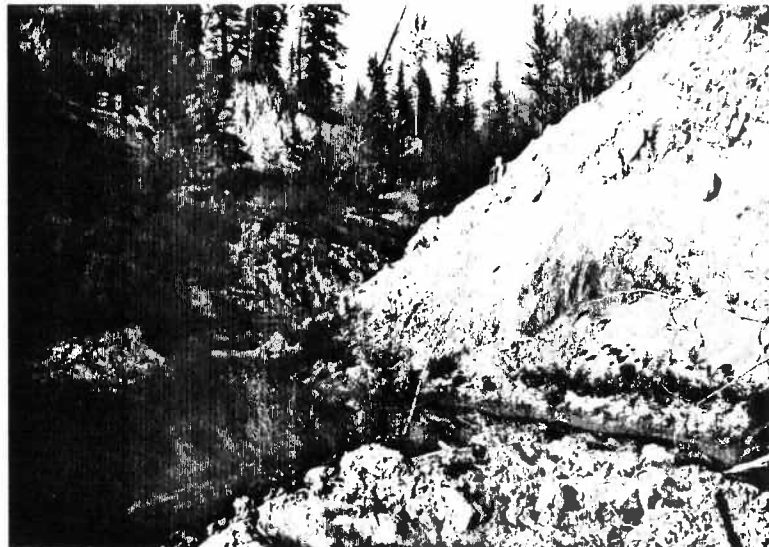
Wilder Creek drops steeply down to the Peace River. Banks in Reach 1 (lower right) are eroding rapidly. Further upstream, near the highway, gradient decreases and the creek flows through a series of beaver ponds (below).

The dams create ponds that average 100 m in length and 8 m in width. Although this section of creek is still confined, it is not canyonous in nature like Reach 1. The valley walls slope back from the stream channel at a much lower gradient. Beaver pond habitat comprises about 30% of the reach (Plate 8). Another 35% consists of smaller pools averaging 25 cm deep in a 5 m wide channel. The rest of the stream was almost dry with flows at approximately  $0.02 \text{ m}^3\text{-s}^{-1}$

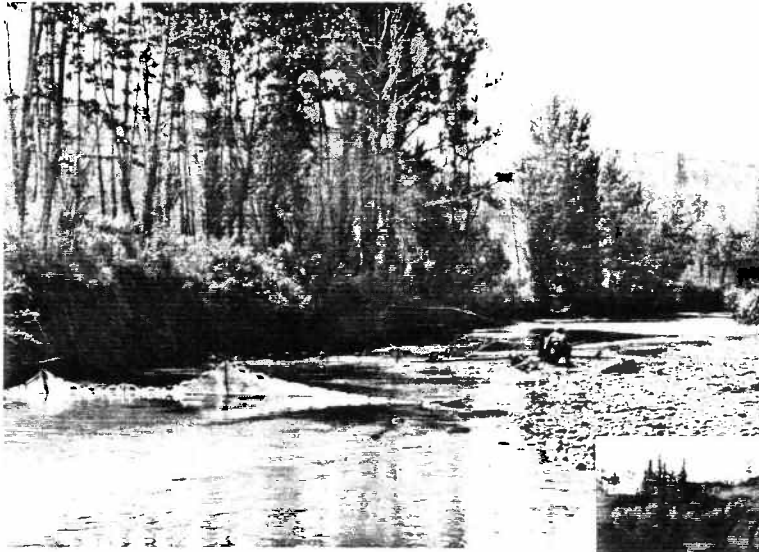
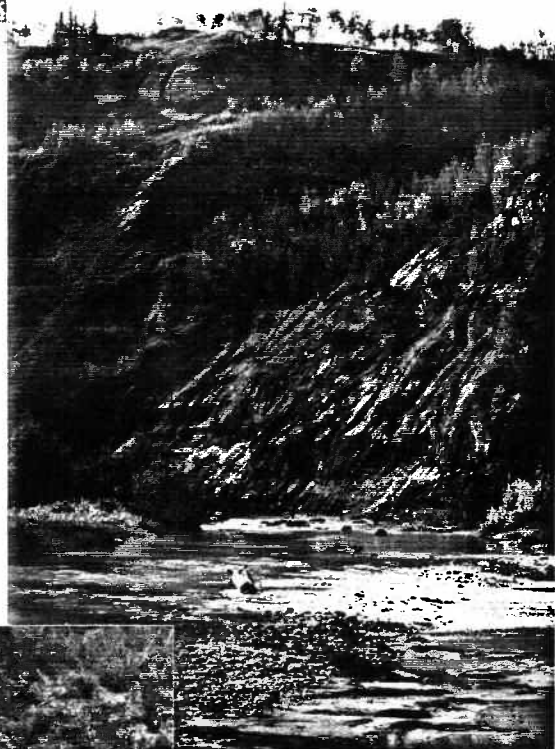
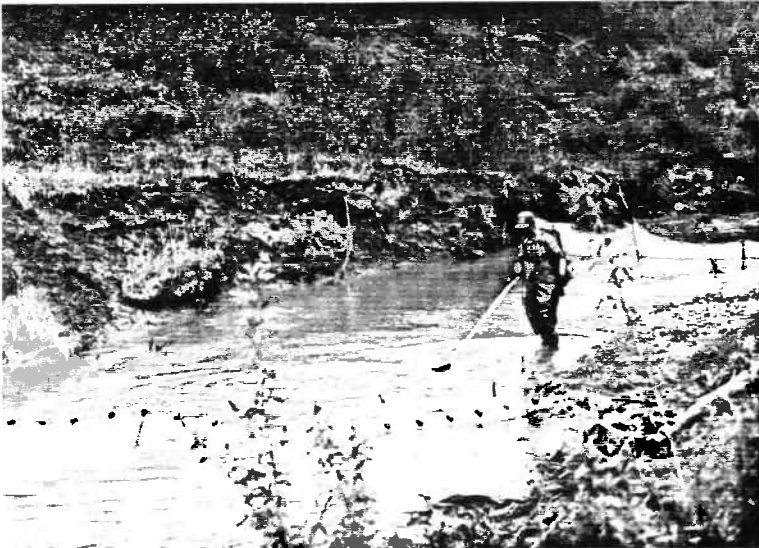
Plate 9

Reach 1 of Cache Creek in June, 1989 (above). By September this area had become a series of shallow pools. Much of Reach 2 is confined by instable banks which contribute large amounts of silt to the system (right). Gradient and confinement decline in Reach 3 (below).

Reach 2 extends above Red Creek to a point 20 km from the Peace River. As Red Creek contributes a substantial portion of the system's flow, the Cache Creek channel is much narrower (16 m wide) above this confluence. Habitat in Reach 2 consists mainly of pools 8 to 60 m long and 3 m wide with average maximum

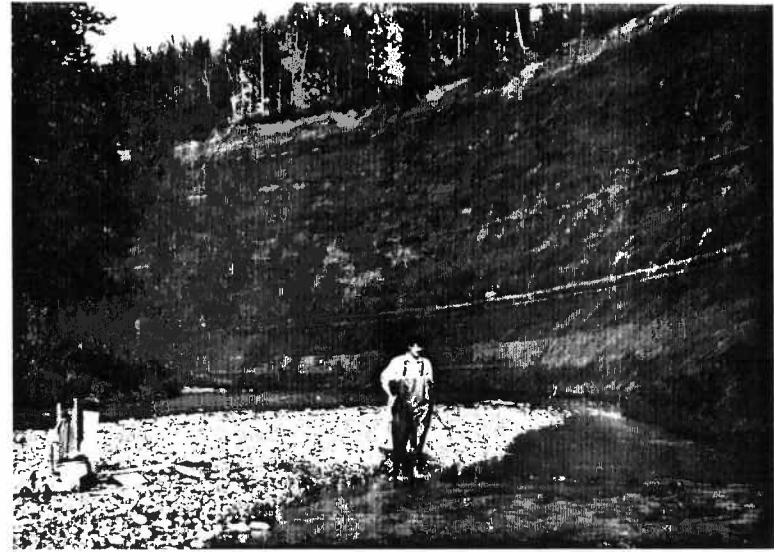
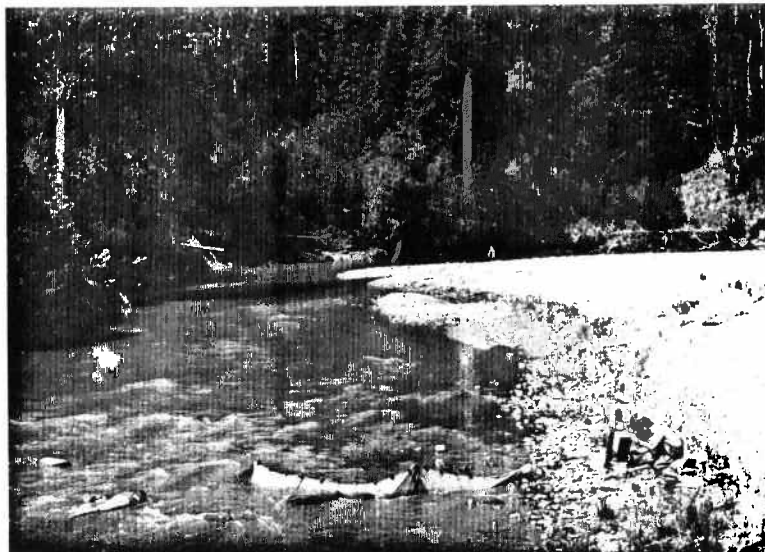
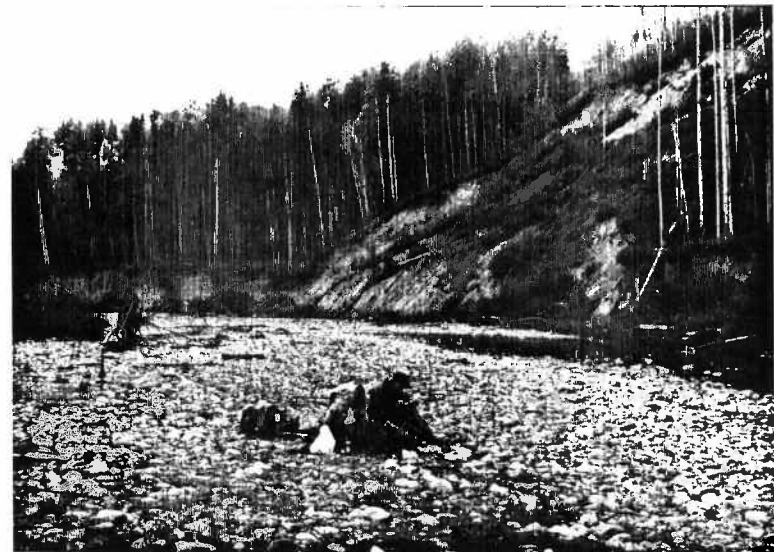
Lower Farrell Creek contains some deeply entrenched meanders which are bounded by silt and shale banks (right). In Reach 2, the valley opens up. At 10 km (lower right) the channel width begins to increase and at 20 km (below) decreased gradient results in a series of shallow glides.

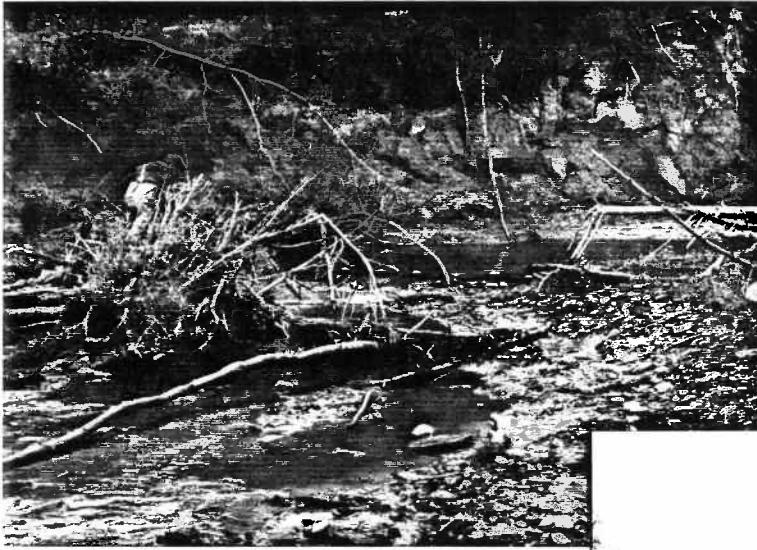
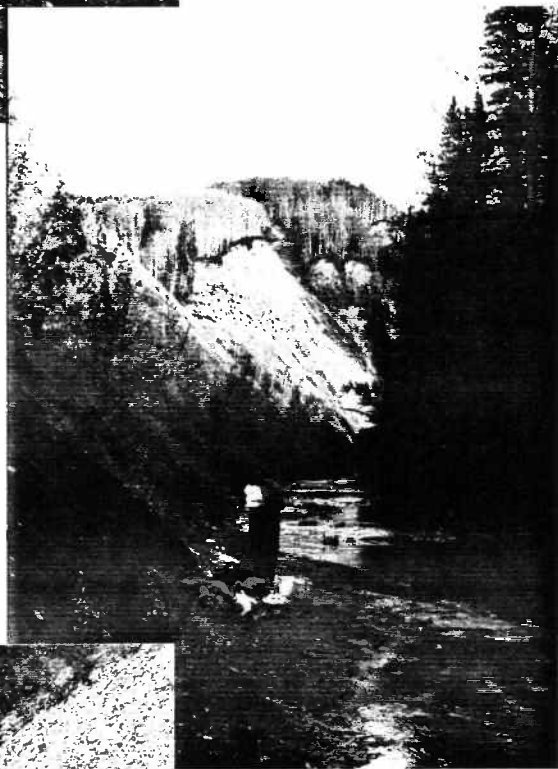
Plate 11.  
Shallow glide and riffle predominate in Reach 3 of Lynx Creek (above). In Reach 4 the system is confined by unstable valley walls up to 150 m in height. Reach 5 is less confined, has a lower gradient, and contains many beaver ponds (below).

Gradient decreases from 2% in Reach 4 to 0.55 in Reach 5, and the proportion of pool habitat increases to 40%. The pools are largely created by 15 or more beaver

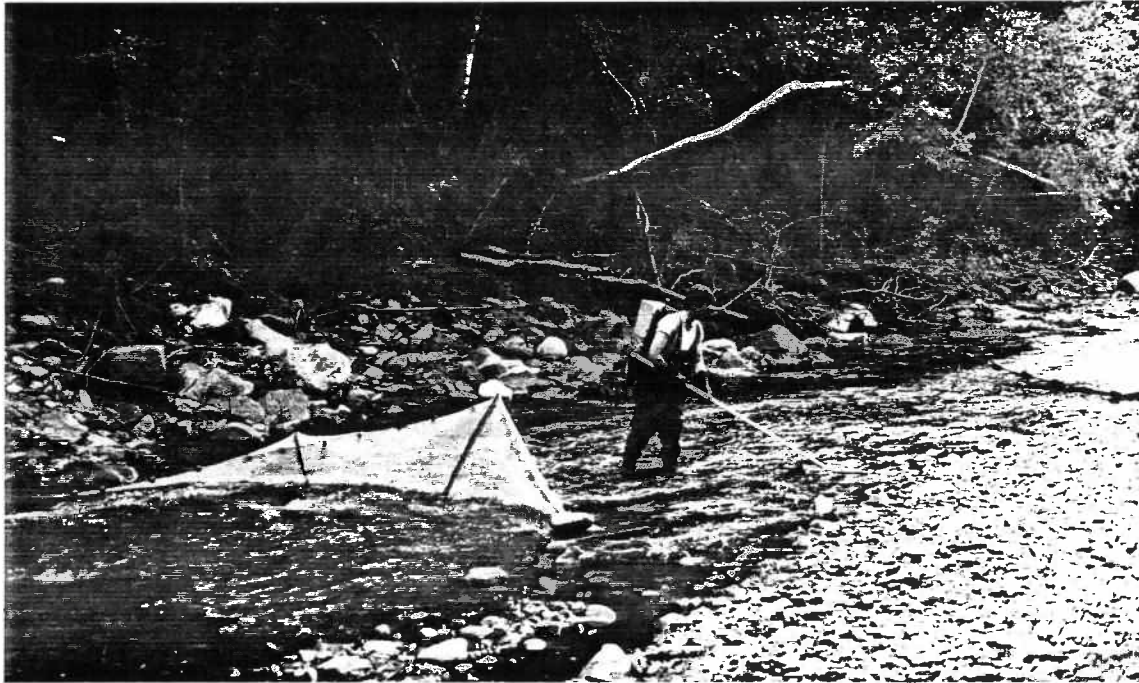
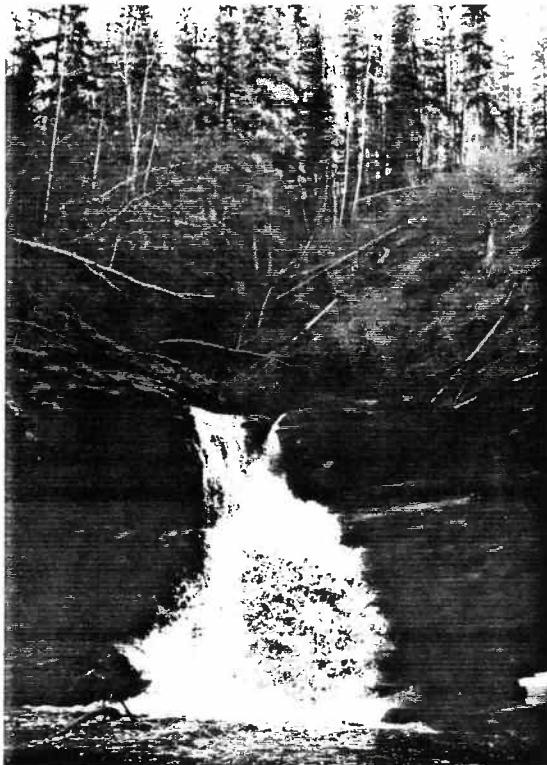
Plate 12.

Reach 1 of Maurice Creek is 1.7 km long and supports spawning and rearing rainbow trout from the Peace River (above). Reach 2 is very confined and carries a high silt load in the spring (below right). It could support rearing trout but is isolated by a series of five water falls up to 30 m in height.

Reach 2, extending from 1.7 km to the end of the study area at 10.5 km, is entrenched into the Peace River plateau. Most of the creek along this reach

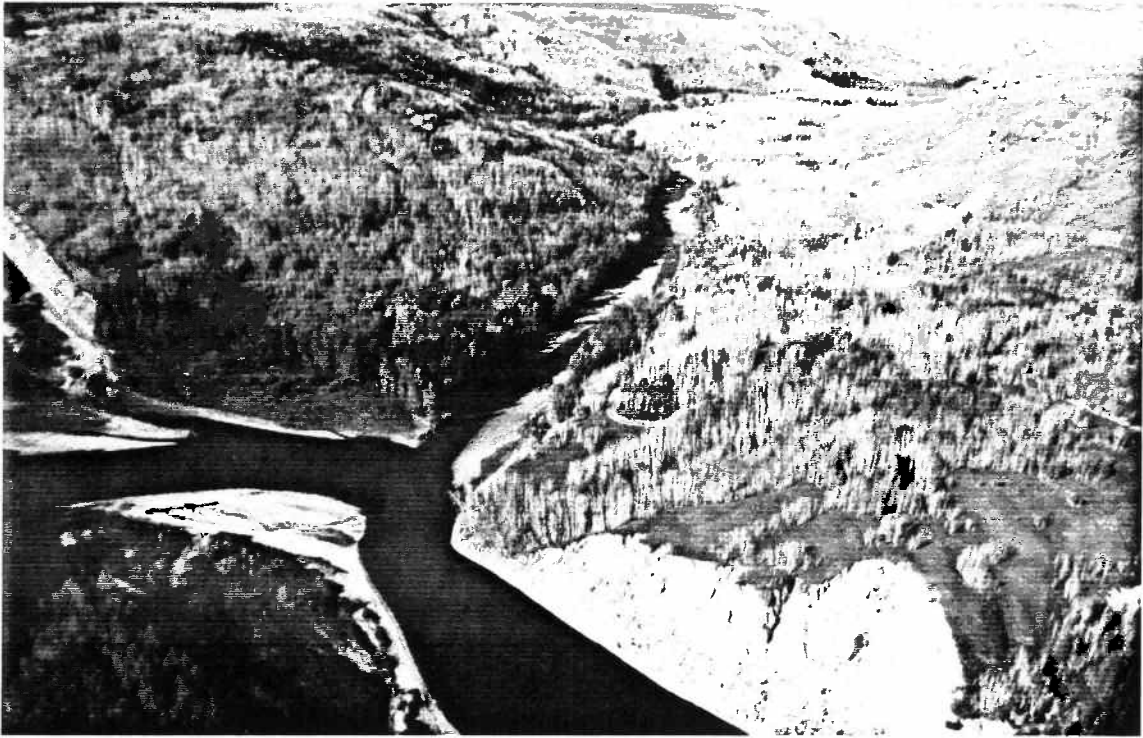
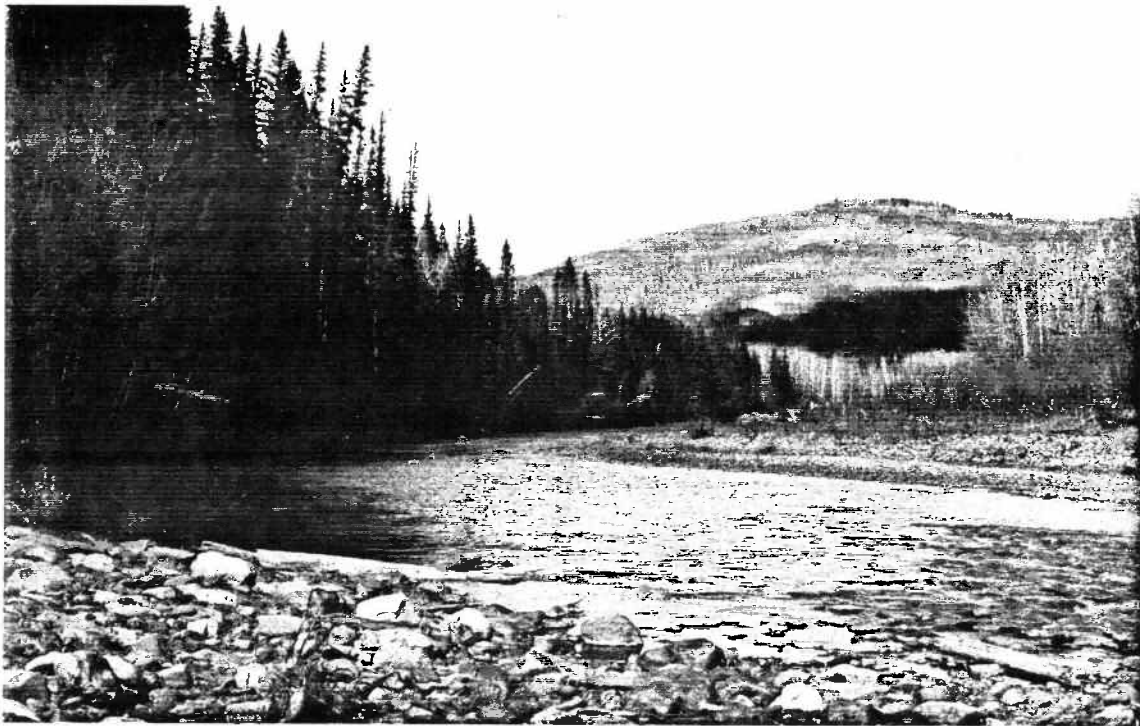
Plate 13

The Cameron River contributes a large amount of silt to the Halfway River even during low flows in late fall (above). It has a moderately stable channel and is largely shallow glide (below).

Reach 1 extends from the Halfway River to 2 km. The 27 m wide channel is unstable so the banks are eroding and aggrading in many places and there is an abundance of channel debris. In a few areas the channel is cutting into the valley wall and causing some slumping. Most of the habitat is riffle and glide (Plate 14). Average maximum depth of the few (5%) pools was 0.9 m.
