**Report Title:** Peace River Site C Development – Fisheries Habitat and Tributary Surveys  
1989 Studies

**Issuer:** Tim Slaney, Aquatic Resources Ltd

**Date:** July, 1991

**PEACE RIVER SITE C DEVELOPMENT:  
FISHERIES HABITAT AND  
TRIBUTARY SURVEYS**

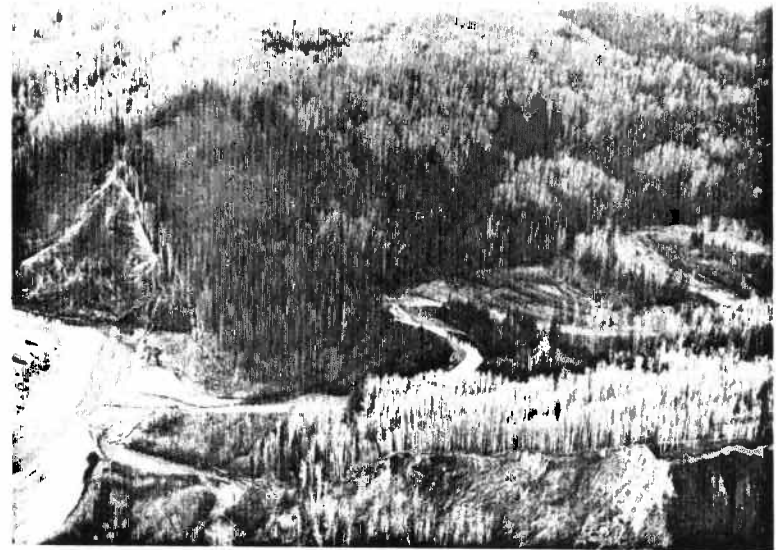
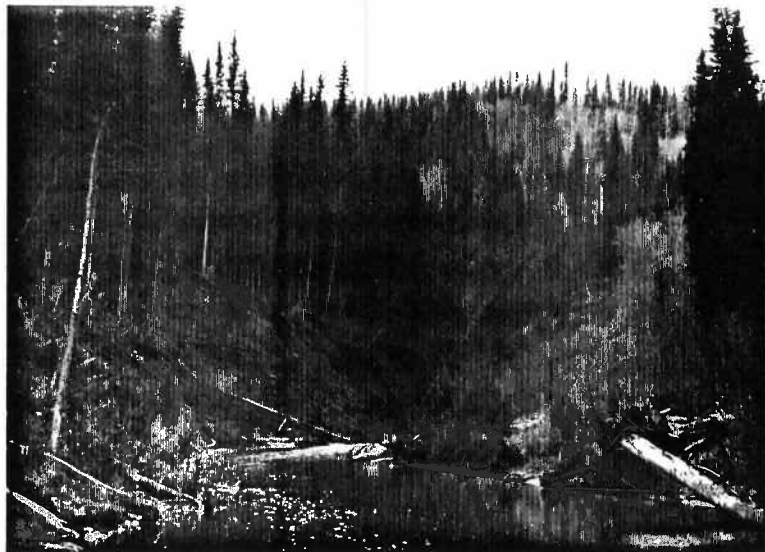
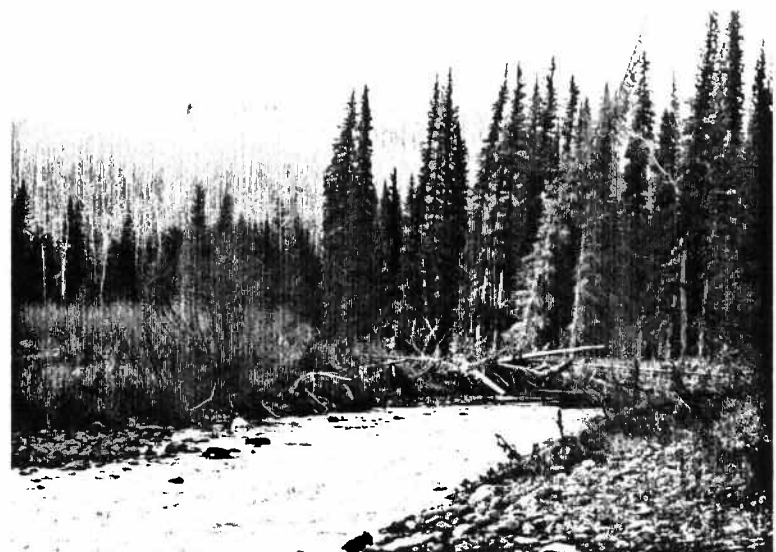
Plate 14

The lower reach of Ground Birch Creek meanders irregularly and shows signs of active channel movement (right, below right). In Reach 2, the channel becomes narrower and more confined (below)

In Reach 2 the channel is more stable, narrower (17.1 m) and becomes more confined. There is less bank erosion and less channel debris (0-5%) in this reach. The channel cuts into the valley walls in several areas, creating slumps and exposing steep, shale slopes up to 30 m in height. The stream contains 5% pool, 30% riffle, and 65% glide. Average maximum pool depth was 1.3 m.

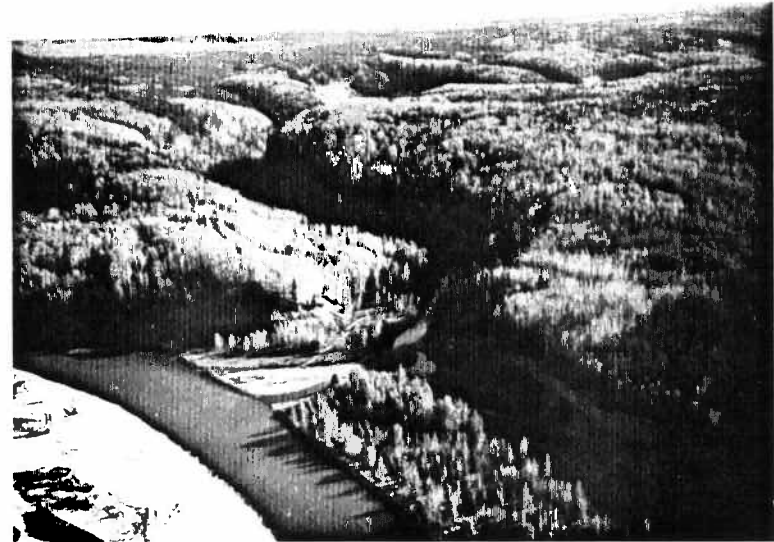
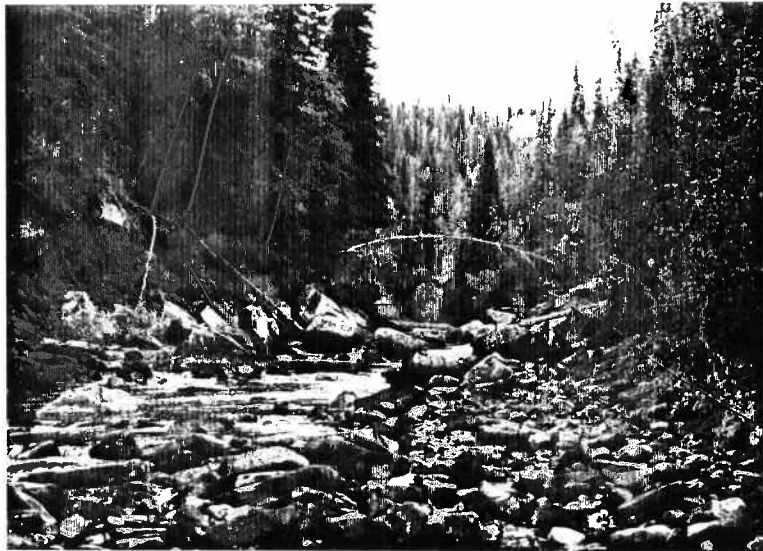
Kobes Creek enters the Halfway River through a narrow valley (above right). Most of the 5 km distance surveyed was riffle with the cobble substrates near 0.2 km (below right) becoming boulder (below) above 1 km.

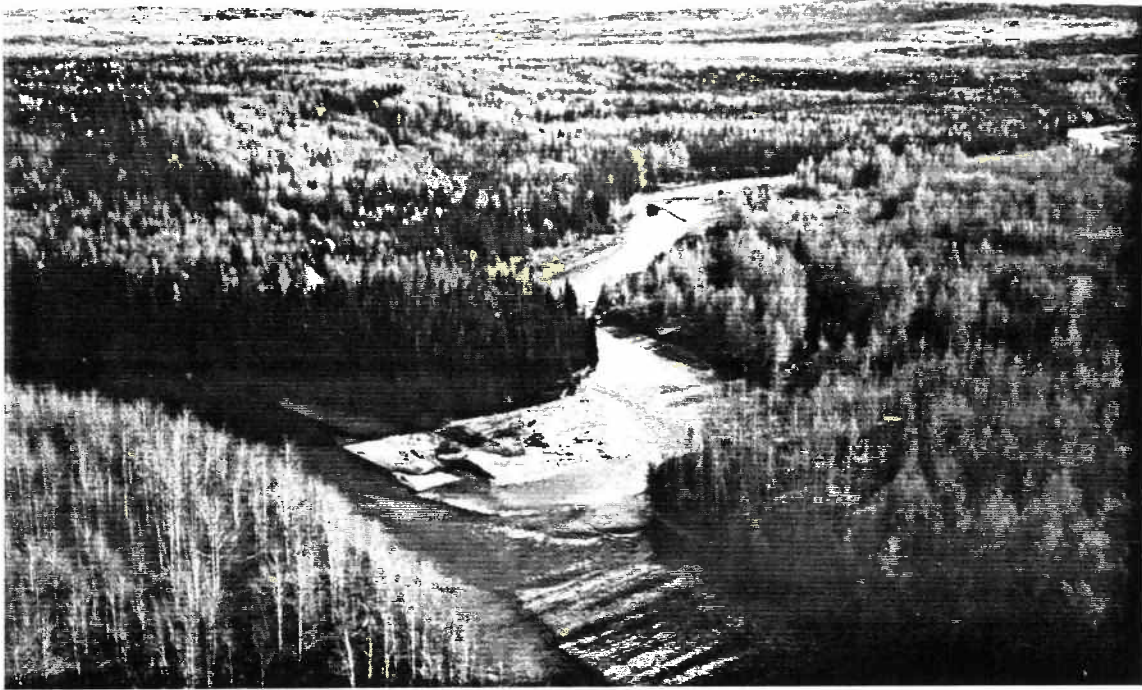
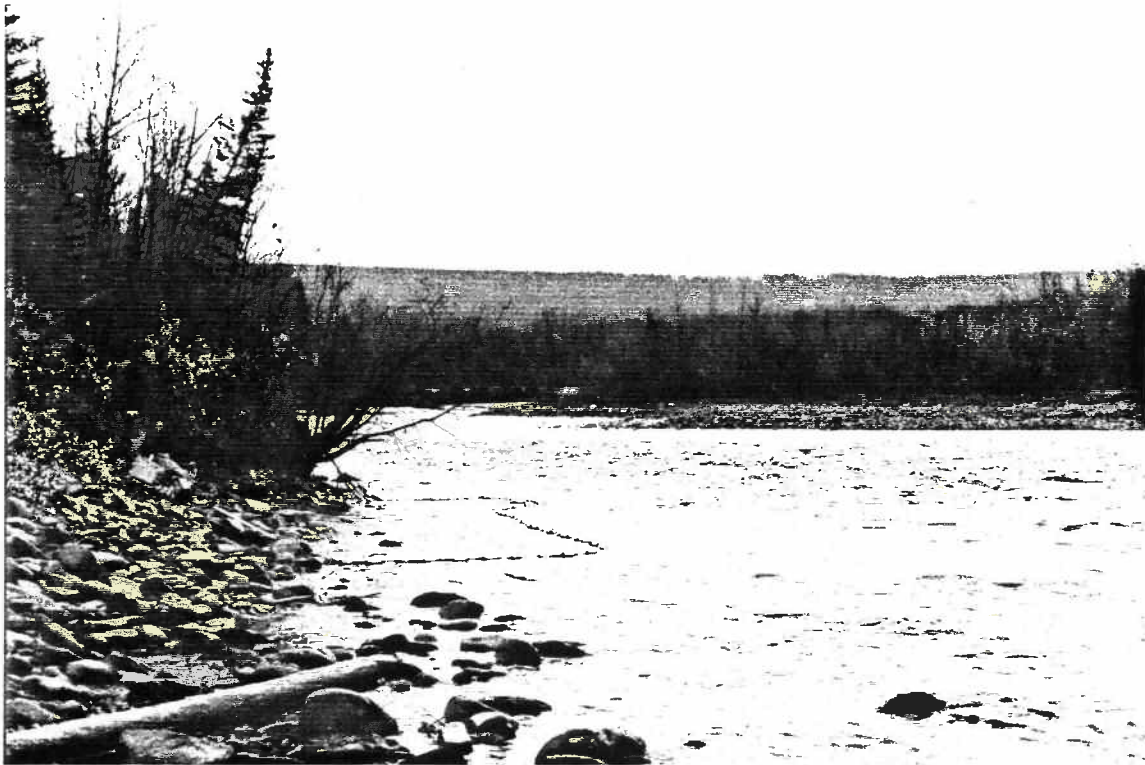
Plate 16

At their confluence, the discharges of the Graham and upper Halfway Rivers are roughly equal (above). Graham River Reach 1 (below) is largely glide with little organic debris. High fish densities in late fall suggest fish overwinter nearby.

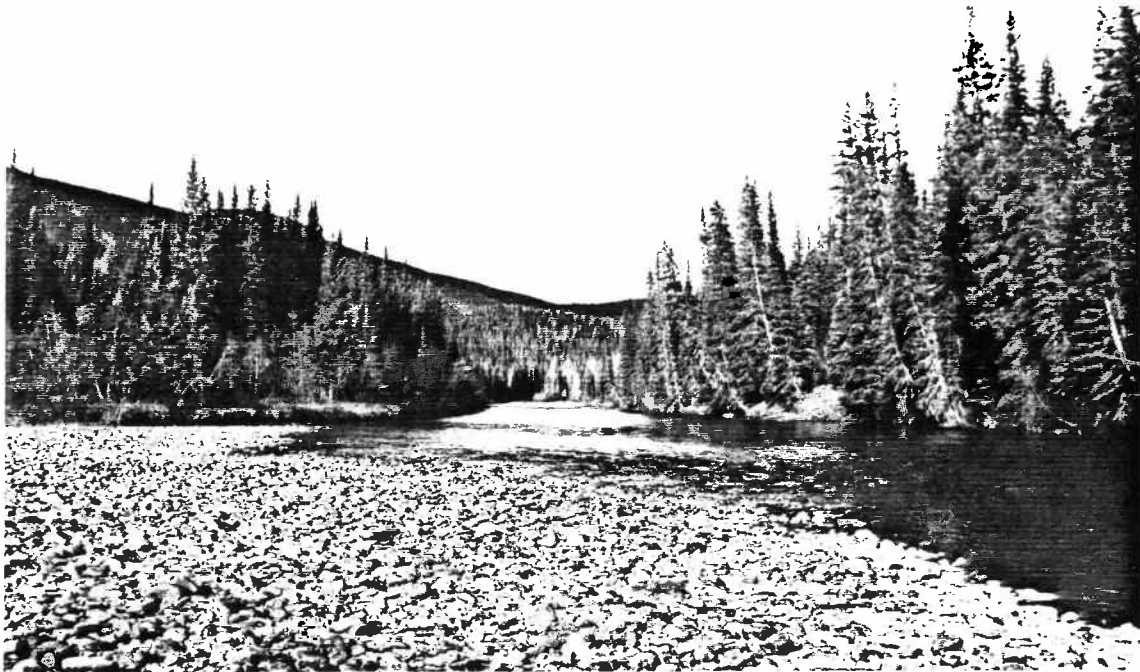
Plate 17

Reach 3 of the Graham River is mainly glide with occasional meanders (above). In Reach 4 the gradient increases and the channel is confined by steep rock walls (below).

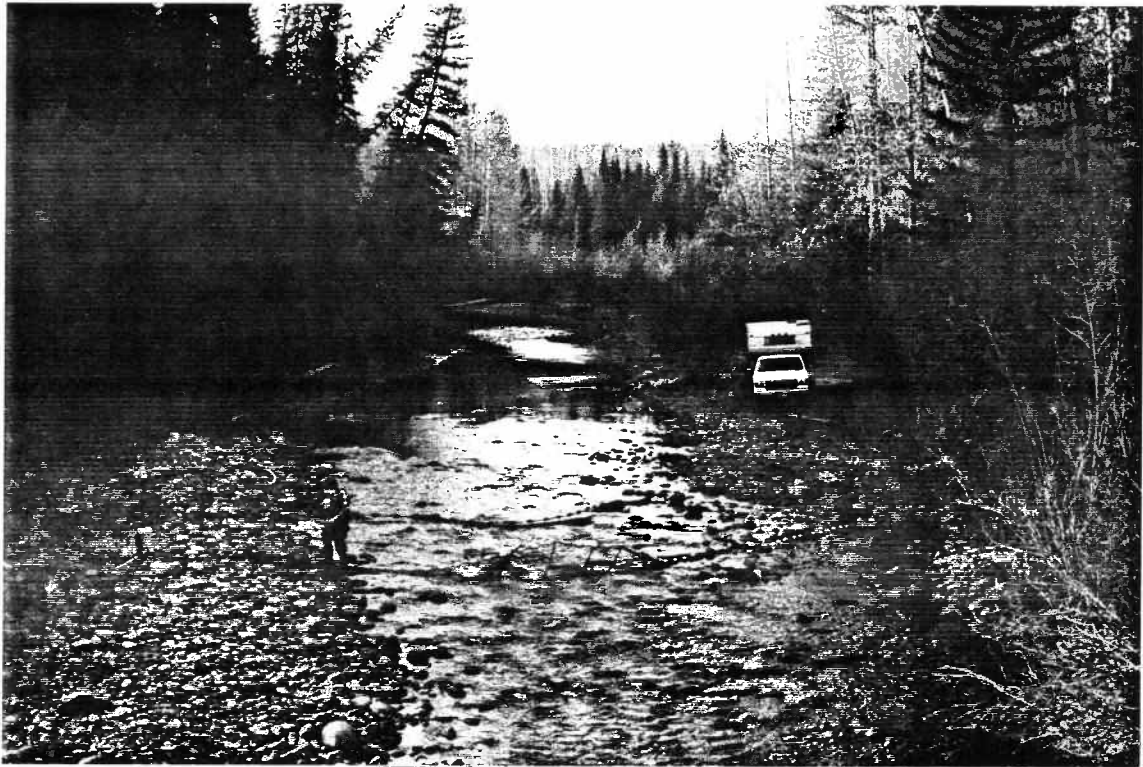
Plate 18  
The Colt Creek channel averaged 20 m in width at 3 km (above) but narrowed to 3 m at 15 km (right). Beaver ponds, the dominant habitat type in Reach 1, were less common in Reach 2.

This small humic stained creek flows into the Graham River approximately 12 km above the Halfway River (Figure 1). The lower 15 km of Colt Creek was inspected by helicopter September 23, 1989 and spot checks were made on the ground September 26 and 27. The discharge was estimated at  $0.5 \text{ m}^3\text{-s}^{-1}$  on September 26, 1989.

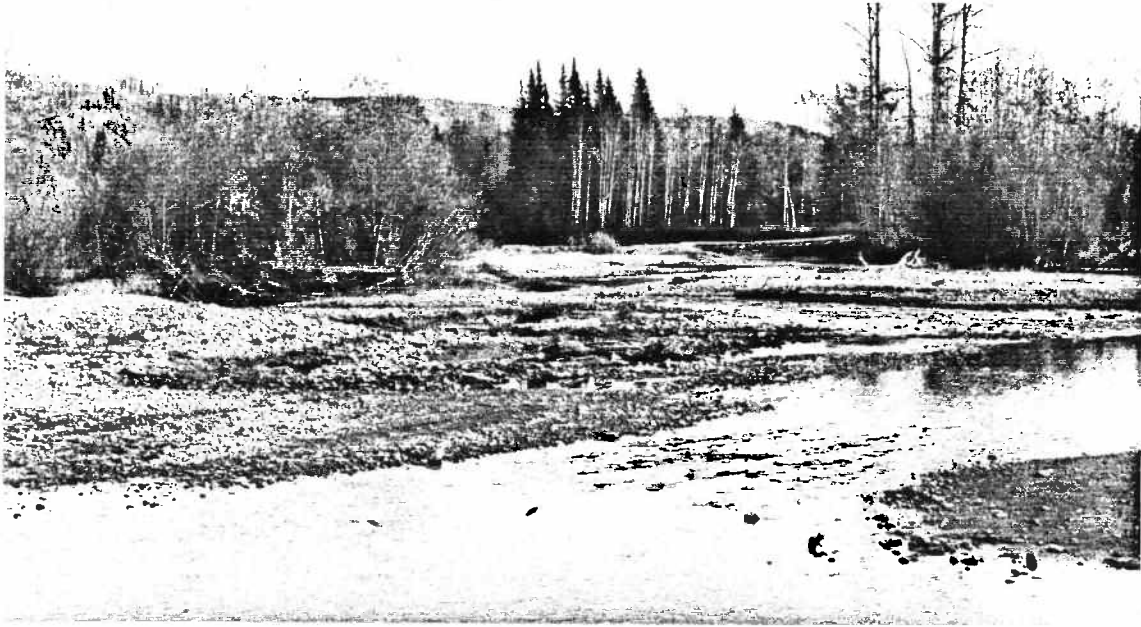
Plate 19.

Blue Grave Creek flows unconfined through a broad flat bottomed valley. Near the mouth the channel is braided and up to 35 m wide (above). Further upstream, at 15 km, the channel is narrower with a regular sequence of 45% glides, 45% riffles and scattered shallow pools (below).

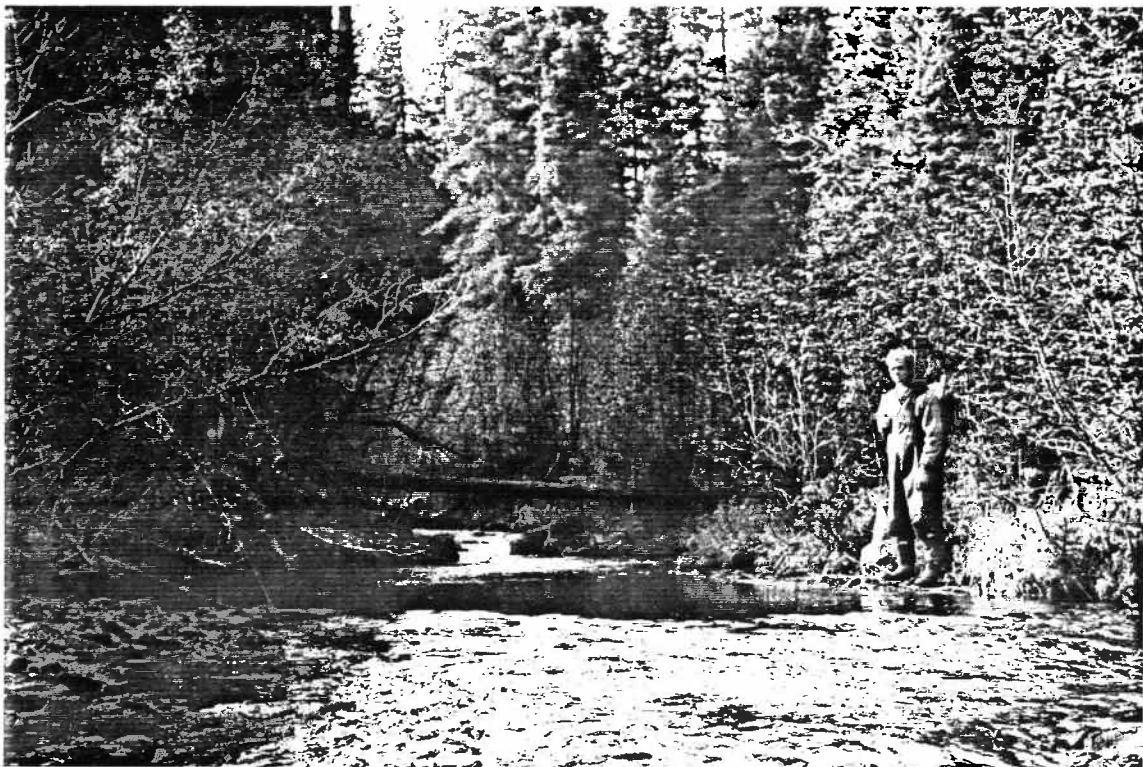
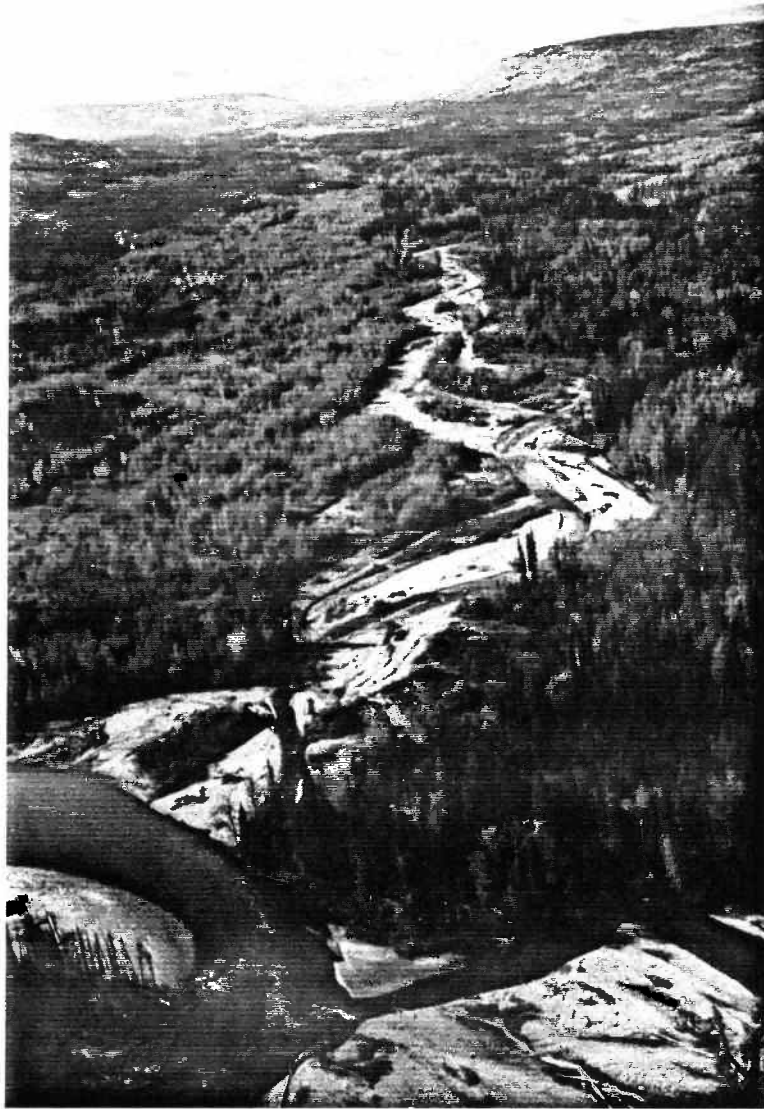
Plate 20

Horseshoe Creek flows through a broad, shallow valley. The channel is braided in many areas with large debris accumulations and other signs of recent bank erosion and channel movement.

Horseshoe Creek was examined by helicopter from its confluence with the Halfway River to a point 15 km upstream (Figure 1). The creek was also sampled by road near the mouth and upstream approximately 16 km. The character of this creek is similar throughout the area surveyed. On September 27, 1989 the discharge was estimated at  $0.4 \text{ m}^3\text{s}^{-1}$ , the water was clear and the water temperature was  $9.5^\circ\text{C}$ . Like Blue Grave Creek, Horseshoe Creek flows through a wide, flat bottomed valley (Plate 20). The creek is occasionally confined by steep silt/shale banks 20-30 m high.

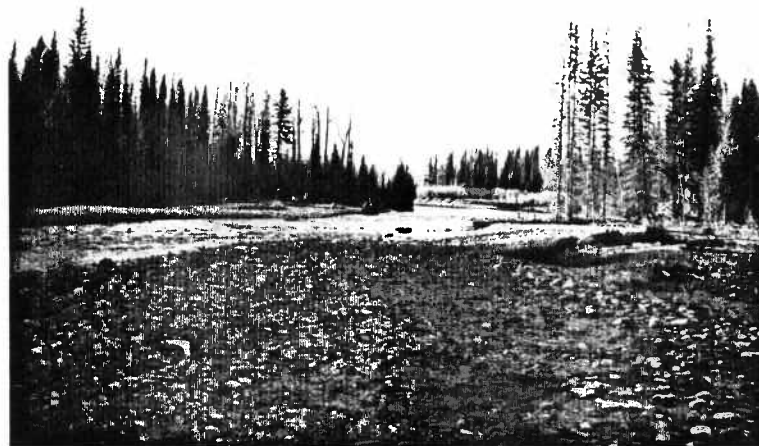
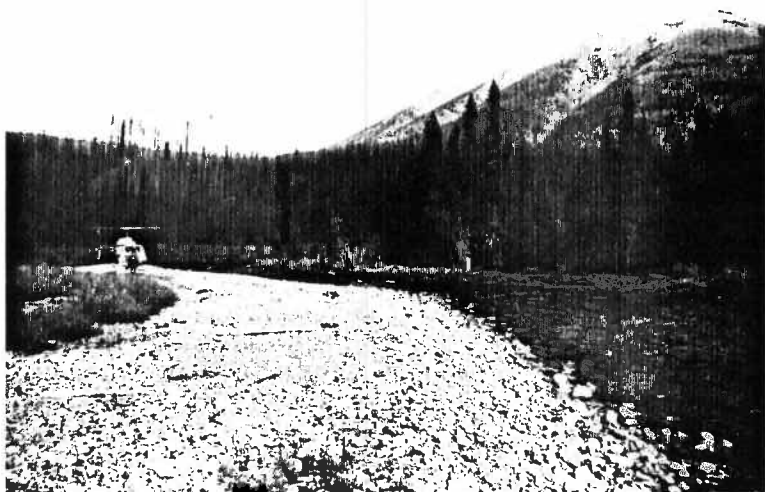
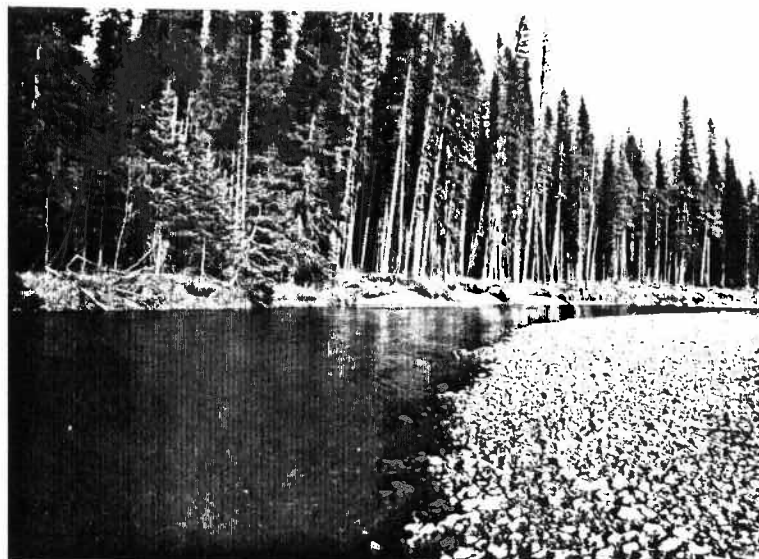
Plate 21

Reach 1 of the Chowade River meanders unconfined across the Halfway Valley (right). Some of the banks contain a large proportion of fines which result in high turbidities even during fall low flows. Reach 2 is similar in character but has much lower turbidity (below right). In Reach 3 (below) the river is stable and largely confined to one channel. The habitat is mainly riffle with a few cascades.

The lower 45 km of the Chowade River was surveyed by helicopter on October 11, 1989 (Figure 1). Three reaches are apparent in the length surveyed. Reach 1 extends from the mouth approximately 3 km upstream. Here the river is very turbid due to the erosion of silt banks in the lower four kilometres of the river. Above Reach 1, the river is clear. Reach 1 is very unstable with an abundance of scattered and accumulated debris. The banks appeared to be either eroding or aggrading and the channel is braided in many areas. Average channel width was 50 m and the wetted width was 18 m during the survey. The channel is largely unconfined and meanders over the valley bottom (Plate 21). There were few pools (10%) as most of the river is glide (60%) and riffle (30%). Average maximum riffle depth was estimated at 0.6 m and average maximum pool depth was over 2 m. Most of the substrate consisted of fines (40%), gravel (40%) and cobble (20%).

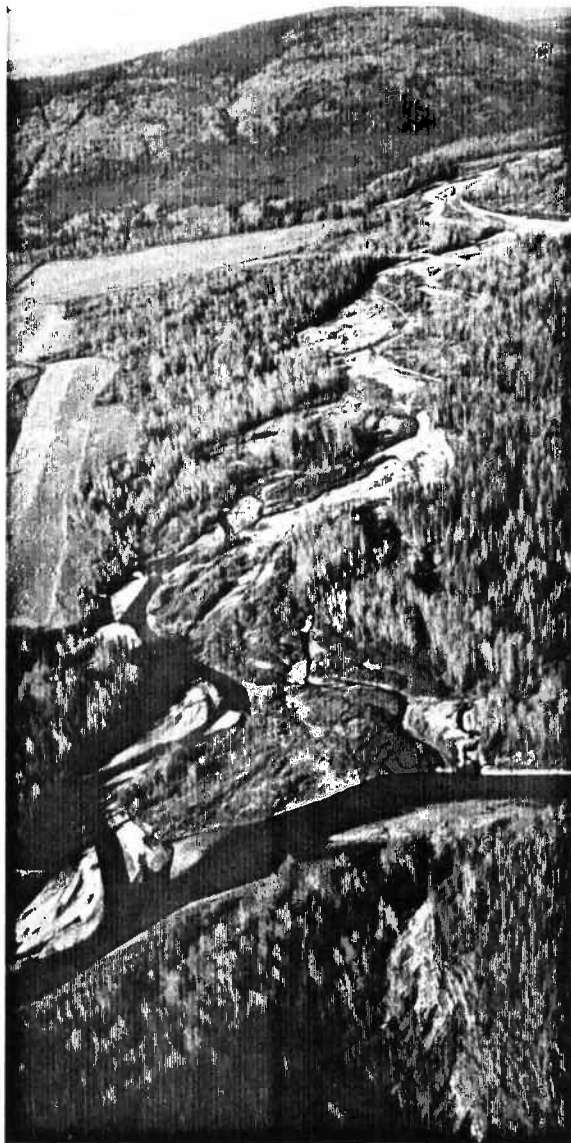
Plate 22

The lower reach of Cypress Creek is largely braided, unconfined, and unstable (left).

The lower reach extends upstream 23 km from the mouth. The creek is mainly unconfined over this section with frequent braiding and appeared very unstable with a wide flood plain (Plate 22). Channel width was 60 m at the 1.5 km mark and 30 m at the 15 km mark. Wetted width averaged 17 m. This reach is approximately 5% pool habitat with the remainder evenly split between glide and riffle. Substrate was mainly gravel (65%). Fines composed 10% of the substrate,

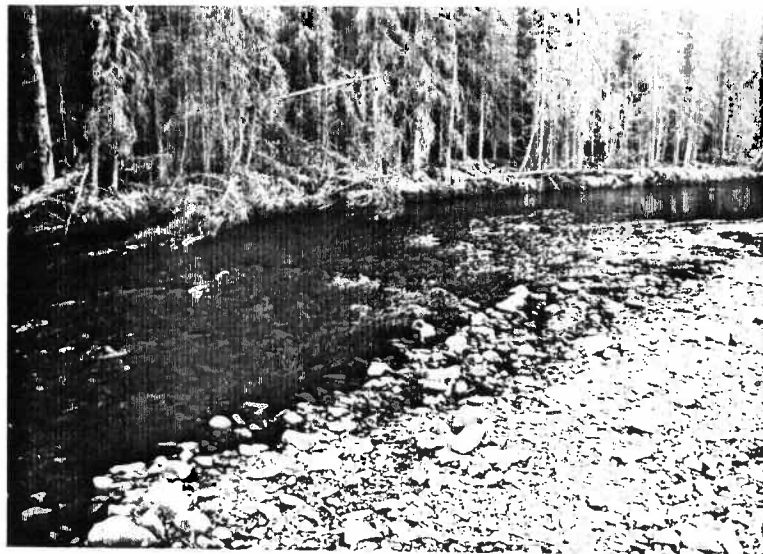
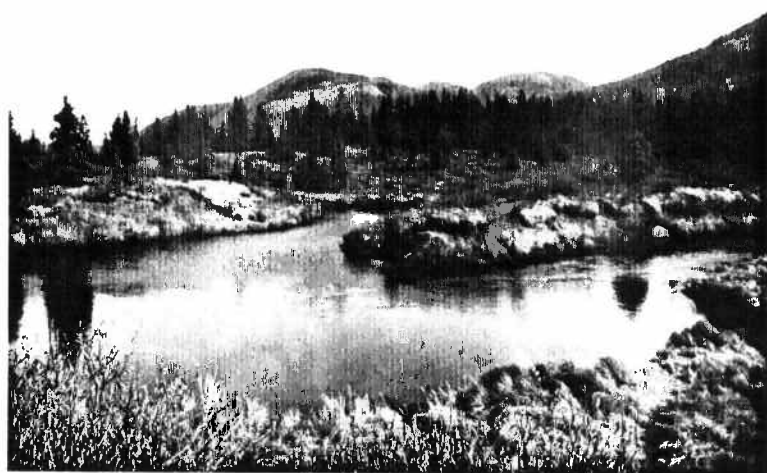
At the upper end of Reach 3 the creek meanders through meadows (below right).
