**Site C Clean Energy Project**

**Site C Fish Stranding Monitoring Program (Mon-12)**

**Construction Year 5 (2019)**

# Site C Fish Stranding Monitoring Program (Mon-12) 2019 Data Report

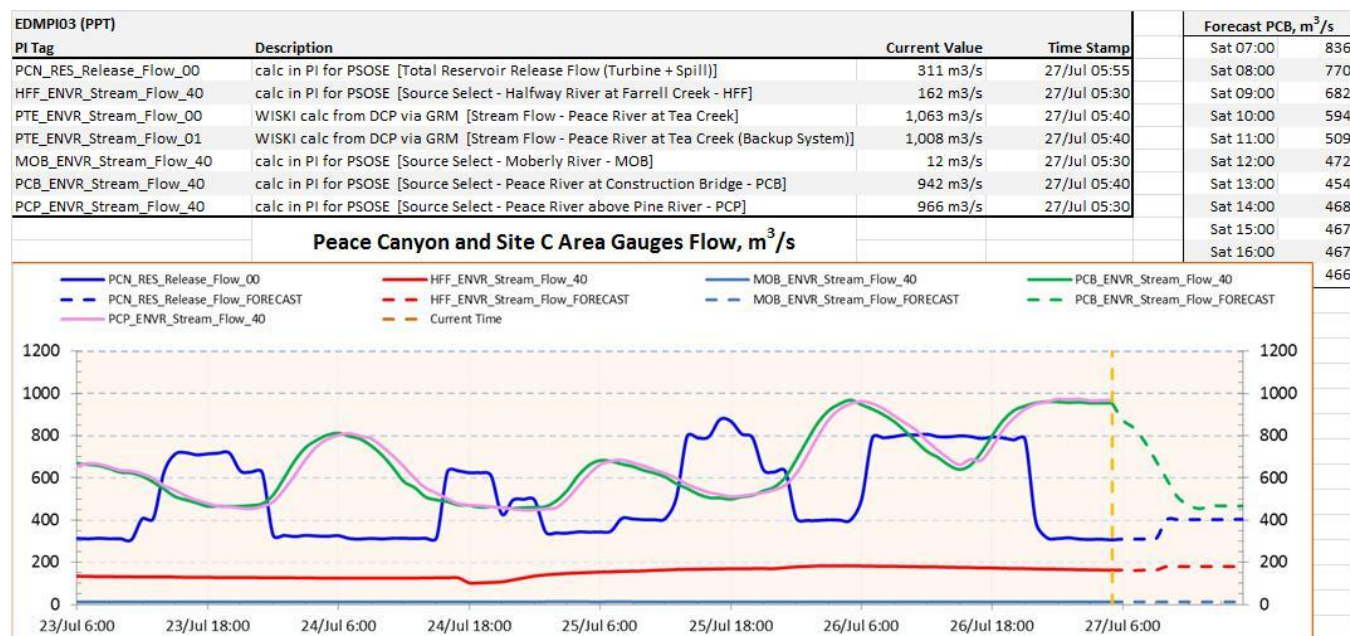
**Figure 2.2** Example of typical flow report provided by BCH showing the forecasted reduction event (dashed lines) at PCN prior to Trip 1 on July 27, 2019.

To help coordinate the timing of crew arrival at each reach, BCH provided Ecora with a Peace River flow report via email every six hours which showed discharge rates over the previous four days and a twelve-hour forecast. An example of a typical report is provided in Figure 2.2.

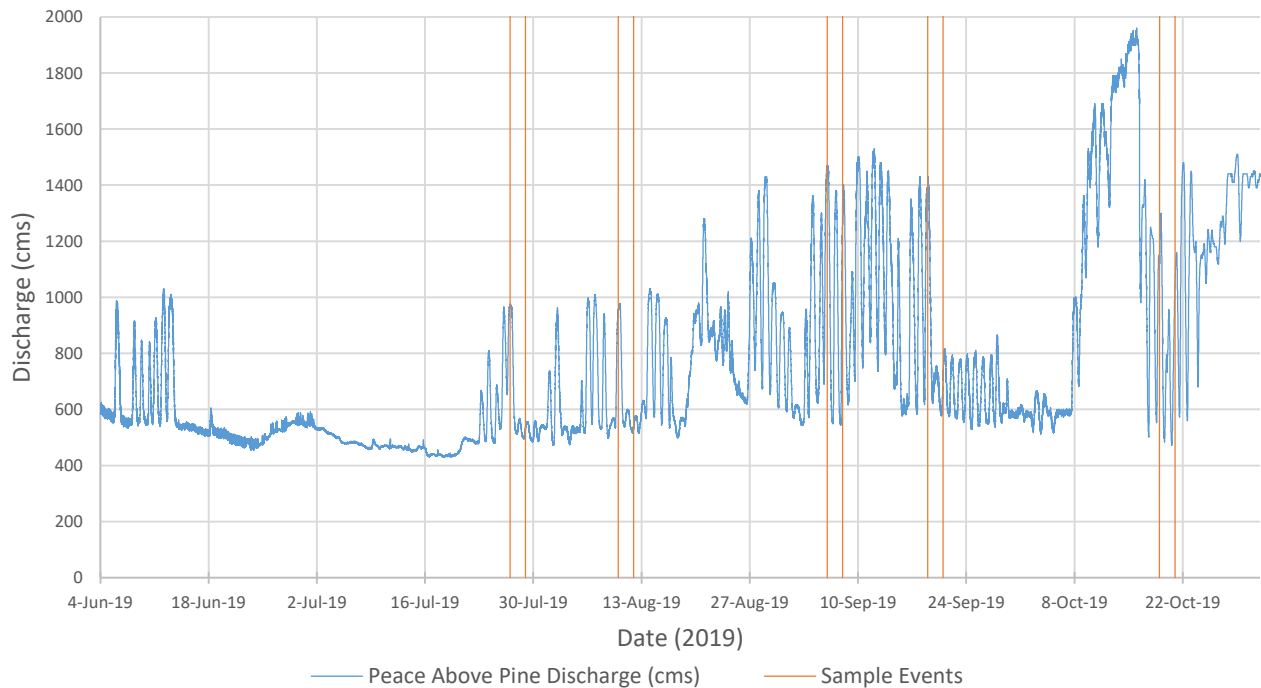
**Figure 3.1 Summary of discharge recorded at the Peace River above Pine River (07FA004) Water Survey of Canada Hydrometric Station and sampling days (vertical lines) between June 1 and October 31**

The Peace River above Pine River (PRPR) Water Survey of Canada hydrometric station data shows that during the sampling period (June to October 2019), maximum discharge of 1,960 cms occurred on October 16, shortly prior to Trip 5. Minimum discharge of 394 cms occurred on July 18 and 19. The timing of sampling days are indicated by the red vertical lines in Figure 3.1.

Base flows remained low through April, May and June (i.e., approximately 500 to 600 cms) and peak discharge events were generally short in duration (i.e., preceded by low flows and therefore short period of wetted history). According to PCN the low flow period was related to the filling of the Williston Reservoir, upstream of PCN.

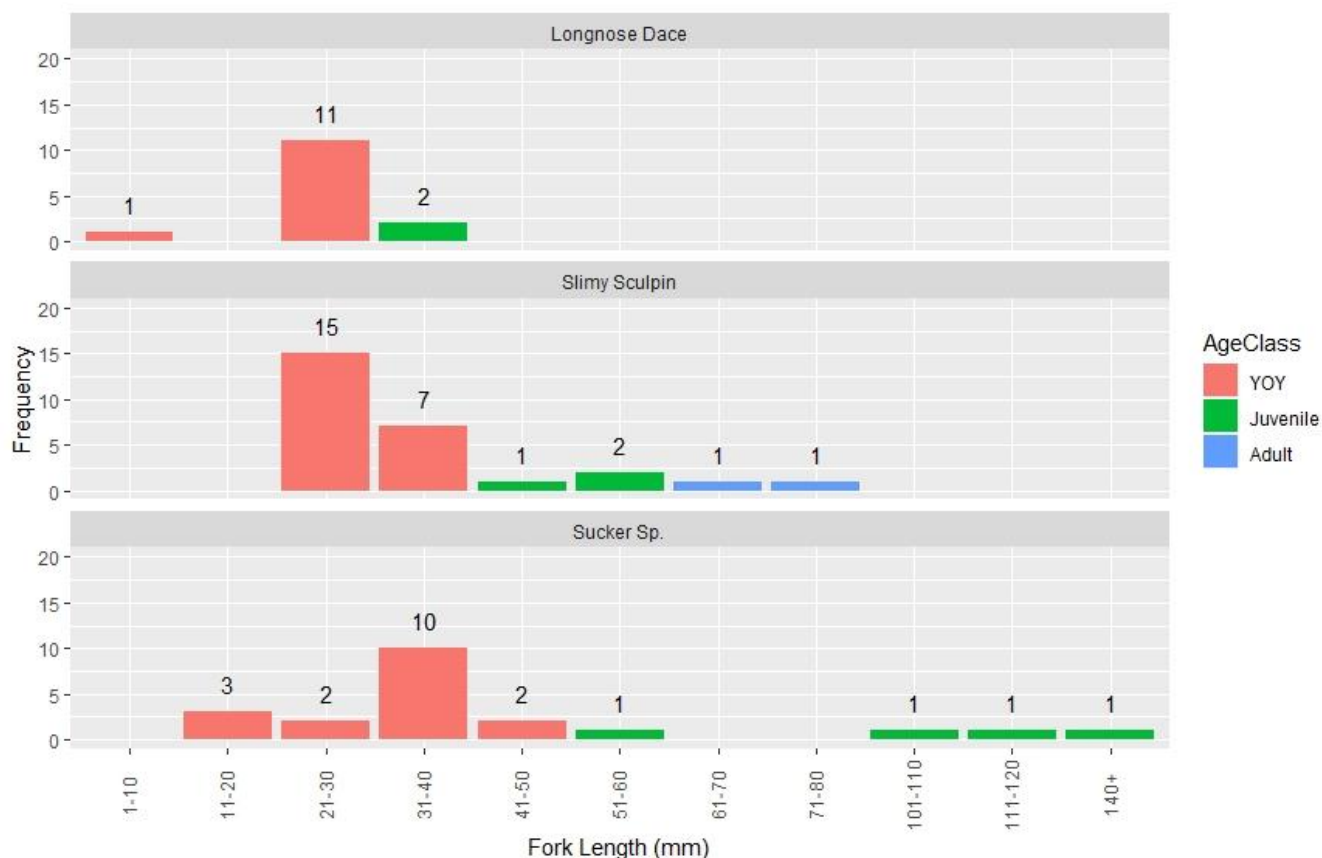
Figure 3.2 Fork length frequency distribution and Sample Sizes for Sucker spp., Slimy Sculpin, and Longnose Dace, collected from stranding surveys in 2019.

Fork length was measured for fish collected during the sampling events. A summary of the fork length frequency data for the three most commonly observed species or species groups (Suckers, Slimy Sculpin, and Longnose Dace) is provided in Figure 3.2.

Figure 3.2 includes data from both isolated and stranded fish collected during the 2019 sampling. Longnose dace and Sucker life stages are dominated by YOY with some juveniles, while Slimy Sculpin includes adult life stages. These species and life stages are generally associated with the shallow and near-shore habitats that are most affected by the sampled ramping events.

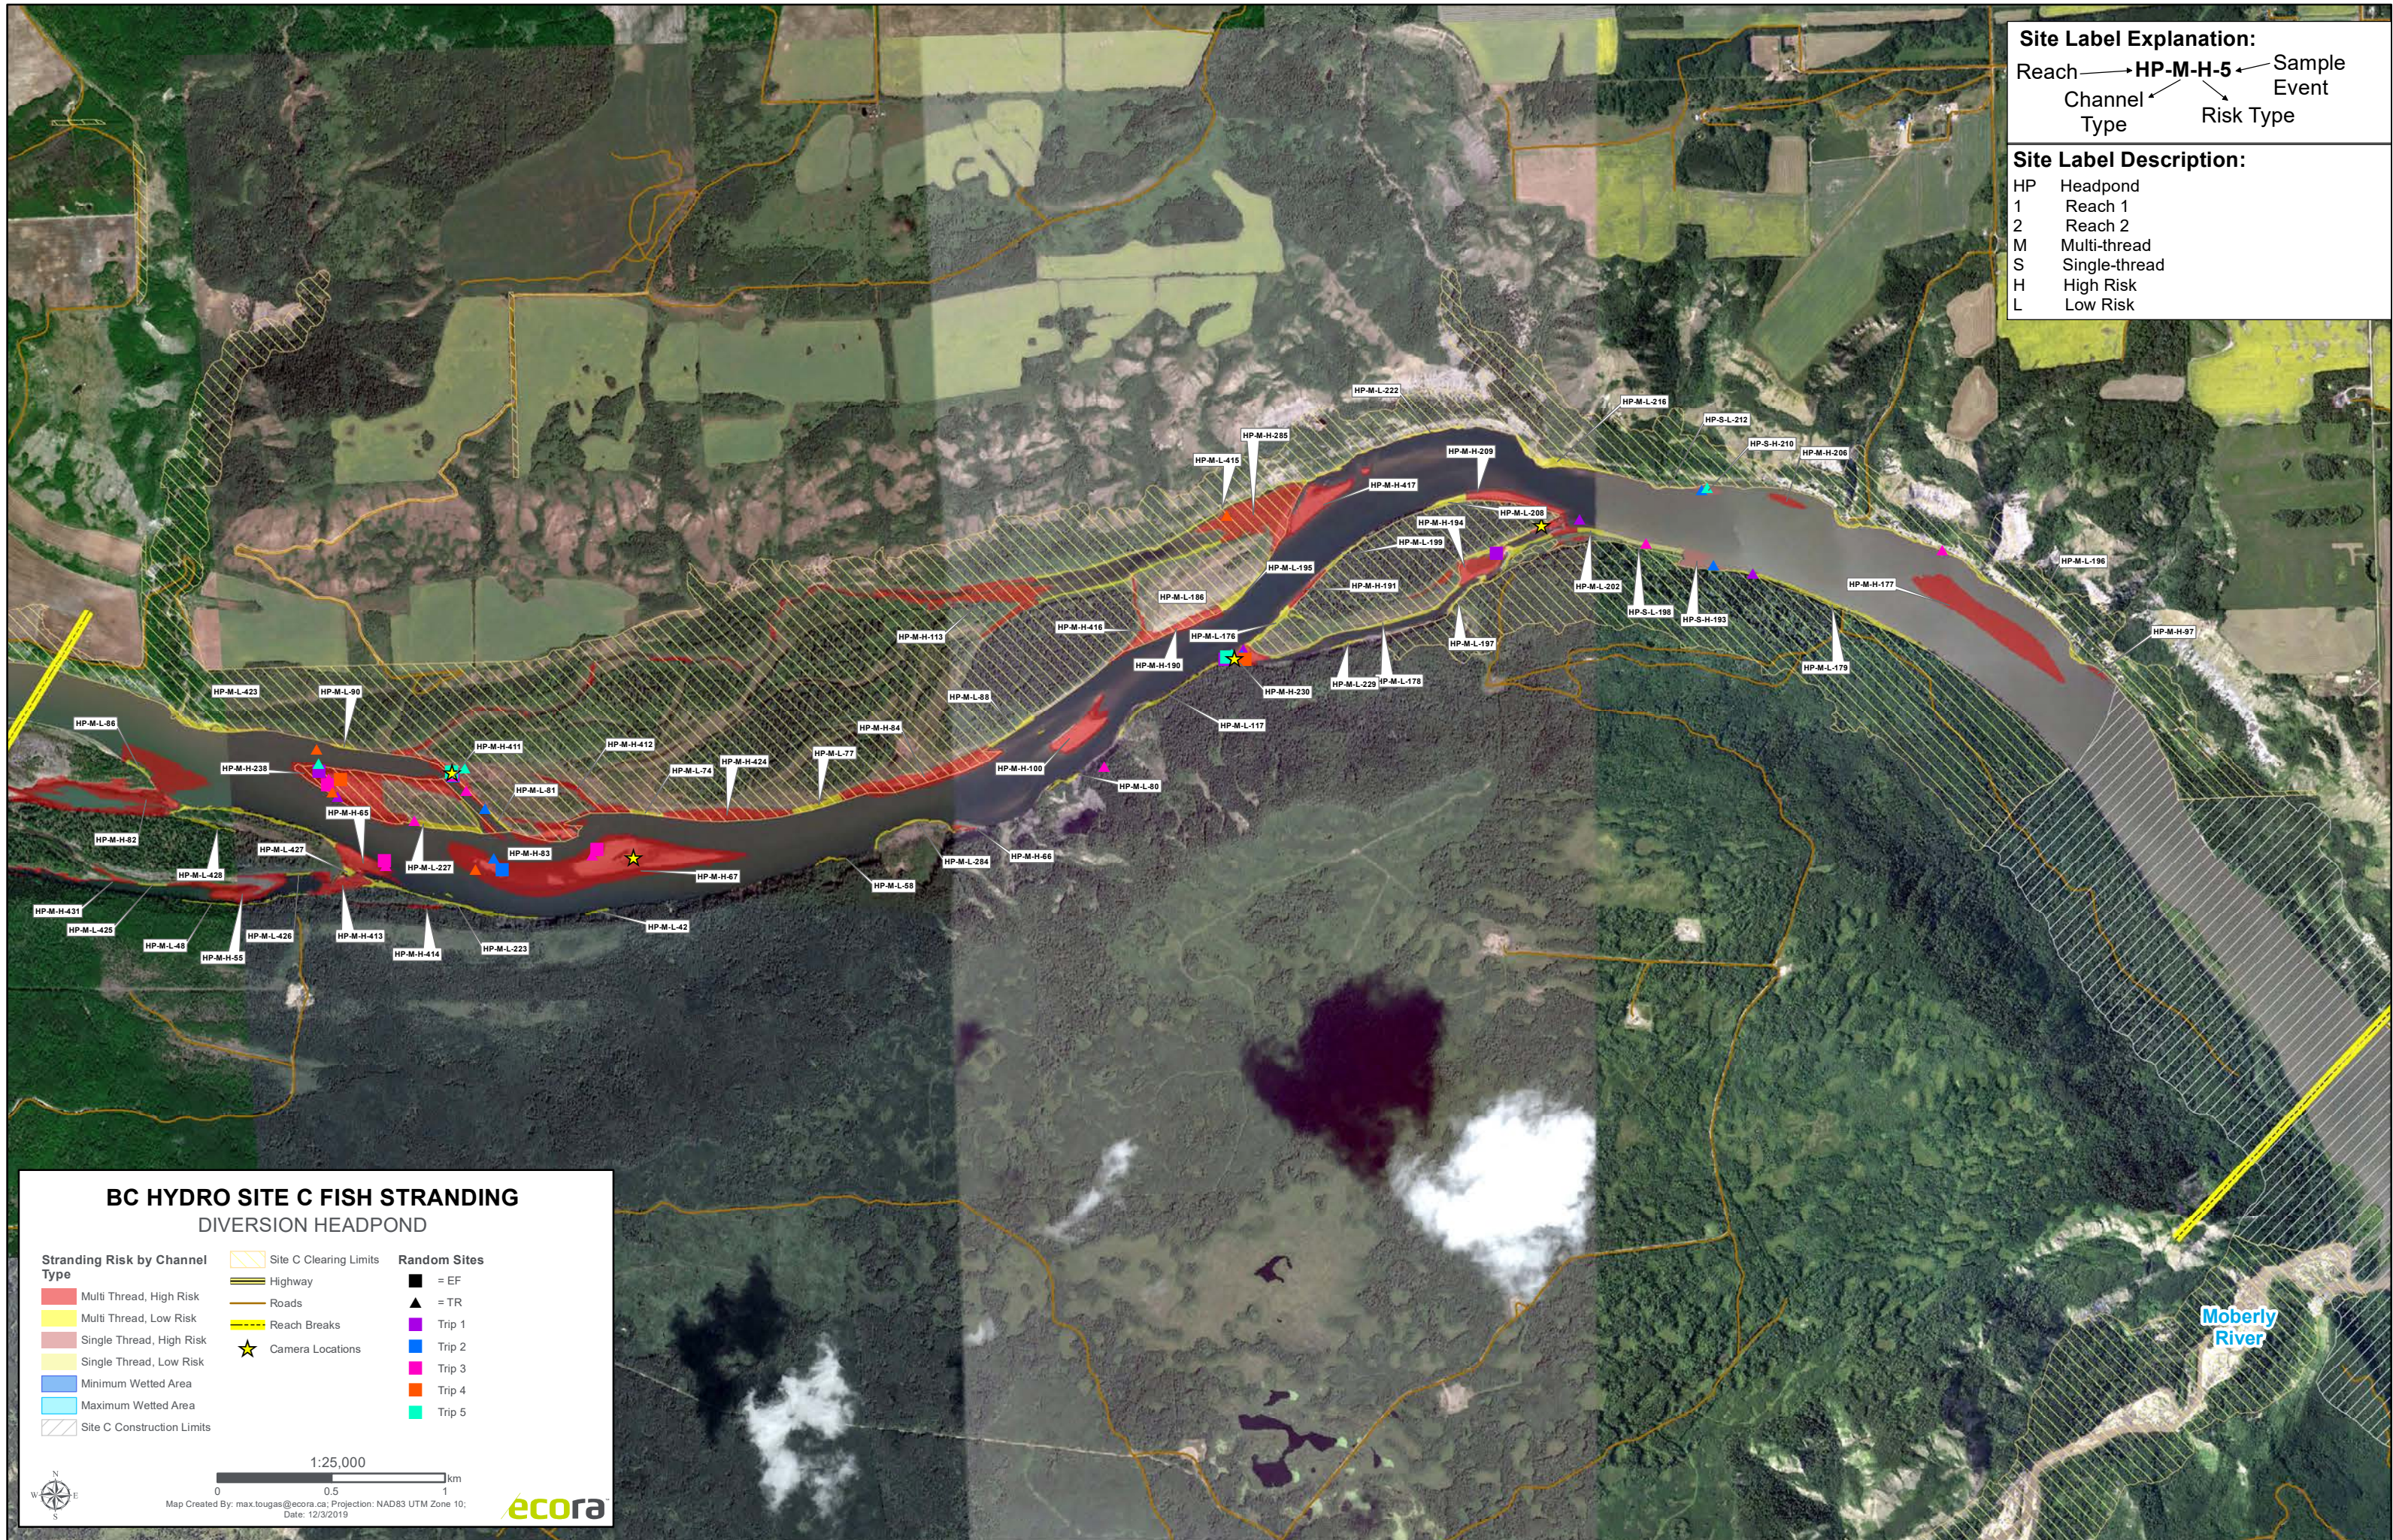
**BC HYDRO SITE C FISH STRANDING  
 DIVERSION HEADPOND**

The locations of the ten time-lapse cameras are shown on the figures in Appendix A. Overall, there were four cameras setup in the Headpond, two in Reach 1, and four in Reach 2. There were eight instances where isolated fish were observed in pools that were monitored by the trail cameras, with fish collected at six of these sites. There was only one instance where it appeared that fish isolated in pools either became stranded or were at increased risk of mortality based on the camera imagery.

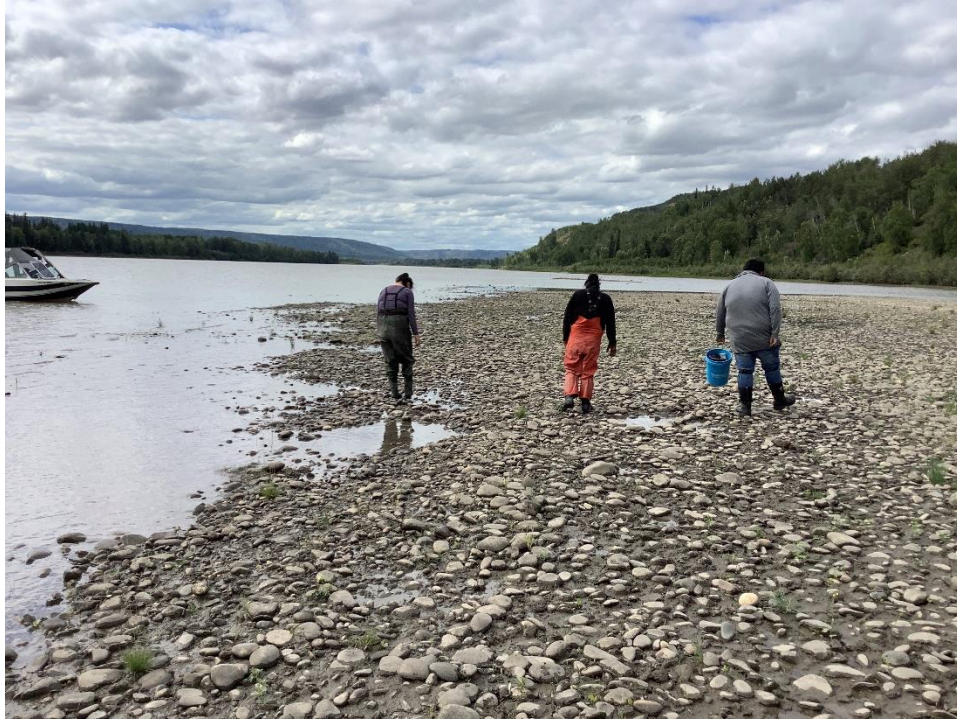
**Plate 1** View of interstitial sampling crew conducting Broad-based survey within the recently dewatered area along the wetted edge of the river at site 2-M-H-259 on Trip 2 – Day 3 (August 10, 2019)

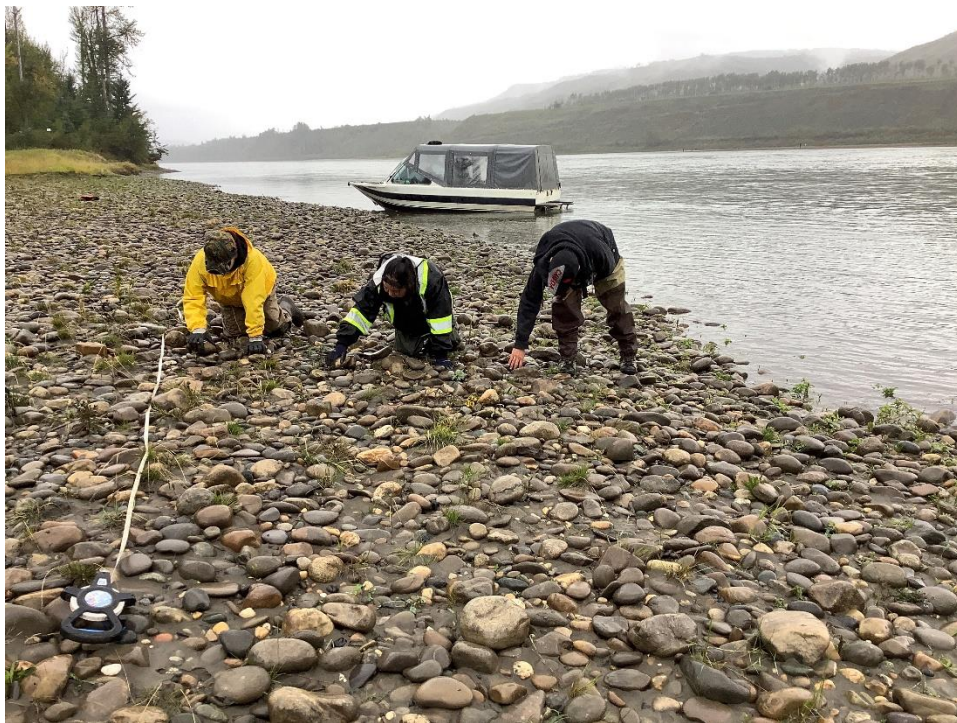
**Plate 2** View of crew conducting Hot-spot interstitial sample at site HP-M-H-65 on Trip 3 – Day 6 (September 7, 2019)

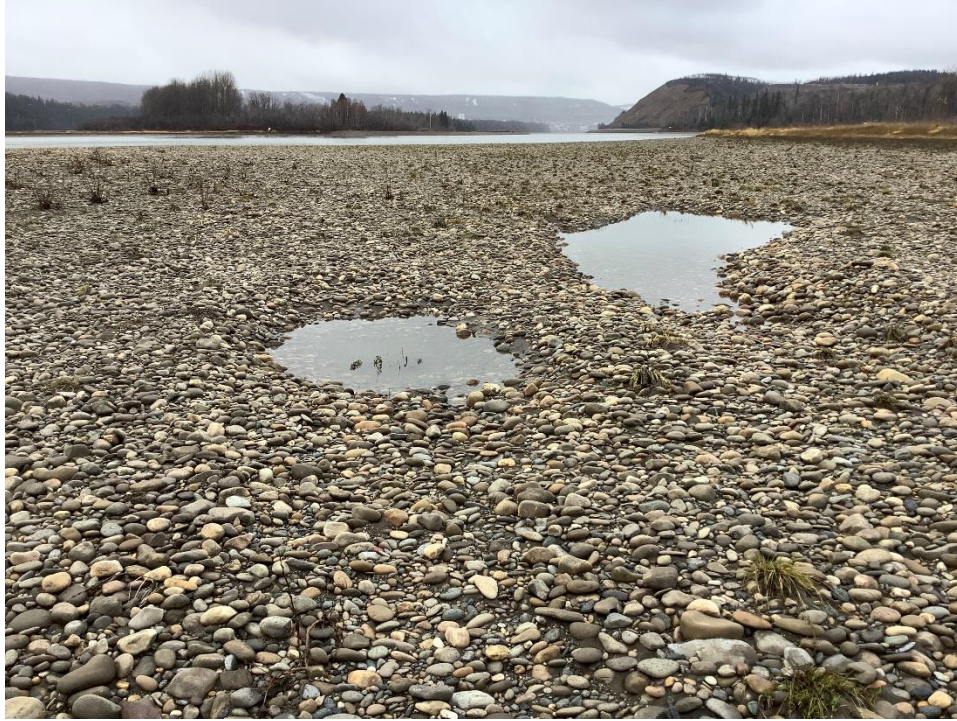
**Plate 3** View upstream towards the project site and typical pool sampling location at site 1-M-H-251 on Trip 5 – Day 9 (October 19, 2019)

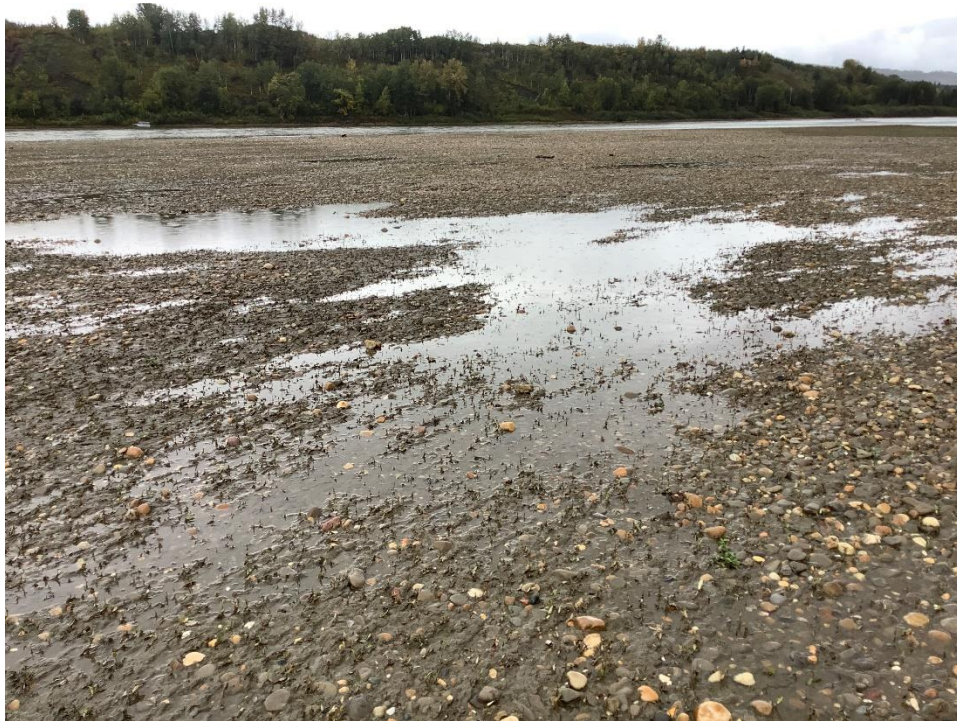
**Plate 4** View of pool sampling site 2-M-H-38 on Trip 3 – Day 6 with multiple shallow pools occurring throughout (September 7, 2019).

- If one to three pools were observed at a site, each pool was sampled. At sites where more than three pools suitable for sampling had formed, a subset of three pools was selected for sampling (Plate 4). Pools with the greatest likelihood of containing fish were selected for sampling, based on habitat suitability, including relative size and depth, coarse substrates, and low embeddedness.

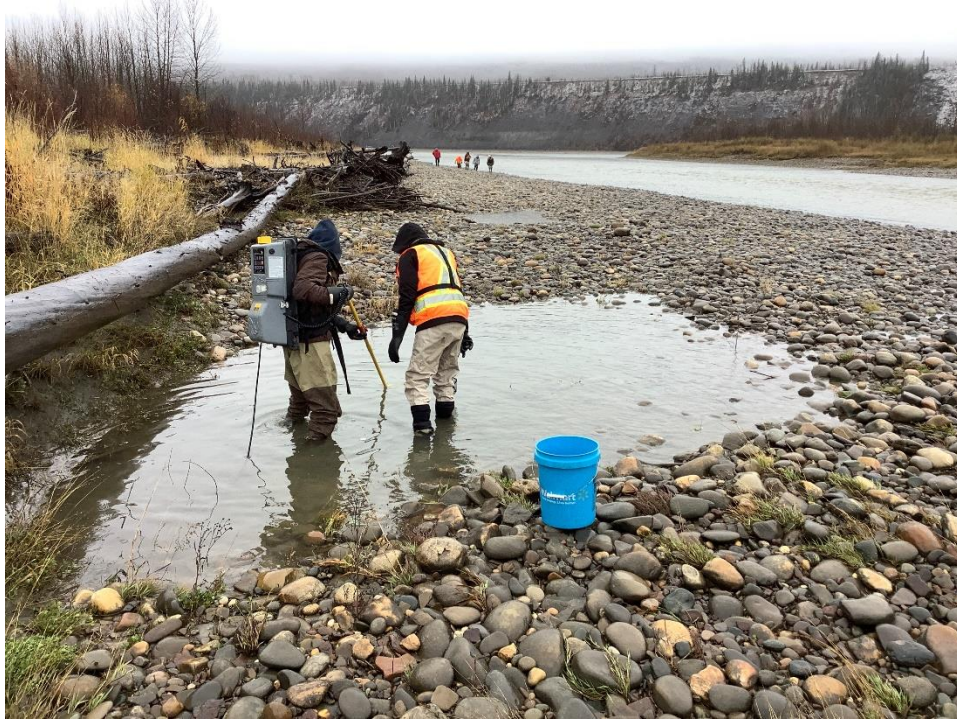
**Plate 5** View of electrofishing sampling at an isolated pool at site HP-M-H-411 on Trip 5 – Day 9 (October 19, 2019)

- Sampled pools were searched visually, and backpack electrofishing was used to confirm fish presence and collect fish, where possible (Plate 5). Multi-pass electrofishing techniques (i.e., minimum two passes per pool; typically, three were conducted) were used to collect all fish present within each pool. The LR-24 quick setup was used to automatically set the initial settings of voltage, frequency and duty cycle, based on the water conditions, with manual adjustments made to optimize capture success, where necessary.

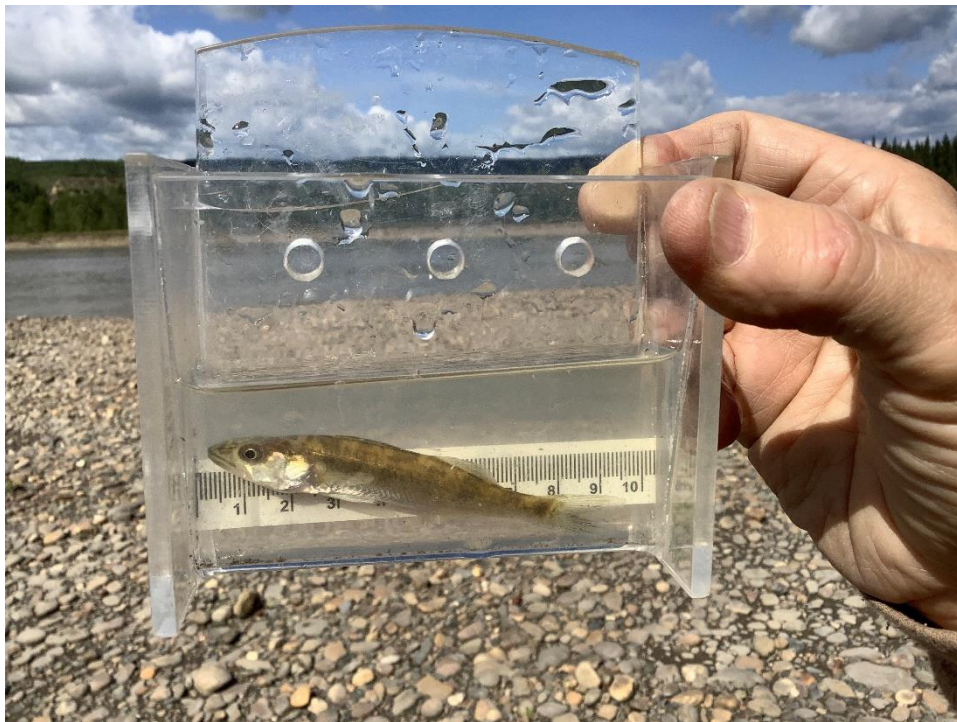
**Plate 6** Fish viewer used to measure and photograph a Walleye collected from a pool at site 2-S-H-316 on Trip 2 – Day 4 (August 11, 2019)

Fish fork length was recorded to the nearest millimeter using a measuring board and/or fish viewer and the life history stage (adult, juvenile, YOY) was determined based on relative size compared to average adult and/or juvenile sizes determined from reference material (McPhail 2007; McPhail and Carveth 1993) and professional judgment (McAllister pers. comm.). Table 2.3 summarizes the life history stage for species observed in 2019.

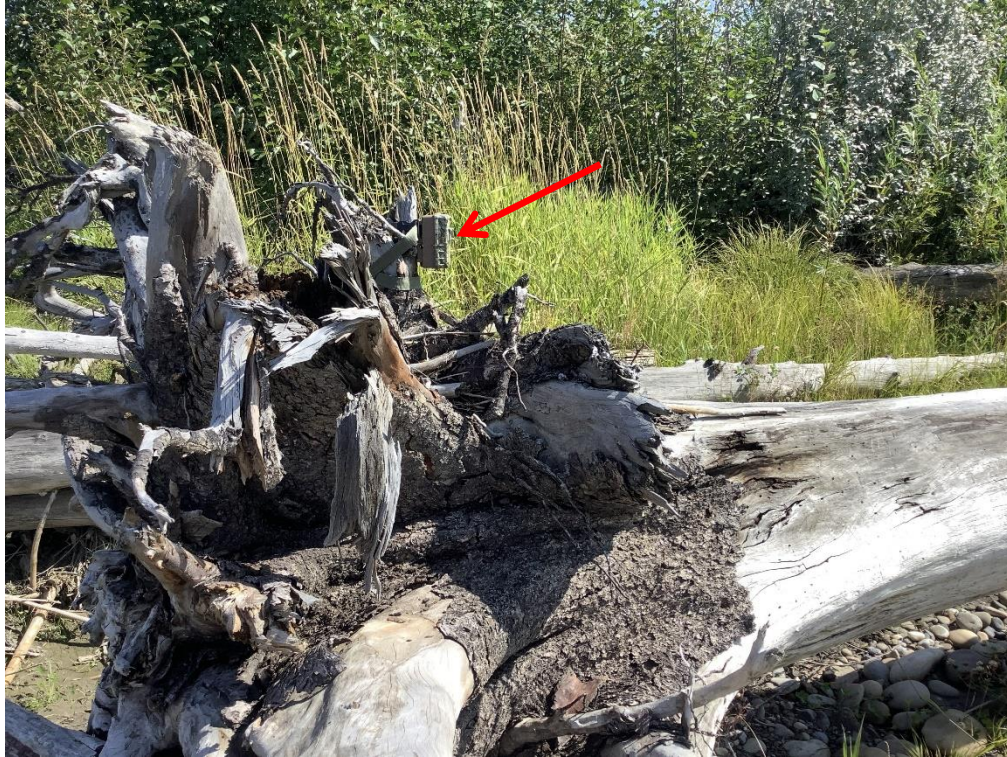
**Plate 7** View of Camera 08 (indicated by red arrow) attached to the root wad of a piece of large woody debris at site HP-M-H-411 on Trip 2 – Day 3 (August 10, 2019)

Time-lapse cameras (Browning Command Ops Model BTC-4-14) were set up at ten sites throughout the 2019 study area (Plate 7). The intended use of the images from the remote cameras was to provide information about the total approximate dewatered area at selected sites, the timing of pool formation, and/or the timing of pool dewatering (i.e., infiltrating to ground or drying out through evaporation), where possible. Each sampling event where isolated fish were observed during pool sampling at a camera location was cross-referenced to estimate the time the pool became isolated until the time the pool became inundated (i.e., until the river level ramped up and re-connected the pool to the mainstem) or the time until the pool dried out.

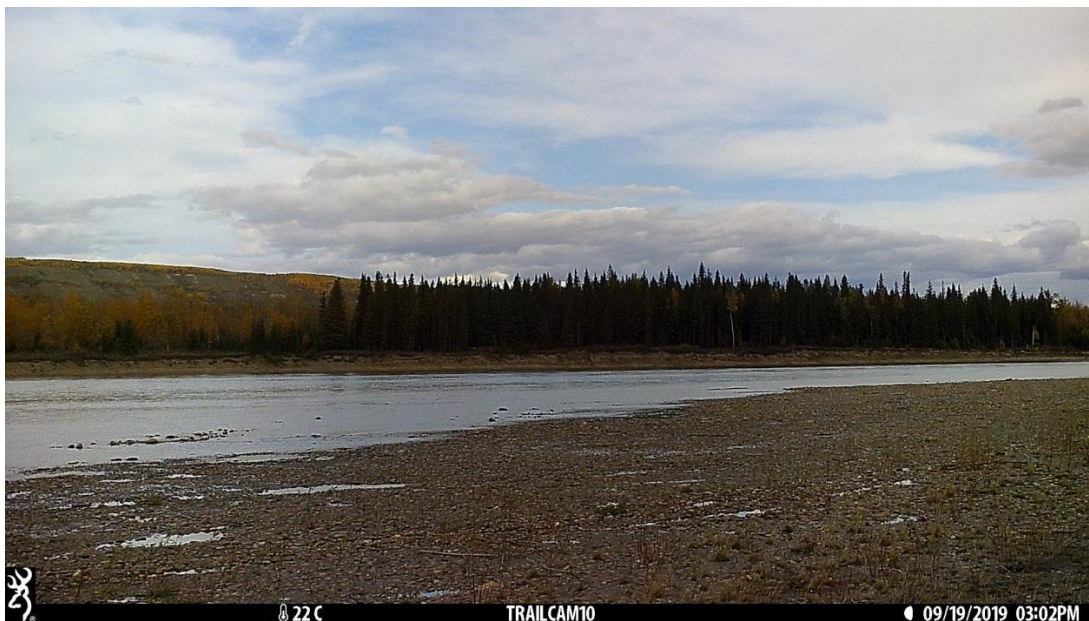
**Plate 8** View of image from Camera 10 at site 2-S-H-316 on September 19, 2019 at 15:02, showing pool formation following a reduction event that occurred during Trip 4

Camera locations were selected based on known formation of pools during ramping events and presence of stranded and/or isolated fish observed during previous surveys. Cameras were generally installed on trees, shrubs, root wads, or on makeshift posts and oriented towards the subject pools. Each camera was given a unique ID and programmed to take high-resolution time-lapse images on a 10-minute interval during daylight hours (Plate 8). During the night the cameras took motion-triggered photos.

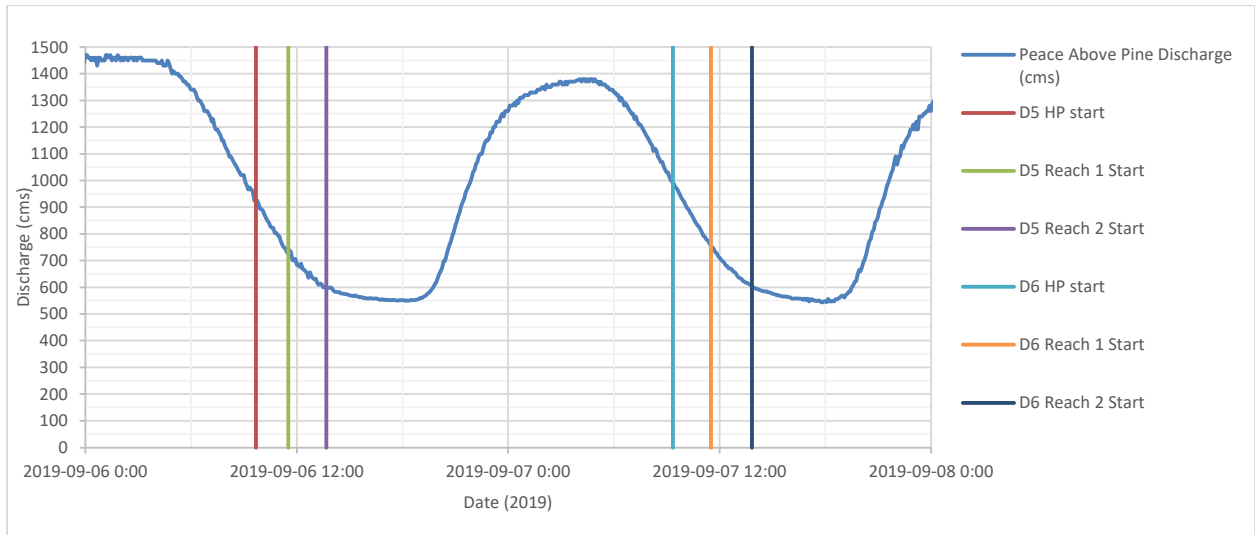
**Figure C-3. Trip 3 (Day 5 and 6) on September 6 and 7, 2019**

Summary of discharge recorded at the Peace River above Pine River (07FA004) Water Survey of Canada Hydrometric Station during each of the five sampling trips between July 27 and October 20, 2019 and the approximate survey start time at each reach (hydrometric data provided by operations staff at Peace Canyon Dam on November 29, 2019).

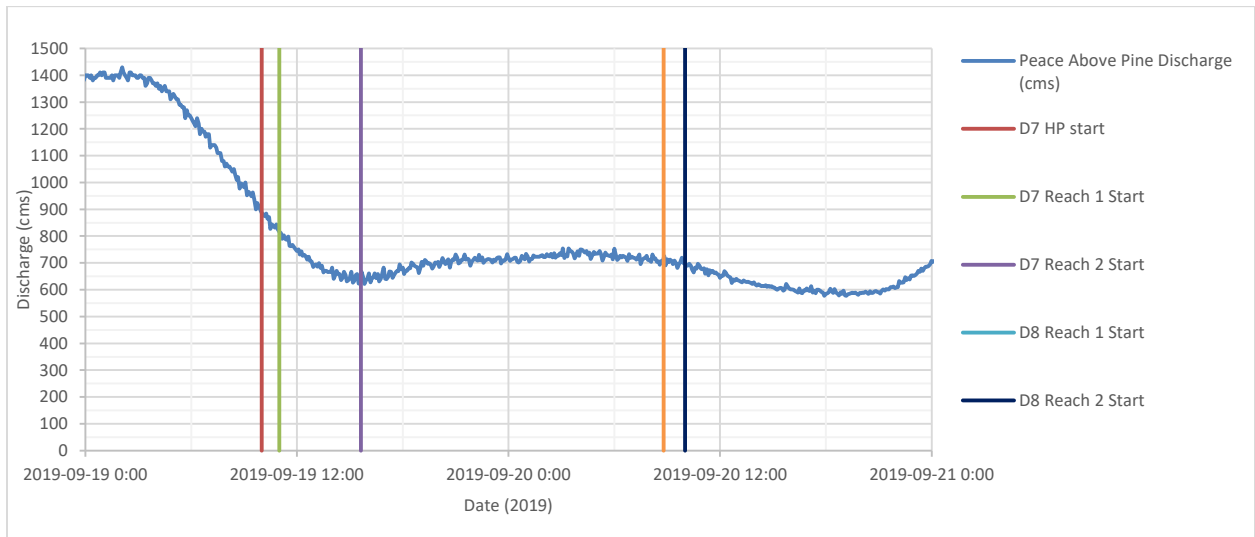
**Figure C-4. Trip 4 (Day 7 and 8) on September 19 and 20, 2019**
