# Site C Clean Energy Project

Offset Effectiveness Monitoring for River Road Rock Spurs and Upper Site 109L – 2019

Peace River Fish Community Monitoring Program (Mon-2, Task 2d) Peace River Physical Habitat Monitoring Program (Mon-3, Task 2c)

**Construction Year 5 (2019)**

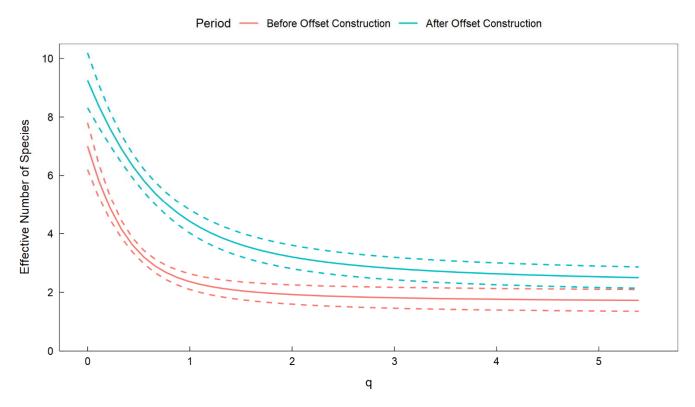
Figure 1: Diversity profiles for the River Road rock spurs area showing effective number of species versus the parameter (q) representing the importance of rare/common species in the calculation. Values are means (solid lines) with 95% confidence interval.

In the diversity profiles, the effective number of species is used to indicate the diversity of fish species, while varying the value of q, which represents the relative contribution of rare species to the diversity metric. The steep decline in the effective number of species with increasing values of q reflects the community composition in the offset area, with a few species dominating the catch and low numbers of rare species (Figure 1). Species richness (q = 0) was approximately 2 effective species higher after the offset was constructed. Based on the Shannon Index (q = 1), community composition was substantially different after construction of the offset, indicating increased diversity (approximately two effective species greater) after offset construction with no overlap in confidence intervals.

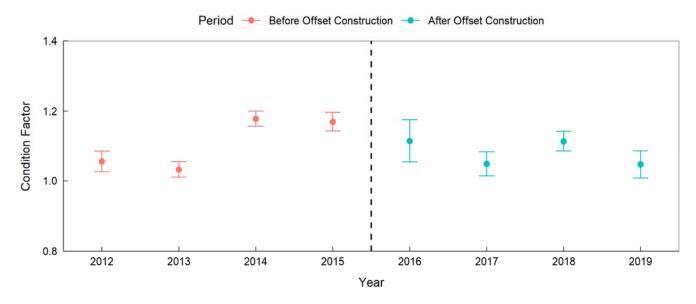
Figure 3: Mean body condition with 95% confidence intervals (CIs) for Mountain Whitefish captured by boat electroshocking in Sites 0505 and 0506 of the Peace River, 2012 to 2019.

The range of mean Mountain Whitefish body condition values was similar before (1.03 to 1.17) and after (1.05 to 1.12) construction at the River Road rock spur offset area (Figure 3). Raw body condition data for all species encountered in 2019 are provided in Appendix C, Table C3; data for all other years are provided in Golder and Gazey (2019).

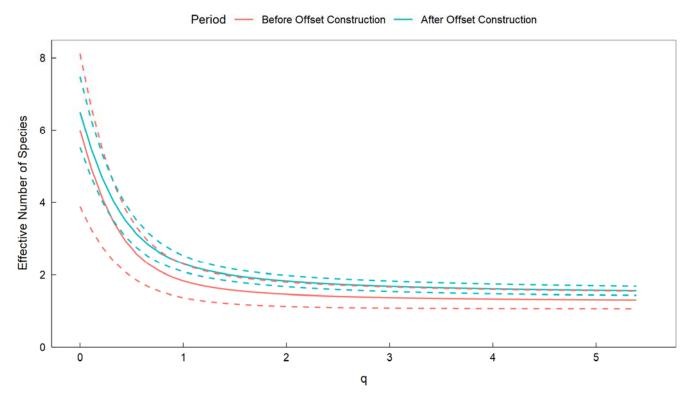
Figure 4: Diversity profiles for the Upper Site 109L area showing effective number of species versus the parameter (q) representing the importance of rare/common species in the calculation. Values are means (solid lines) with 95% confidence intervals (dashed line).

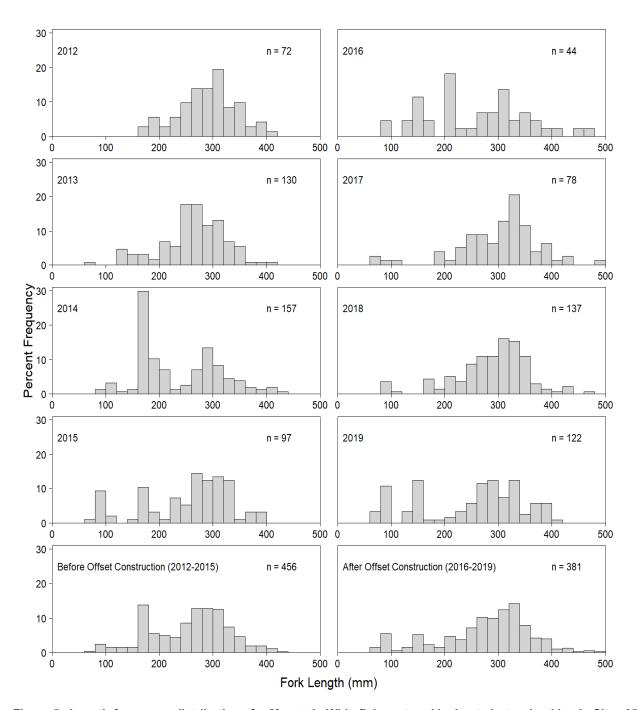
Figure 5: Length-frequency distributions for Mountain Whitefish captured by boat electroshocking in Sites 0509, 109OSA, 109OSB, and 109OSC of the Peace River by year for the before and after construction periods.

Length-frequency data for Mountain Whitefish (Figure 5) indicate that the Upper Site 109L area is used by age classes of Mountain Whitefish from young-of-the-year to adults. One difference between the length distribution of Mountain Whitefish captured before and after the construction of Upper Site 109L was a decrease in fish with fork lengths between approximately 170 and 200 mm, which are likely age-1 fish (based on length-at-age data provided by Golder and Gazey 2019). The difference was mostly attributed to a large cohort of age-1 Mountain Whitefish captured in 2014 compared to other study years. A large percentage of Mountain Whitefish with fork lengths less than 100 mm were captured in 2019, similar to the length-frequency data for Sites 0505 and 0506 (the River Road rock spurs area). Overall, length frequency distributions do not indicate any substantial differences in the sizes of Mountain Whitefish using habitats in Upper Site 109L before and after construction (Figure 5).

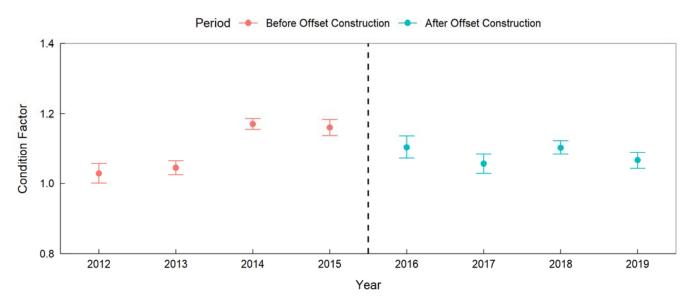
Figure 6: Mean body condition with 95% confidence intervals (CIs) for Mountain Whitefish captured by boat electroshocking in Sites 0509, 109OSA, 109OSB, and 109OSC of the Peace River, 2012 to 2019.

The range of mean body condition values was similar before (1.03 to 1.17) and after (1.06 to 1.10) construction of the Upper Site 109L offset area (Figure 6). Raw body condition data for all species encountered in 2019 are provided in Appendix C, Table C3; data for all other years is provided in Golder and Gazey (2018).

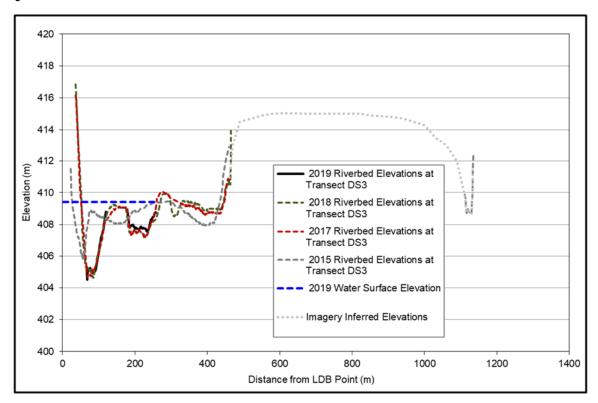
Figure 1: Cross section results for Transect DS03. Transect was surveyed as part of BC Hydro's Site C Offset Effectiveness Monitoring, 14 September 2019.

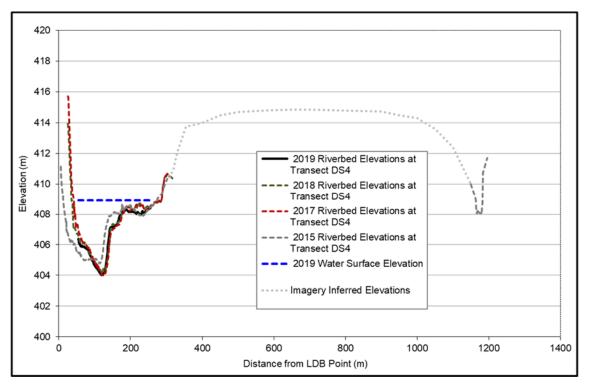
Figure 2: Cross section results for Transect DS04. Transect was surveyed as part of BC Hydro's Site C Offset Effectiveness Monitoring, 14 September 2019.

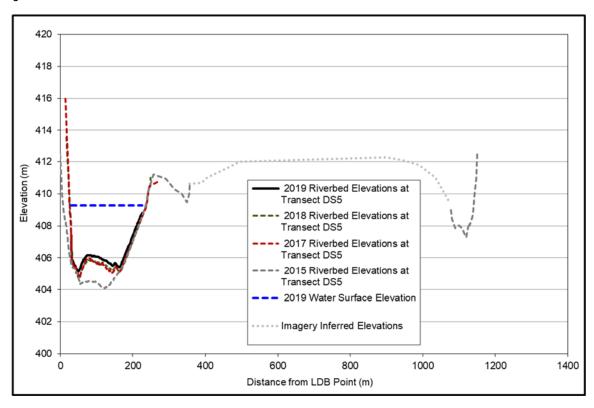
Figure 3: Cross section results for Transect DS05. Transect was surveyed as part of BC Hydro's Site C Offset Effectiveness Monitoring, 14 September 2019.

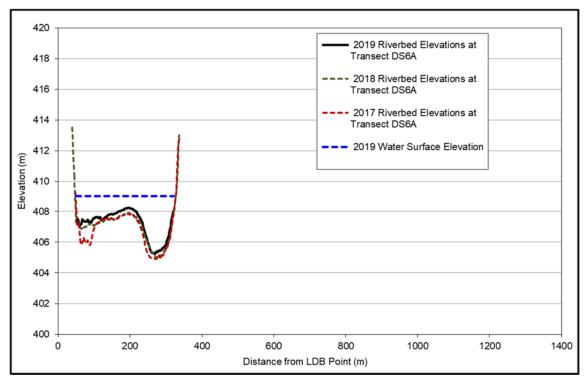
Figure 4: Cross section results for Transect DS06A. Transect was surveyed as part of BC Hydro's Site C Offset Effectiveness Monitoring, 14 September 2019.

previous surveys from 2017 and 2018, the results of the 2019 surveys indicate profile changes along the left downstream bank at Transects DS06A and DS06B (Appendix B; Figures B4 and B6). At these two transect locations, riverbed elevations increased by an average of 1.5 m between 2017 and 2019. The majority of the changes observed at Transect DS06A occurred between the 2017 and 2018 surveys, while the majority of the changes observed at Transect DS06B occurred between the 2018 and 2019 surveys. Near the thalweg area at Transect DS06 (Appendix B; Figure B5), riverbed elevation increased by approximately 2 m between 2017 and 2018 with minimal change in riverbed elevation noted between 2018 and 2019. In addition, the overall riverbed elevations appear slightly higher in the 2019 surveys when compared to the previous surveys from 2017 and 2018.

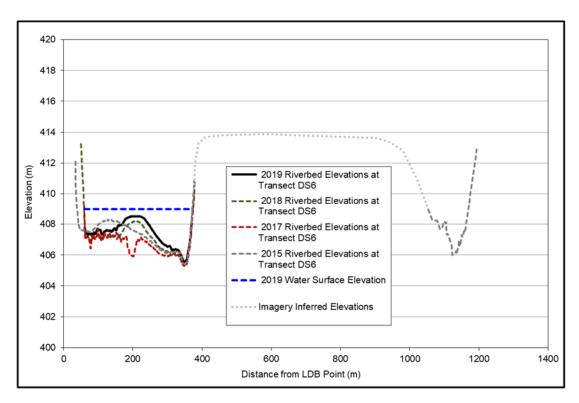
Figure 5: Cross section results for Transect DS06. Transect was surveyed as part of BC Hydro's Site C Offset Effectiveness Monitoring, 14 September 2019.

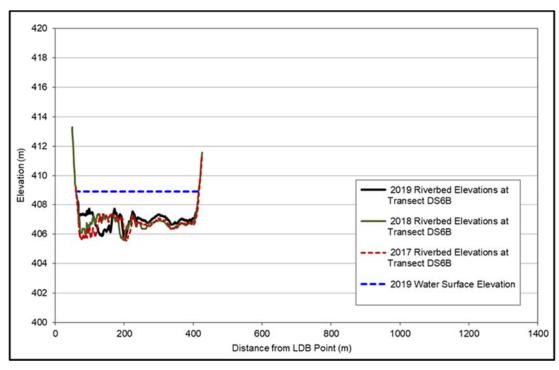
Figure 6: Cross section results for Transect DS06B. Transect was surveyed as part of BC Hydro's Site C Offset Effectiveness Monitoring, 14 September 2019.

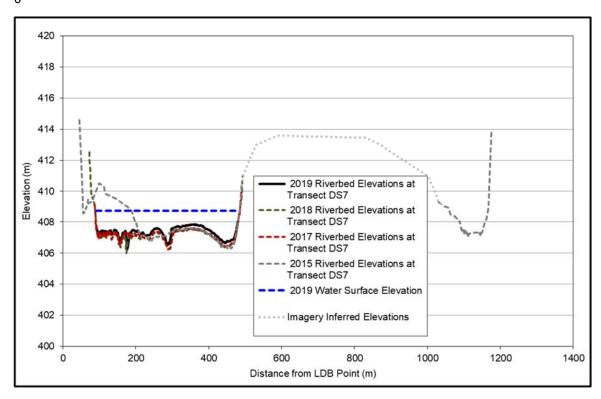
Figure 7: Cross section results for Transect DS07. Transect was surveyed as part of BC Hydro's Site C Offset Effectiveness Monitoring, 14 September 2019.

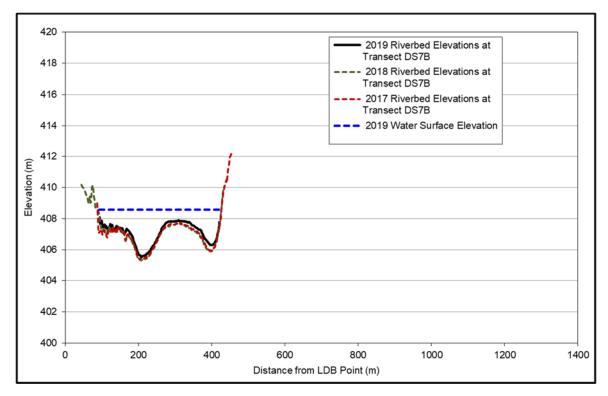
Figure 8: Cross Section results for Transect DS07B. Transect was surveyed as part of BC Hydro's Site C Offset Effectiveness Monitoring, 14 September 2019.
