Site C Clean Energy Project

Temporary Upstream Fish Passage Facility Operations Report

Reporting Period: April 1 to 30, 2023

Prepared by BC Hydro

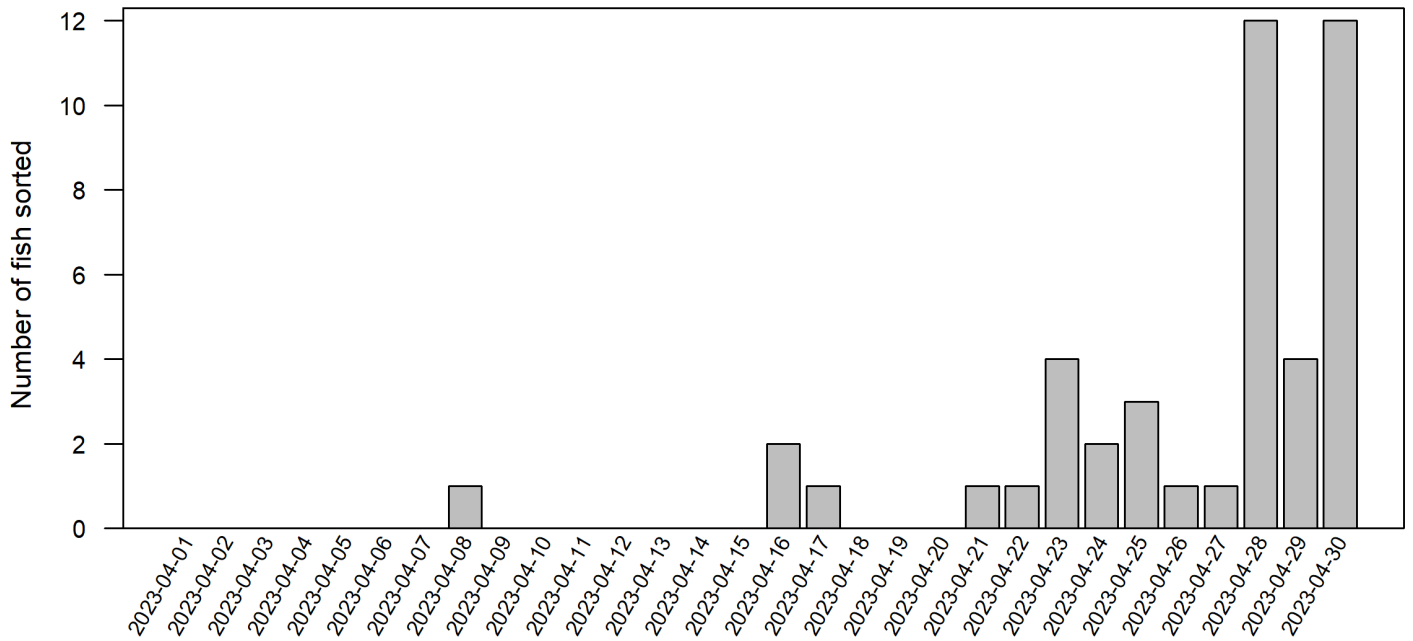
Figure 1. Daily number of fish sorted in the temporary facility during the reporting period.

In total, 45 fish were sorted in the temporary facility during the reporting period (Table 1; Figure 1). No mortalities were observed during the reporting period.

Between zero and 12 fish were sorted daily during the reporting period (Figure 1).

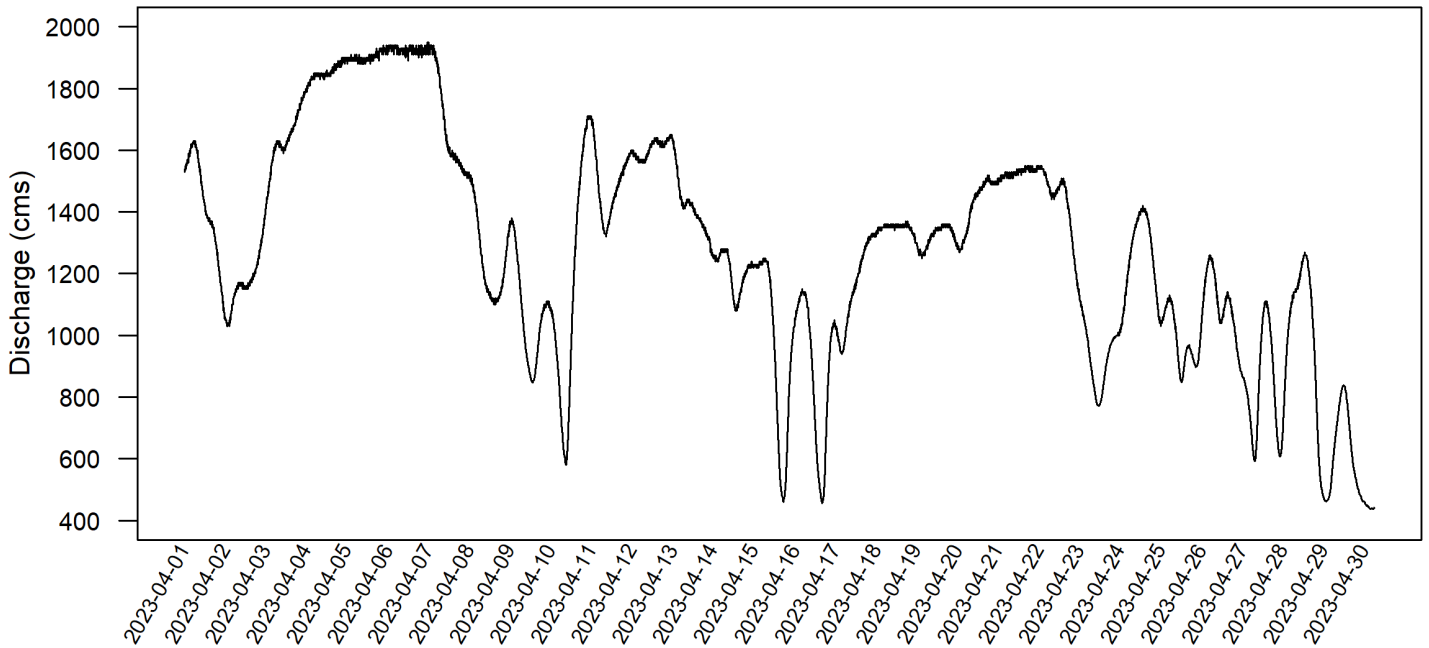
Figure 2. Discharge in the Peace River during the reporting period as measured at the Peace River above Pine River (07FA004) Water Survey of Canada (WSC) hydrometric station. Data were downloaded from the WSC on May 2; the downloaded data were provided at 5-minute intervals and were listed as provisional by the WSC.

Discharge in the Peace River fluctuated during the reporting period from a low of 437 cms on April 30 to a high of 1950 cms on April 7 (Figure 2).

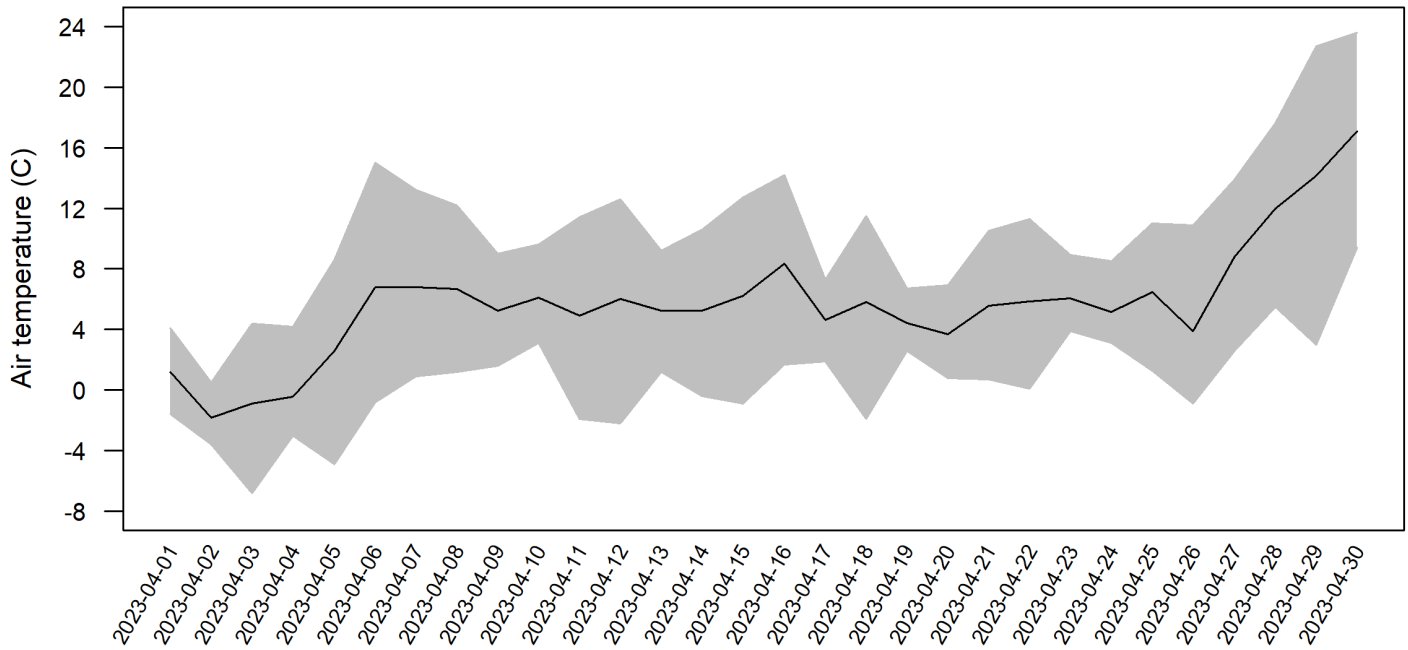
Figure 3. Mean daily air temperature (black line; °C) during the reporting period as measured by the provincial air monitoring station located on the dam site at the Site C Workers Accommodation³ (E309527). Shaded area represents the minimum and maximum daily air temperatures.

Air temperature steadily increased during the reporting period from a low of -6.8°C on April 3 to a high of 23.6°C on April 30 (Figure 3).

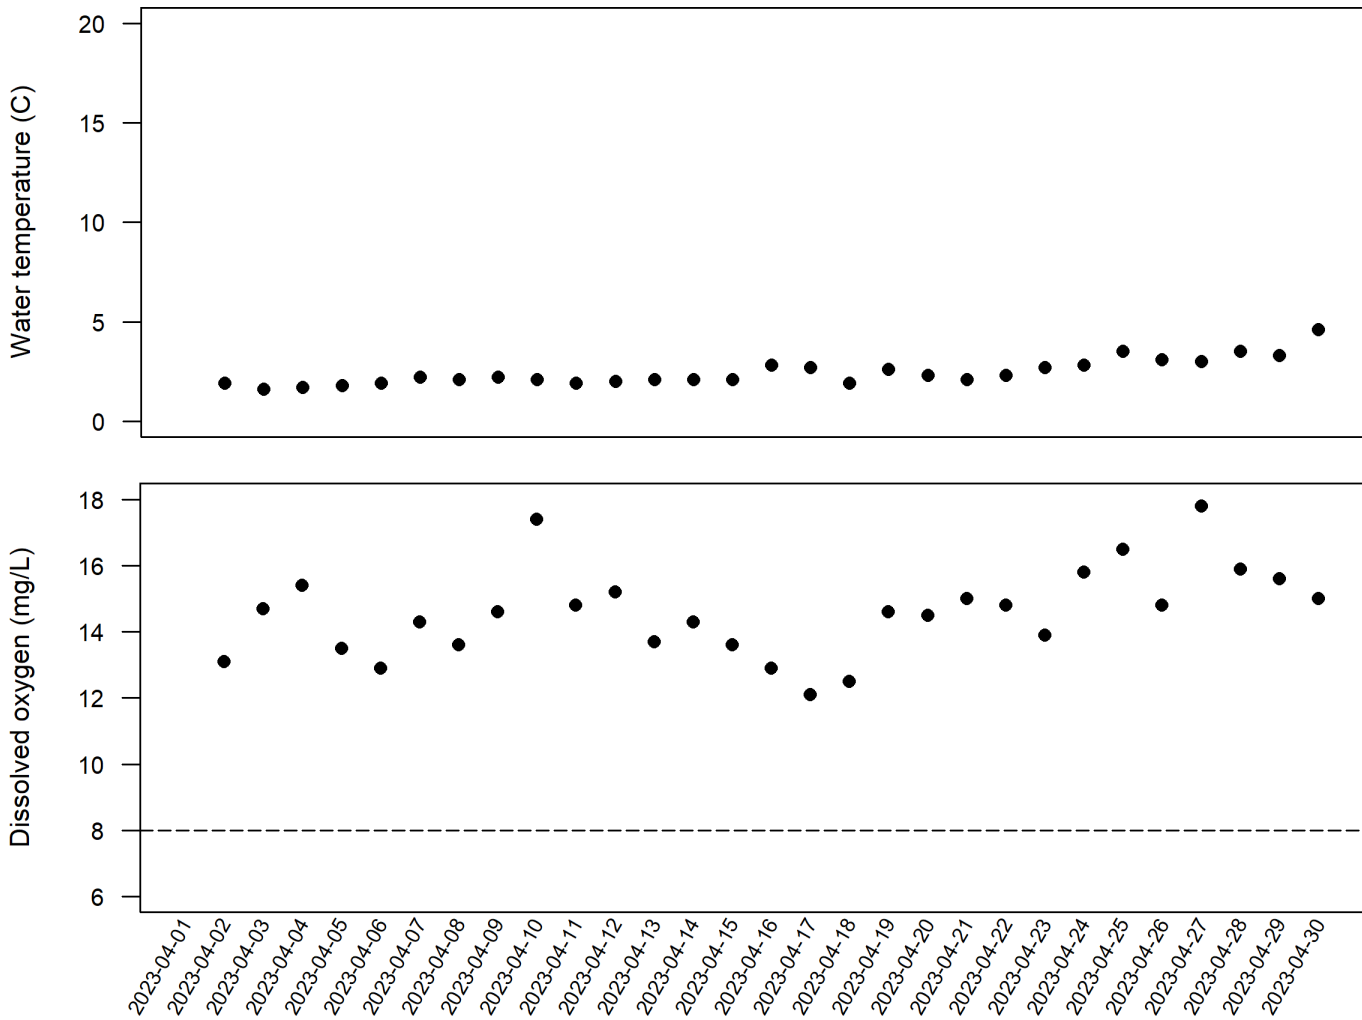
Figure 4. Daily water temperature (°C) and dissolved oxygen (mg/L) during the reporting period as measured in the pre-sort holding pool of the temporary facility.

Water temperature remained stable during the reporting period (Figure 4). Dissolved oxygen remained above the minimum dissolved oxygen level (8.0 mg/L) described in the design report of the temporary facility.

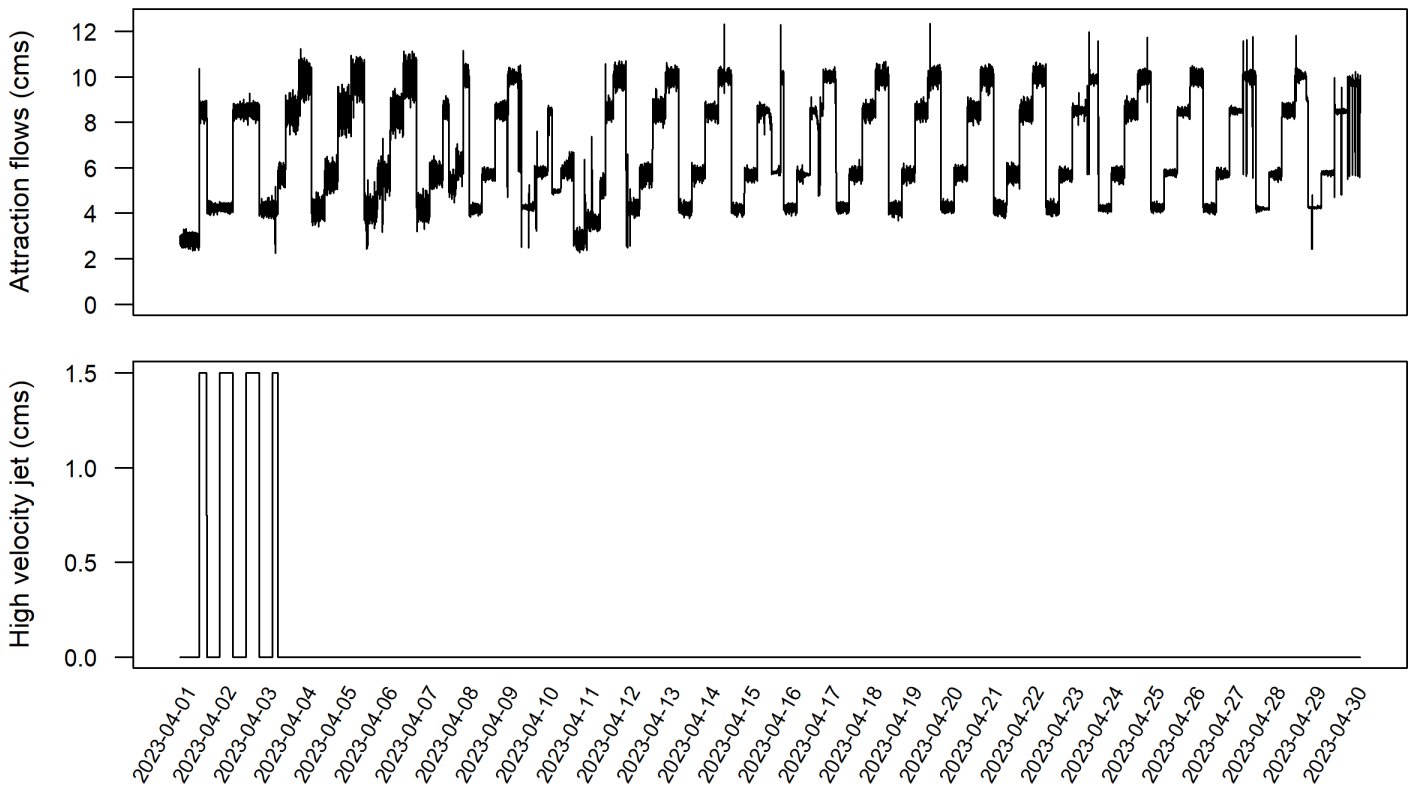
Figure 5. Operation of the attraction flows and high velocity jet during the reporting period.

BC Hydro operated the attraction flows as described in Section 3.2.1.3 of the OPP, whereby conditions were changed every 8 hours during the reporting period (Figure 5). BC Hydro did not operate the high velocity jet during the reporting period as monitoring data from 2022 suggested that the high velocity jet (1) did not improve the ability of fish to approach and enter the facility and (2) interfered with the ability of monitoring equipment to detect tagged fish and determine the biological effectiveness of the facility.

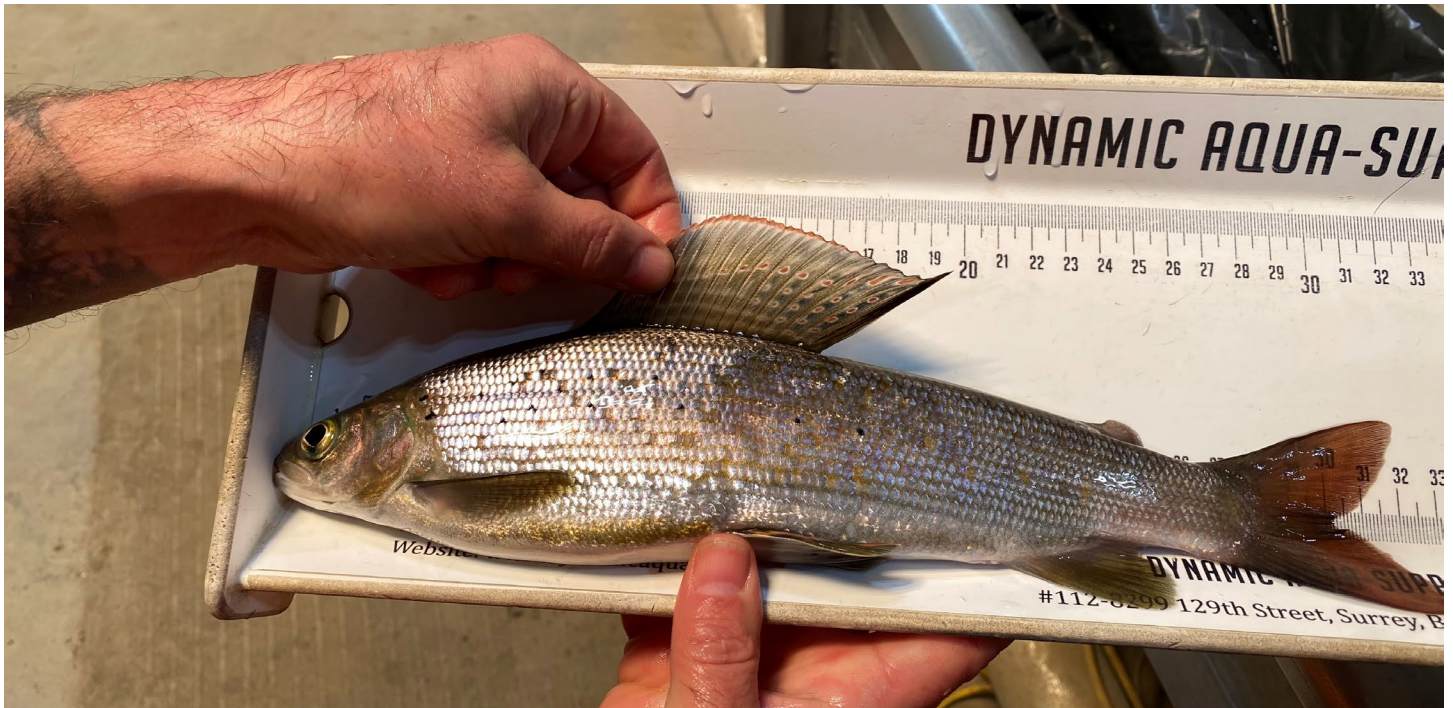
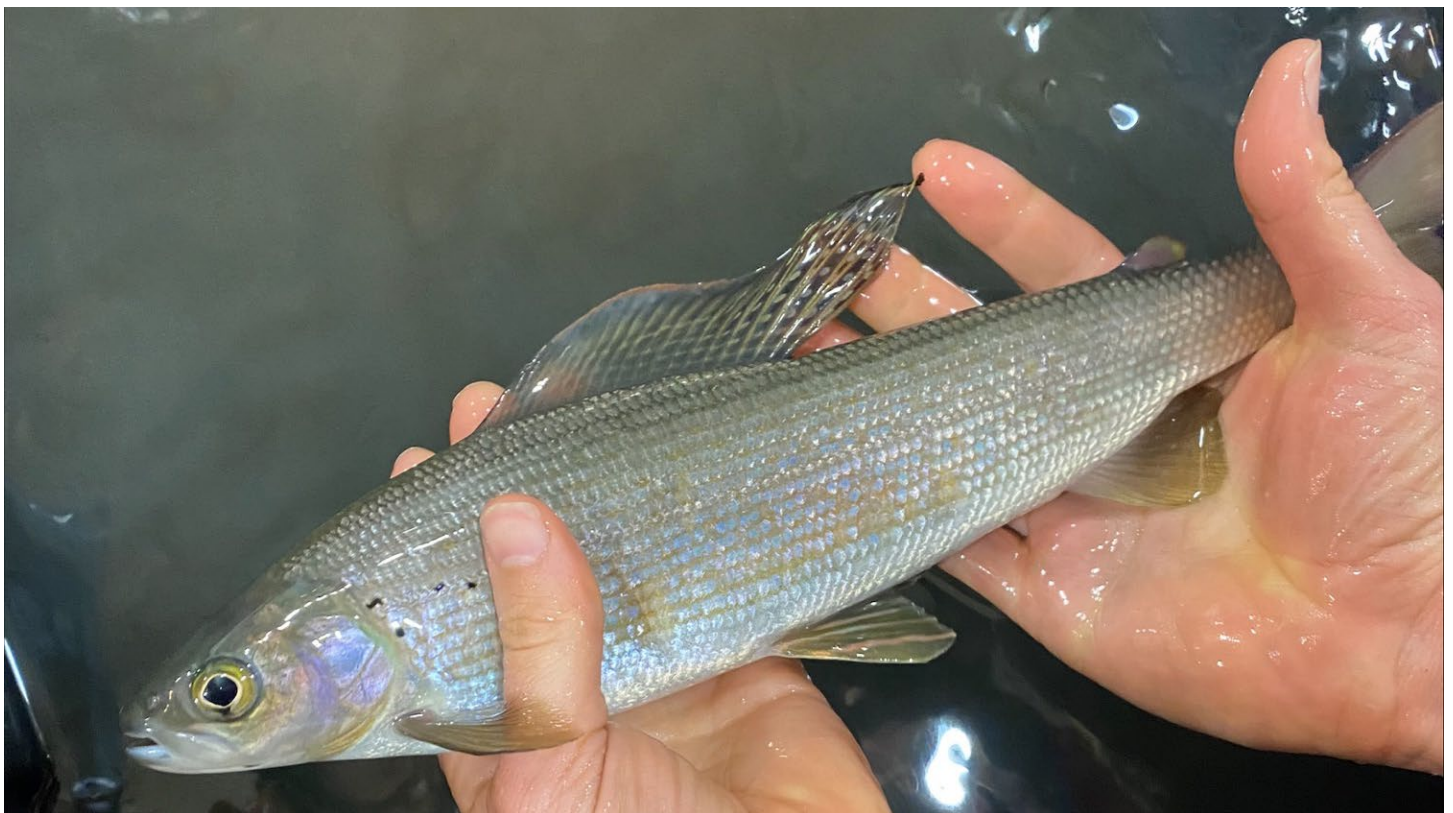
Photo 1. Biologists sample Arctic Grayling in the sorting facility (top: April 8, 2023, bottom: April 24, 2023).

Forty five fish – 34 Mountain Whitefish, 10 Arctic Grayling, and 1 Rainbow Trout – were sorted and sampled at the temporary facility, and transported and released into the Peace River upstream of the Project (Table 1, Photo 1).

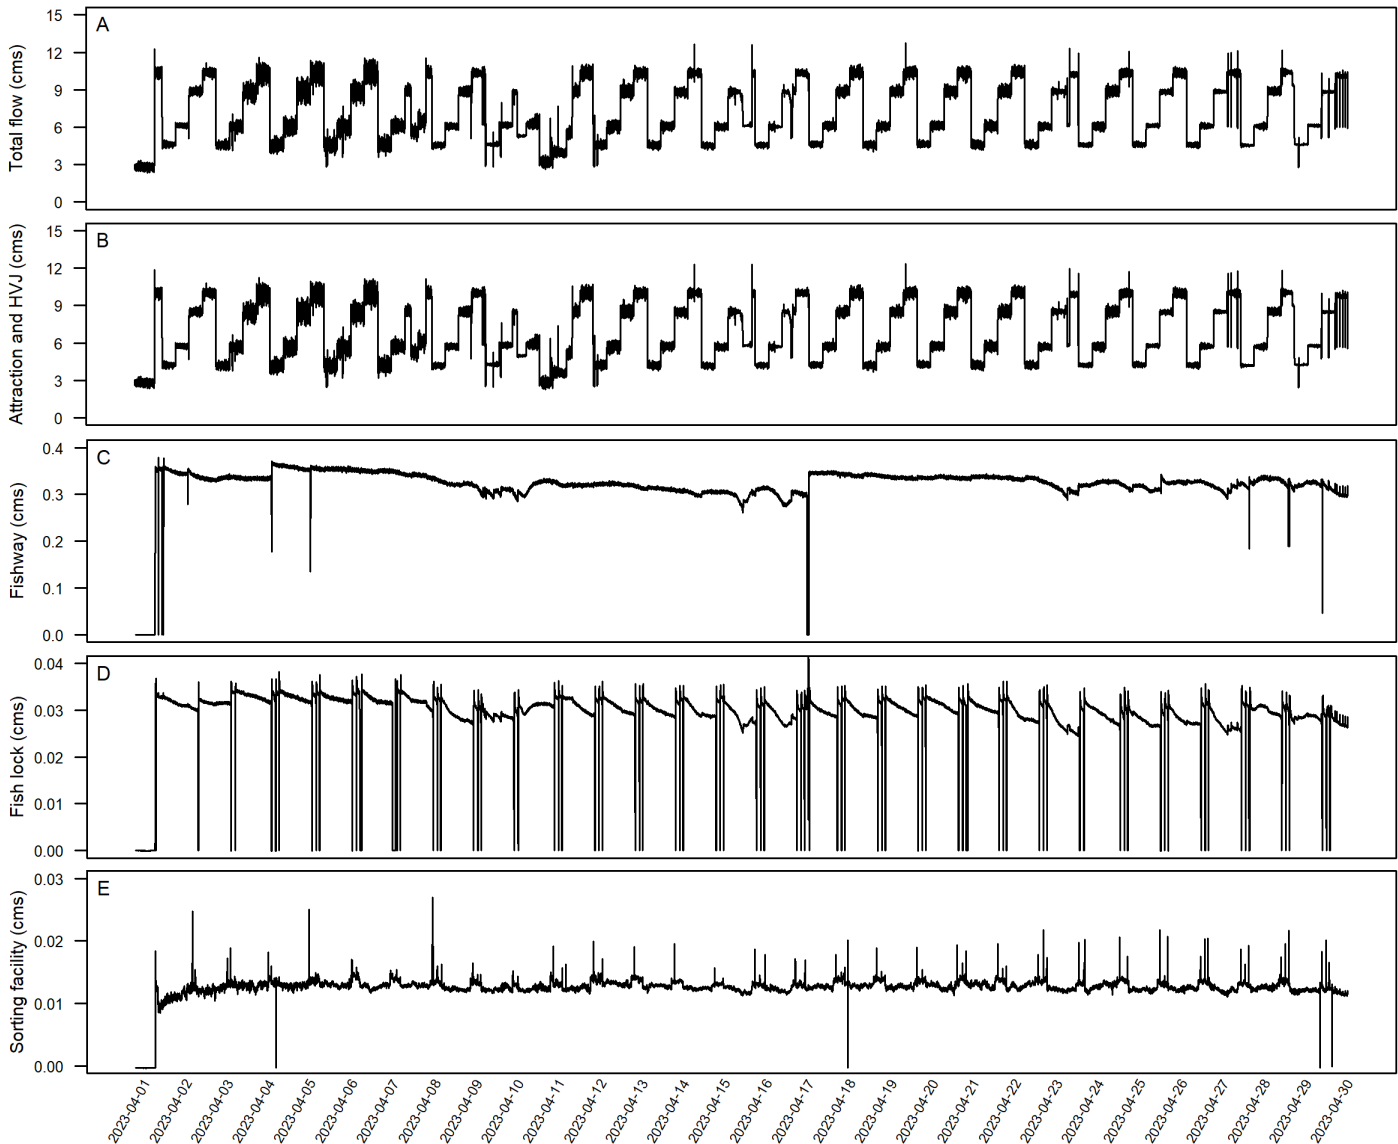
Appendix II. (A) Total flow (cms) diverted from the Peace River to operate the temporary facility during the reporting period. Total flow is a combination of flows used for the attraction flows and high velocity jet (B), fishway (C), fish lock (D), and sorting facility (E), as described in T023 Plan for Measurement of Flow. Under Conditional Water Licence 133987⁴, BC Hydro is authorized to divert up to 15 cms of flow from the Peace River to operate the temporary facility; this authorized quantity was not exceeded during the reporting period (A).

Appendix II summarizes the total flow diverted from the Peace River to operate the temporary facility during the reporting period.
