Site C Clean Energy Project

Temporary Upstream Fish Passage Facility Operations Report

Reporting Period: August 1 to 31, 2023

Prepared by BC Hydro

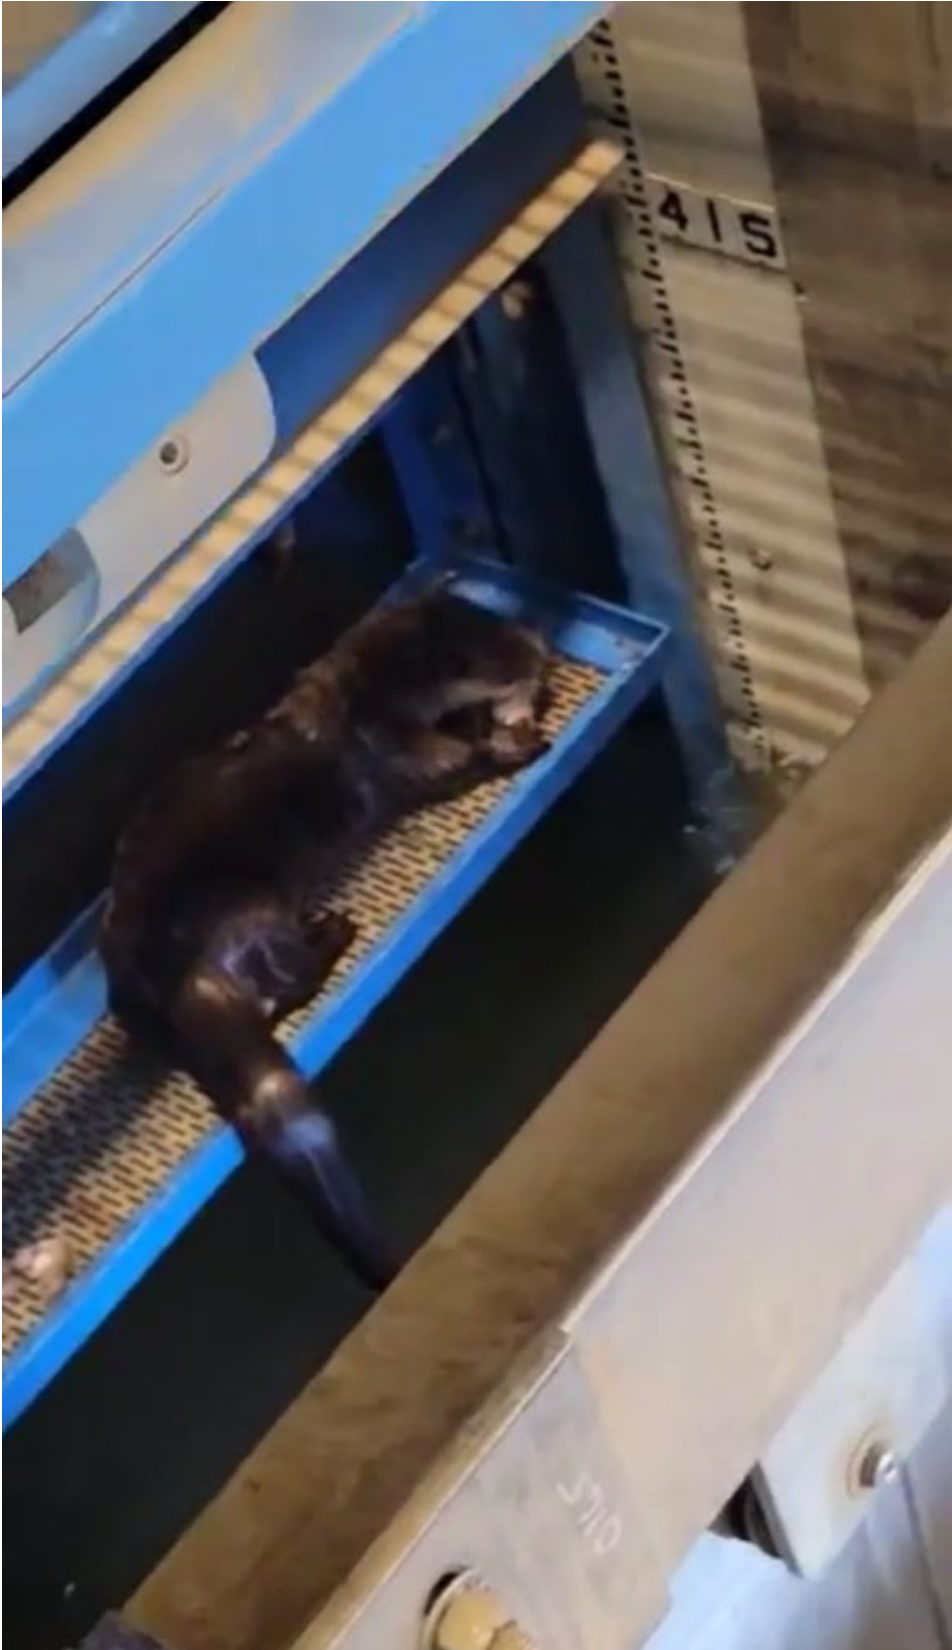
Photo 1. River otters continue to perch on facility infrastructure – such as the fish crowder at the top of the fishway (below) – to predate on fish (July 30, 2023).

Component	Adjustment
Mechanical operation	Low river levels, hydraulics, and debris build-up resulted in a large water level differential at the pump screen intakes on August 10, 20, and 27 (Table 3). Shutting the facility down for a brief period (12 to 24 hours) to clean the screens and 'reset' the differential appeared to help solve the problem and avoid mechanical damage.
Biological operation	River otters continue to routinely predate on fish in and around the facility, and use facility infrastructure (e.g., baffle walls, fish crowder) to assist in the capture and consumption of fish (Photo 1). Otters and otter sign continue to be observed by the facility operator, with a portion of the mortalities observed during the reporting period being attributed to otter predation (Table 1). Deterrence through sound and scent aversion and human presence has been ineffective since 2021. BC Hydro continued efforts to mitigate this issue through the deployment of live traps (Photo 2). If trapped, river otters would be relocated away from the facility.

Learning & Adjustment	Meets or Exceeds Expectations	<ul style="list-style-type: none"> Continue to mitigate otter predation through live trapping and relocation away from the facility (Photos 1 and 2)

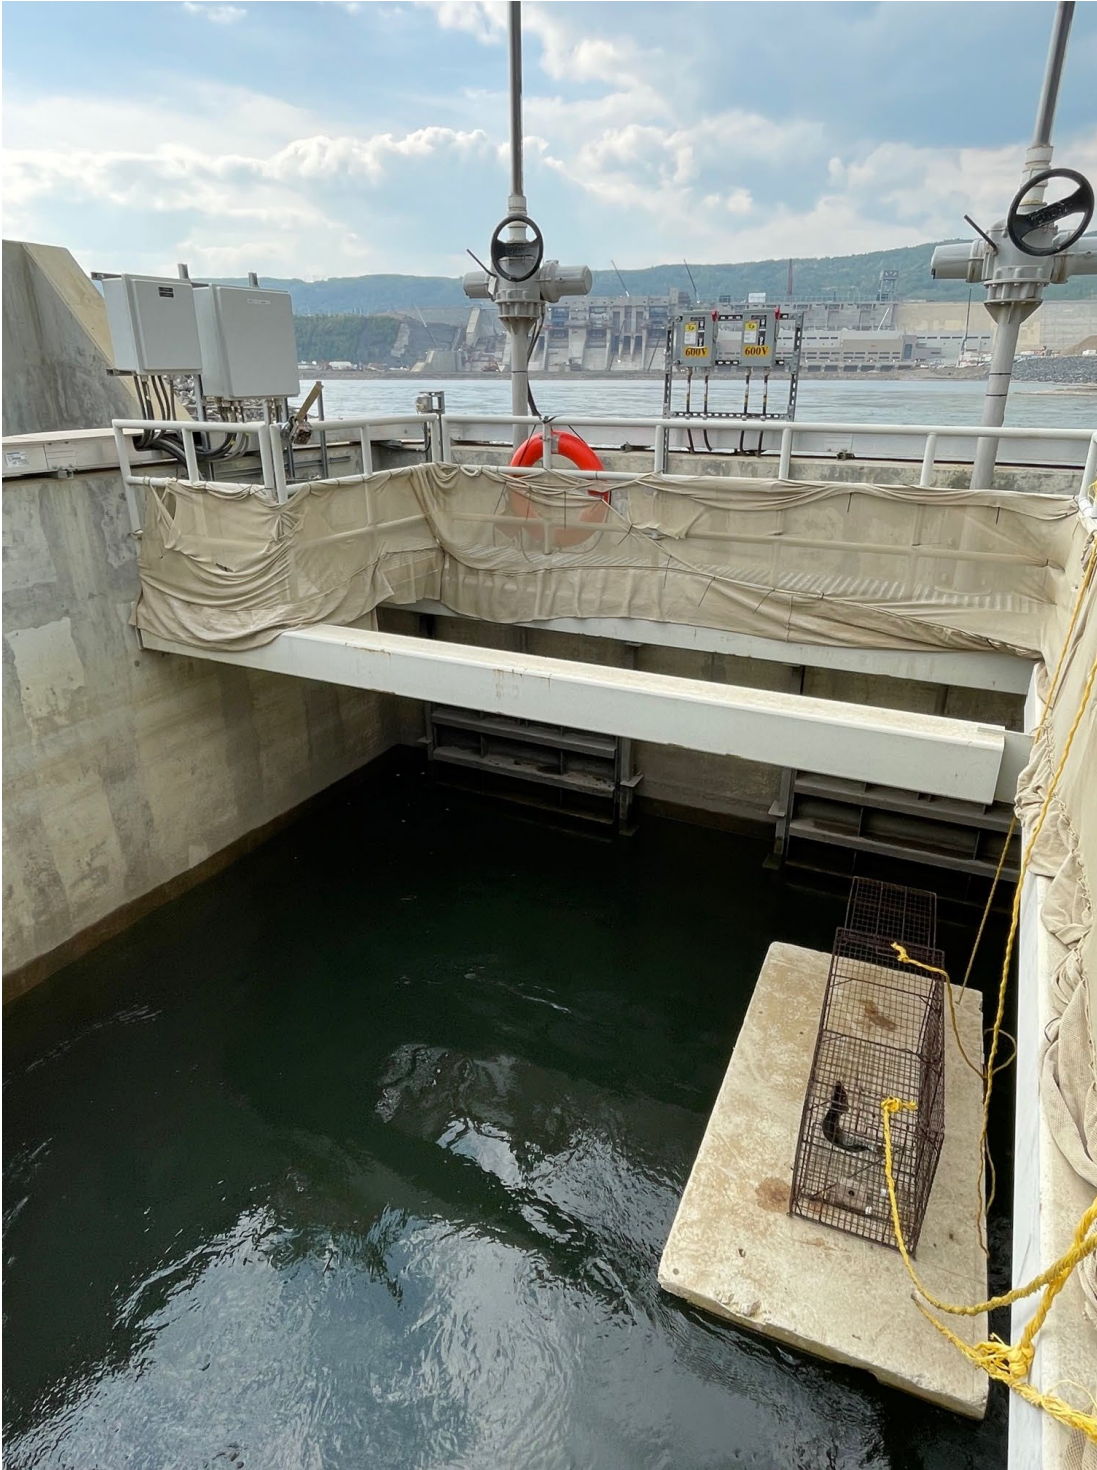
Photo 2. Baited trap deployed on a floating platform in the entrance pool in an attempt to trap and relocate river otters away from the facility (August 30, 2023).
