Site C Clean Energy Project

Temporary Upstream Fish Passage Facility Operations Report

Reporting Period: September 1 to 30, 2021

Prepared by BC Hydro

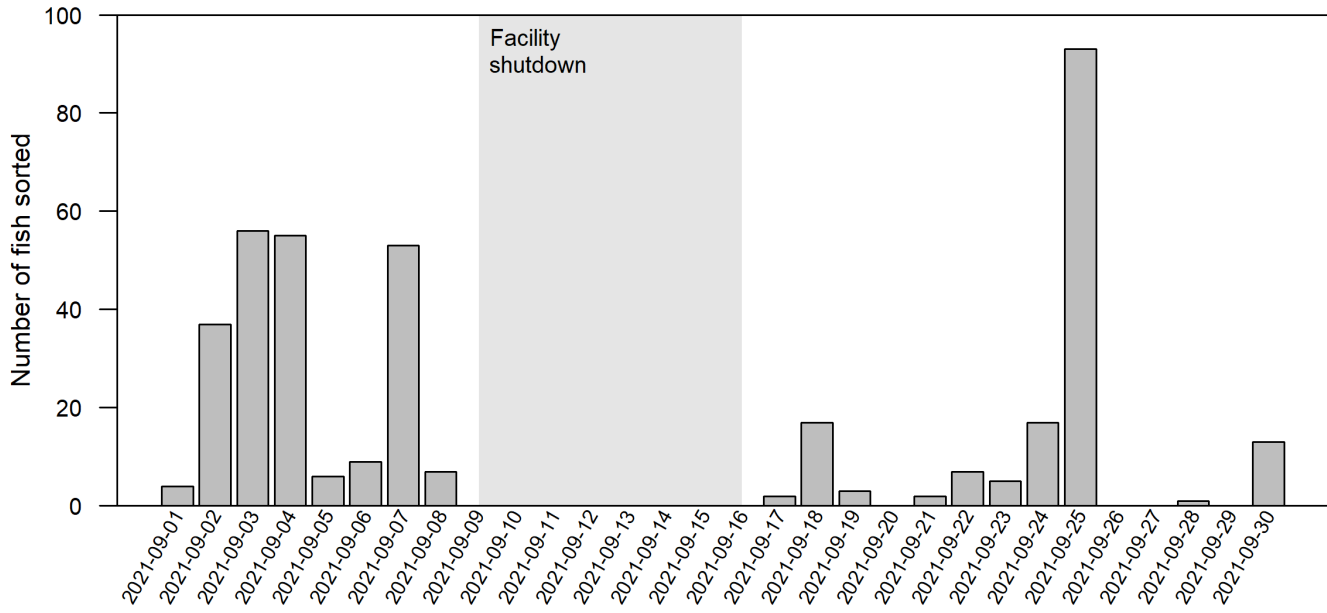
Between zero and 93 fish were sorted daily during the reporting period (Figure 1).

Figure 1. Daily number of fish sorted in the temporary facility during the reporting period.

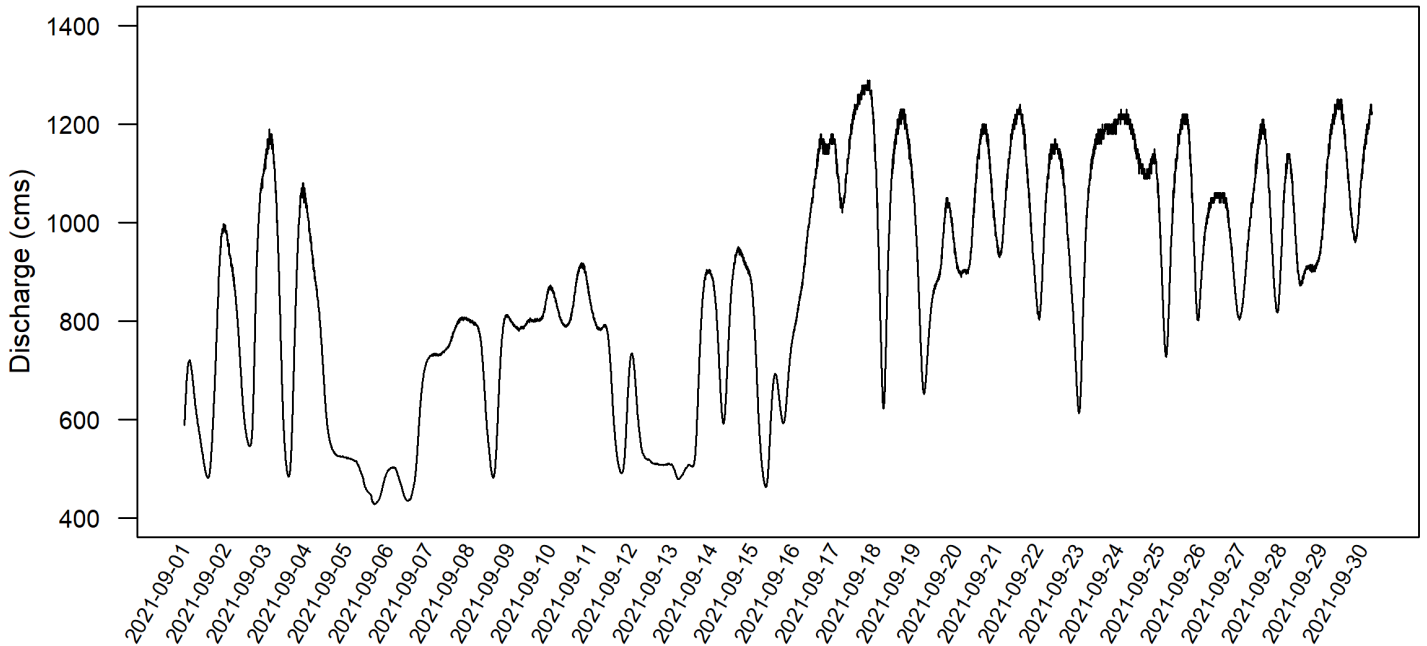
Discharge in the Peace River fluctuated during the reporting period from a low of 427 cms on September 5 to a high of 1290 cms on September 18 (Figure 2).

Figure 2. Discharge in the Peace River during the reporting period as measured at the Peace River above Pine River (07FA004) Water Survey of Canada (WSC) hydrometric station. Data were downloaded from the WSC on October 6; the downloaded data were provided at 5-minute intervals and were listed as provisional by the WSC.

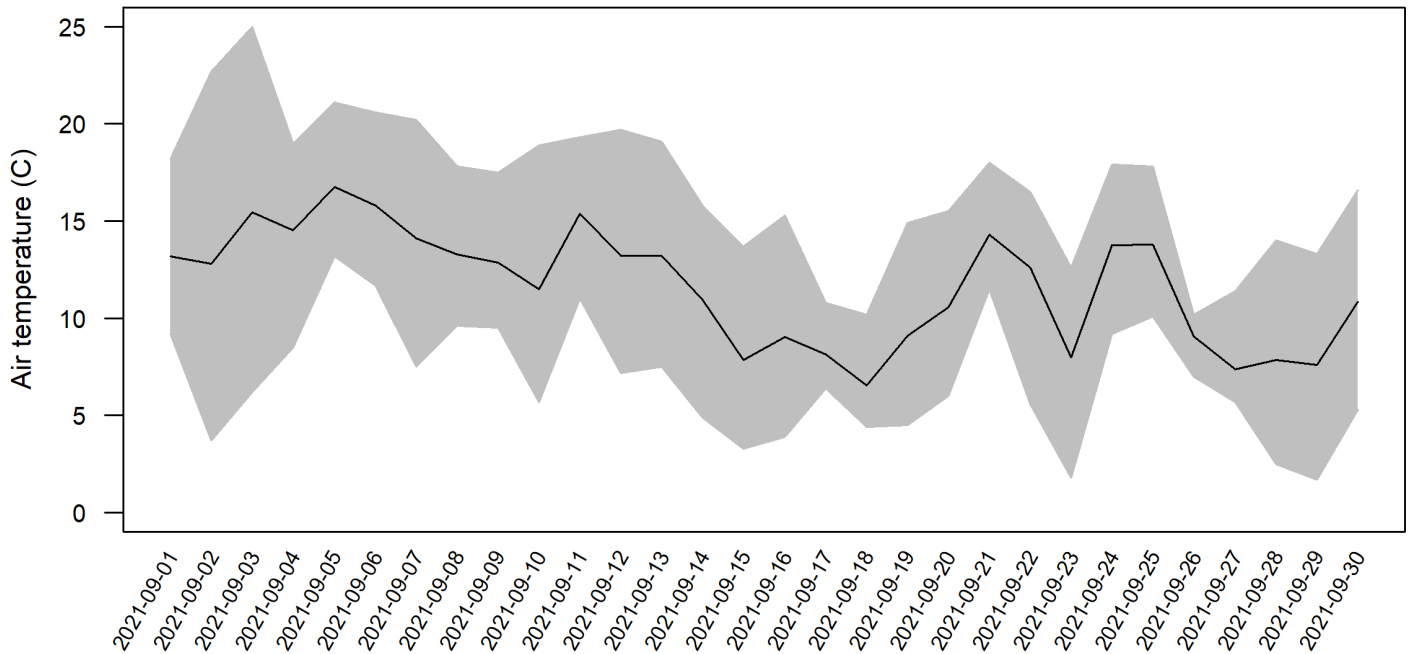
Air temperature fluctuated during the reporting period from a low of 1.7°C on September 29 to a high of 25.0°C on September 3 (Figure 3).

Figure 3. Mean daily air temperature (black line; °C) during the reporting period as measured by the provincial air monitoring station located on the dam site at the Site C Workers Accommodation⁵ (E309527). Shaded area represents the minimum and maximum daily air temperatures.

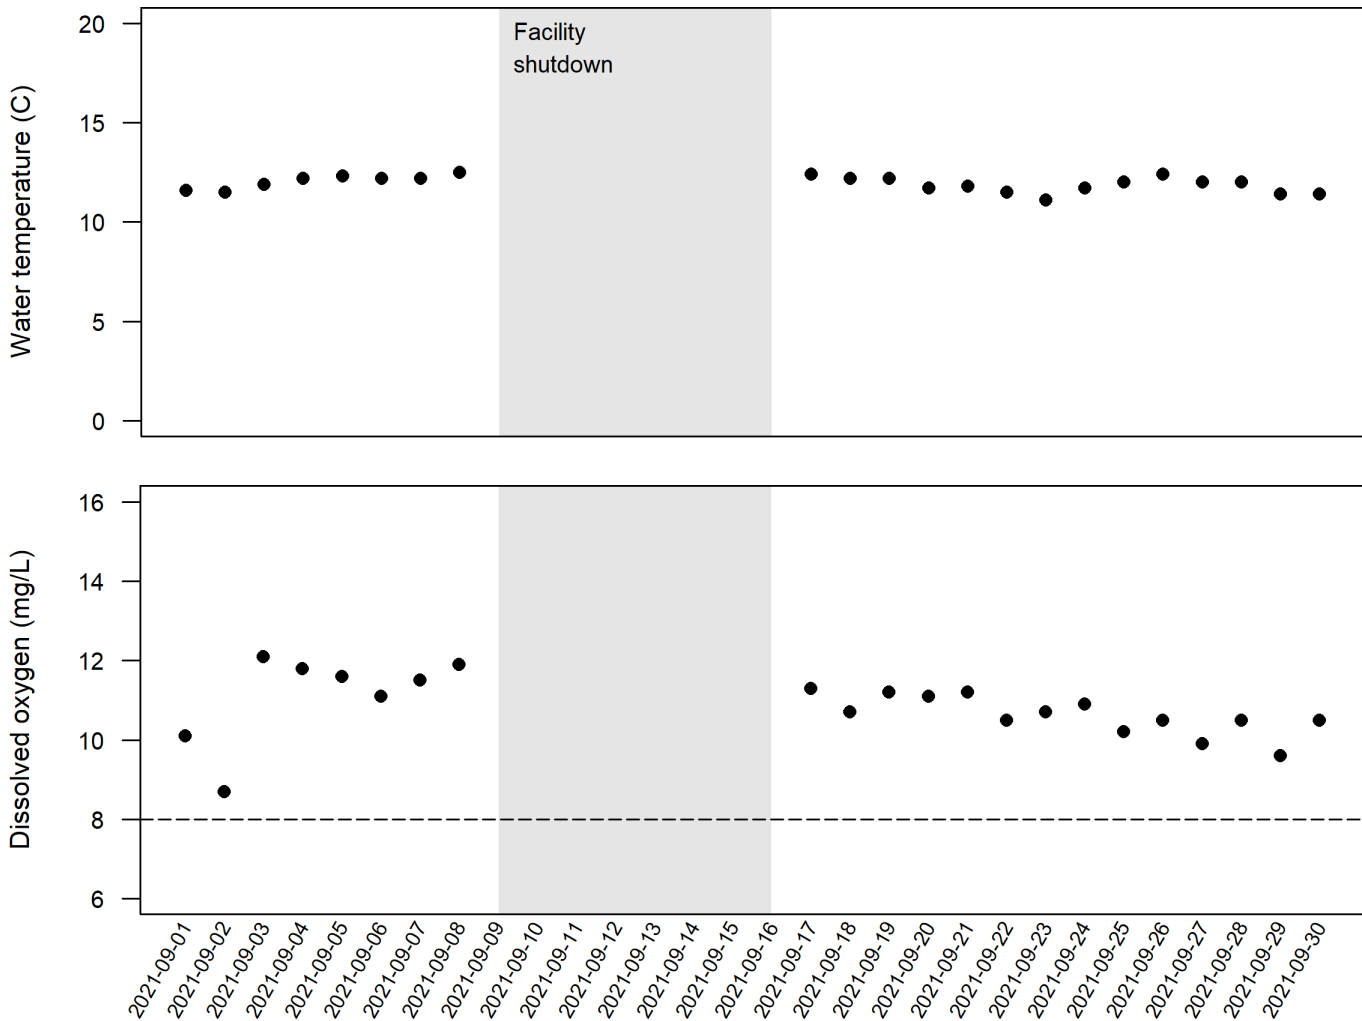
Water temperature remained stable during the reporting period from a low of 11.1°C on September 23 to a high of 12.5°C on September 8 (Figure 4). Dissolved oxygen remained above the minimum dissolved oxygen level (8.0 mg/L) described in the design report of the temporary facility.

Figure 4. Daily water temperature (°C) and dissolved oxygen (mg/L) during the reporting period as measured in the pre-sort holding pool of the temporary facility.

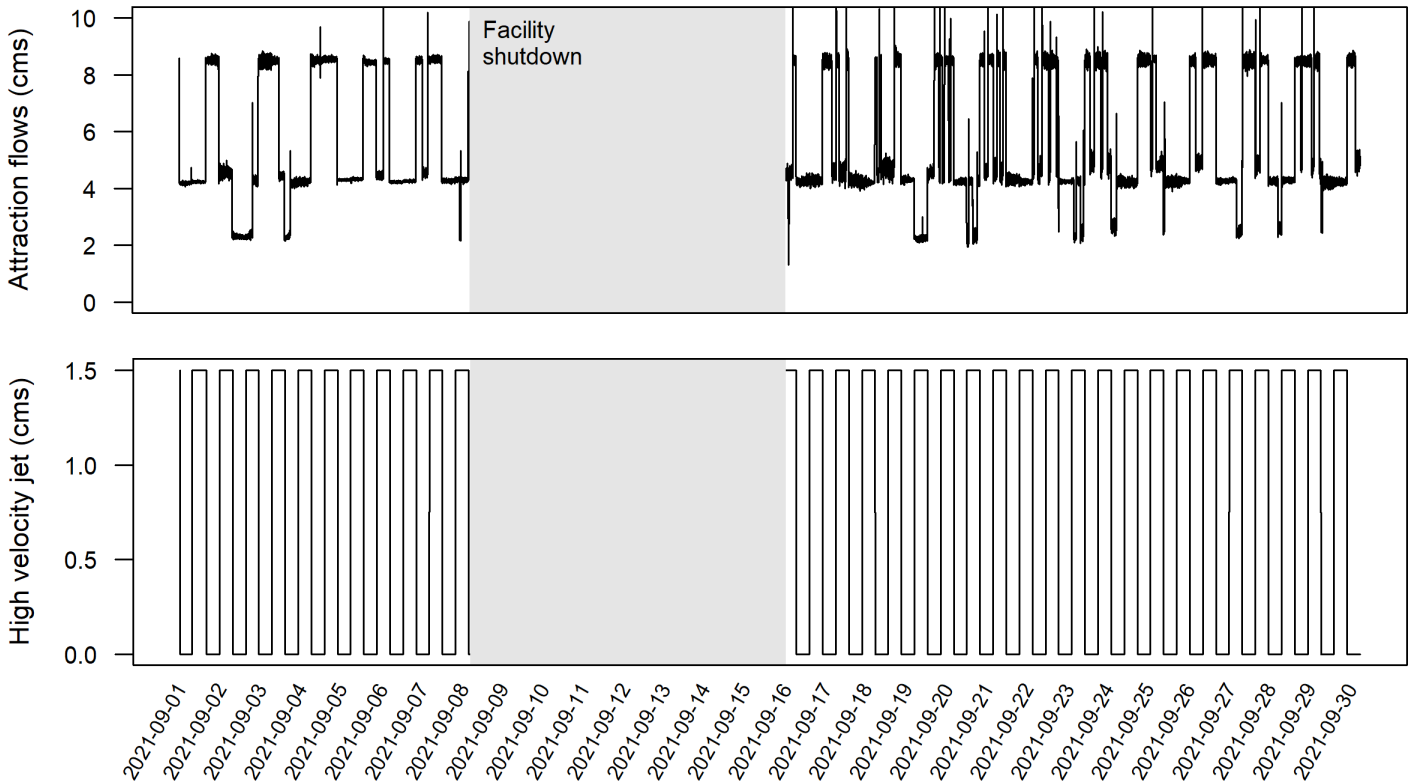
BC Hydro operated the attraction flows and high velocity jet as described in Section 3.2.1.3 of the OPP, whereby conditions were changed every 8 hours during the reporting period (Figure 5). Attraction flow pumps continued to fault throughout September, which consisted of short periods of higher or lower attraction flow (Table 4).

Figure 5. Operation of the attraction flows and high velocity jet during the reporting period.

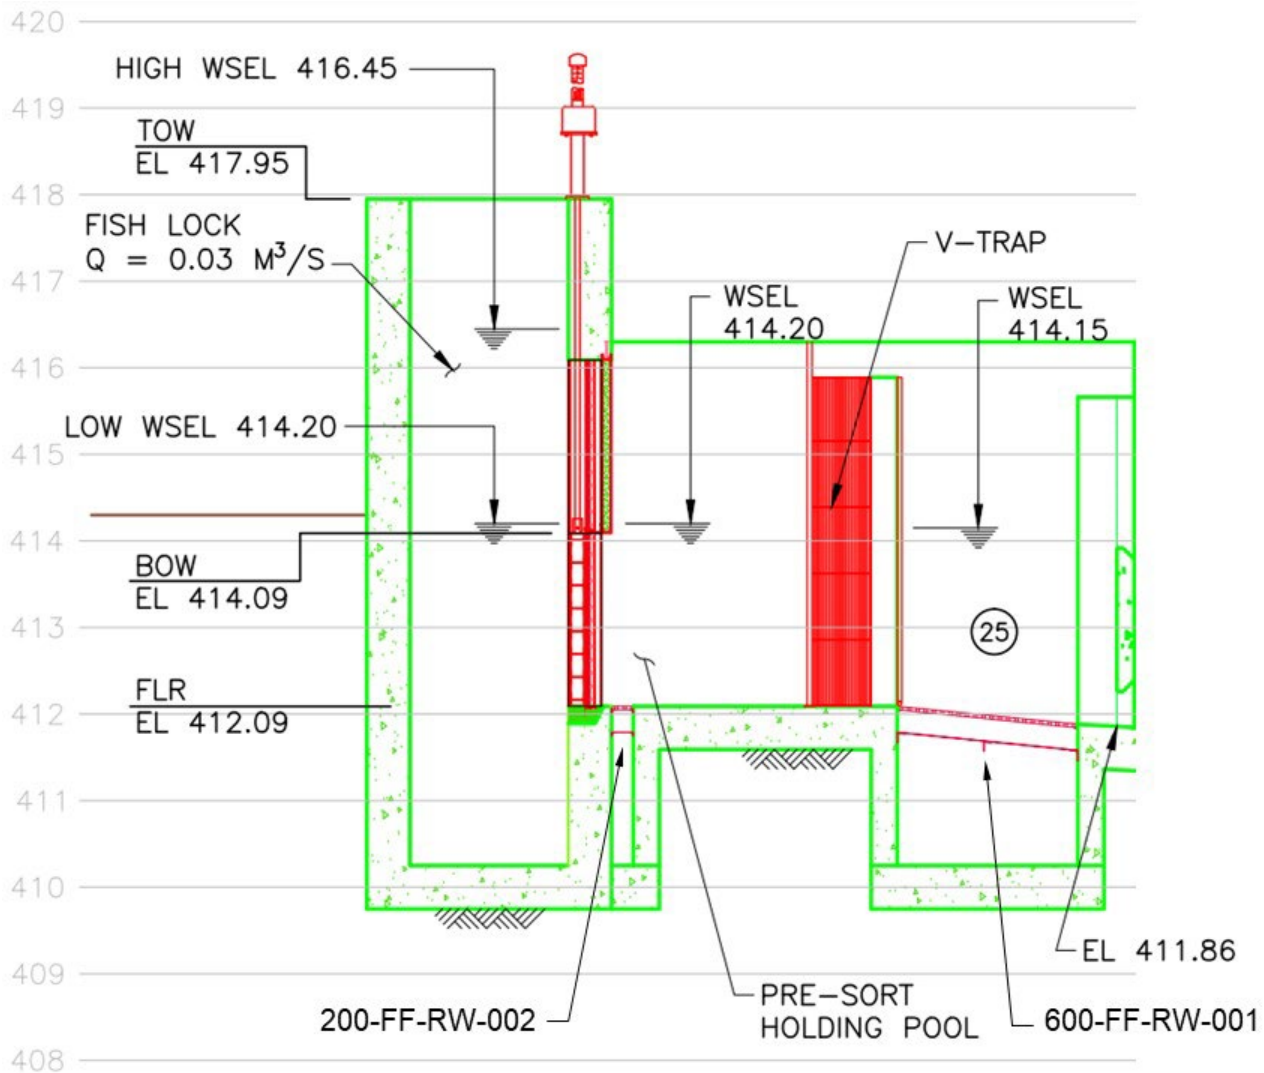
BC Hydro shut the facility down from September 9 to 16 to adjust the distribution of flow at the top of the fishway. More specifically, the adjustments allowed the operator to change the amount and location where flow entered the top of the fishway, while maintaining a total fishway flow of 0.36 cms. In general the intent was to increase flow through the vee-trap entrance to encourage fish to enter the pre-sort holding pool, and decrease flow downstream of the vee-trap that may reduce attraction into the pre-sort holding pool (Photo 2).

Photo 2. Analog cards were added to valves at the top of the fishway (600-FF-RW-001 and 200-FF-RW-002) to change the distribution of flow. In general the intent was to increase the amount of flow from the pre-sort holding pool (200-FF-RW-002) and decrease the amount of flow from Pool 25 (600-FF-RW-001). Total flow in the fishway, however, remained constant at 0.36 cms (Panel C in Appendix II). Adapted from IFC Construction Drawing 1020-C13-00305.

Several adjustments to the top of the fishway in August were continued in September to improve the biological and mechanical operation of the temporary facility. Additional adjustments were made in September, including the location where flow entered the top of the fishway (described above; Photo 2). Where appropriate, the adjustments summarized in Table 5 will be reflected in an updated revision of the OPP for operations in 2022.

Date	Standby or shutdown	Rationale
2021-09-08 09:26 to 2021-09-16 14:04	Shutdown	Facility was shutdown to: (1) install analog cards to valves at the top of the fishway (600-FF-RW-001 and 200-FF-RW-002) to change the distribution of flow and improve passage and increase trapping efficiency; and (2) replace a brass bushing on the fish lock that had worn down from operations.

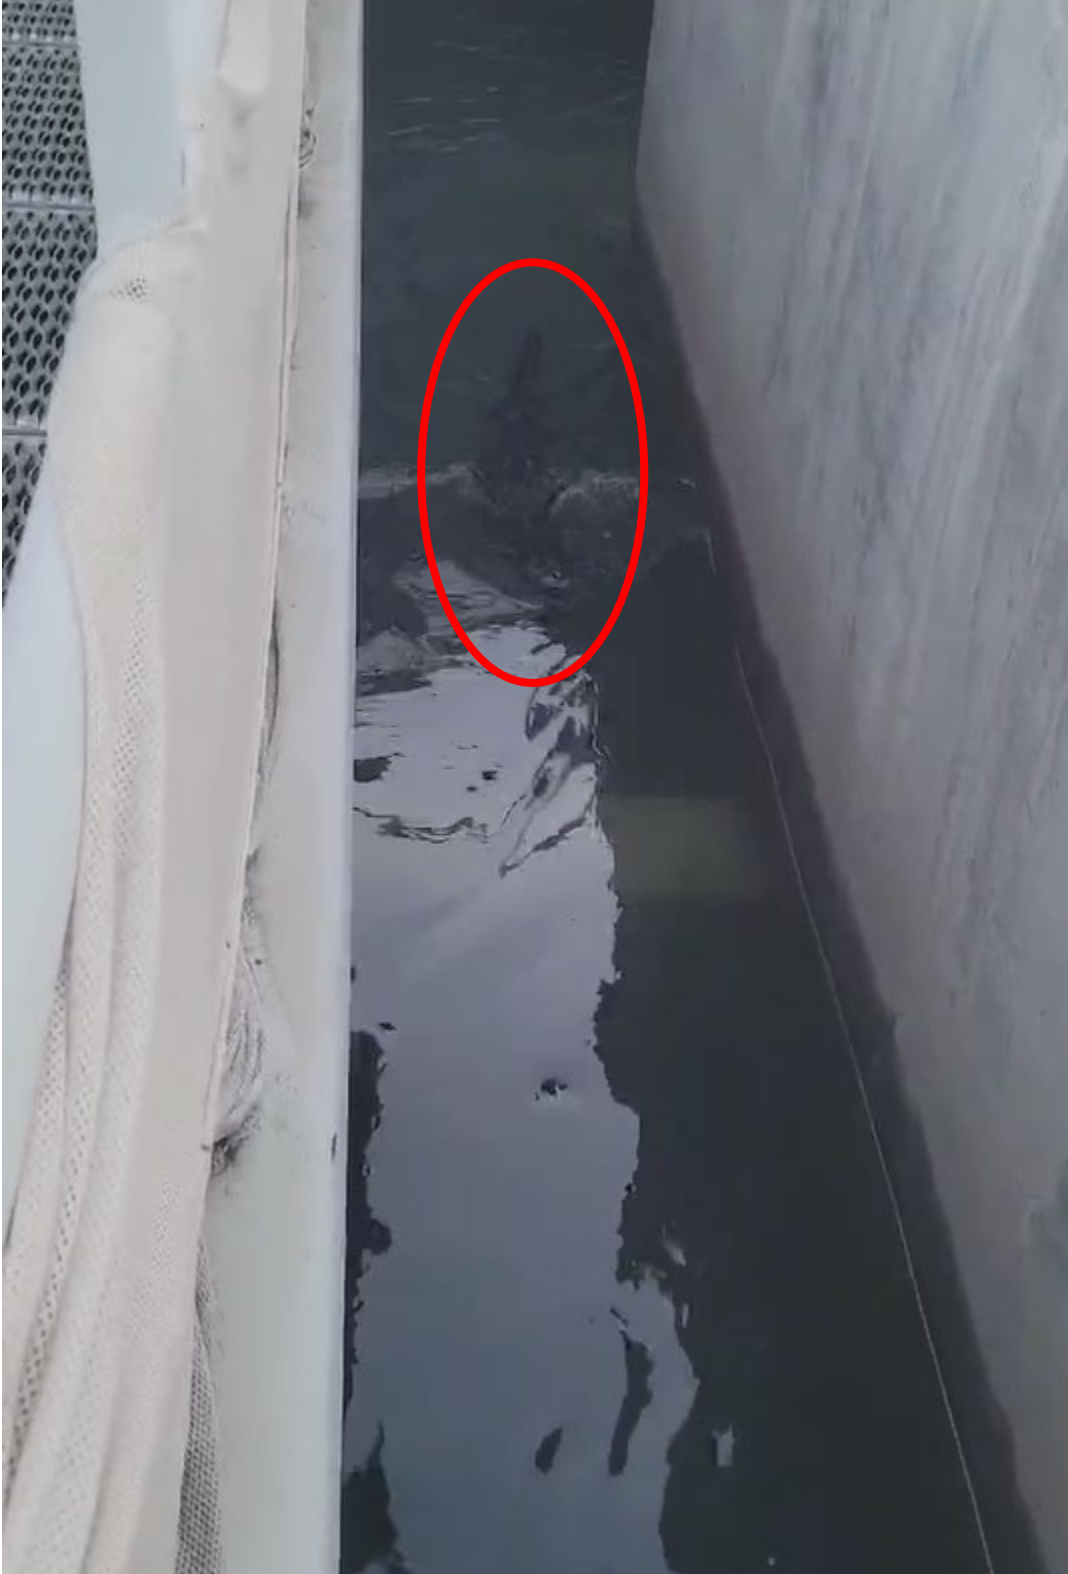
Photo 3. River otters were repeatedly observed predated on fish during the reporting period (September 30, 2021).

River otters were repeatedly observed preying on fish inside the fishway during the reporting period (Photo 3). BC Hydro retained a qualified environmental professional to assess the activities of the otters and deter them from returning to the facility. Daily inspections for otters were mandated and radio noise and a predator scent were used to deter them. Deterrents will continue to be used if proven to be effective.

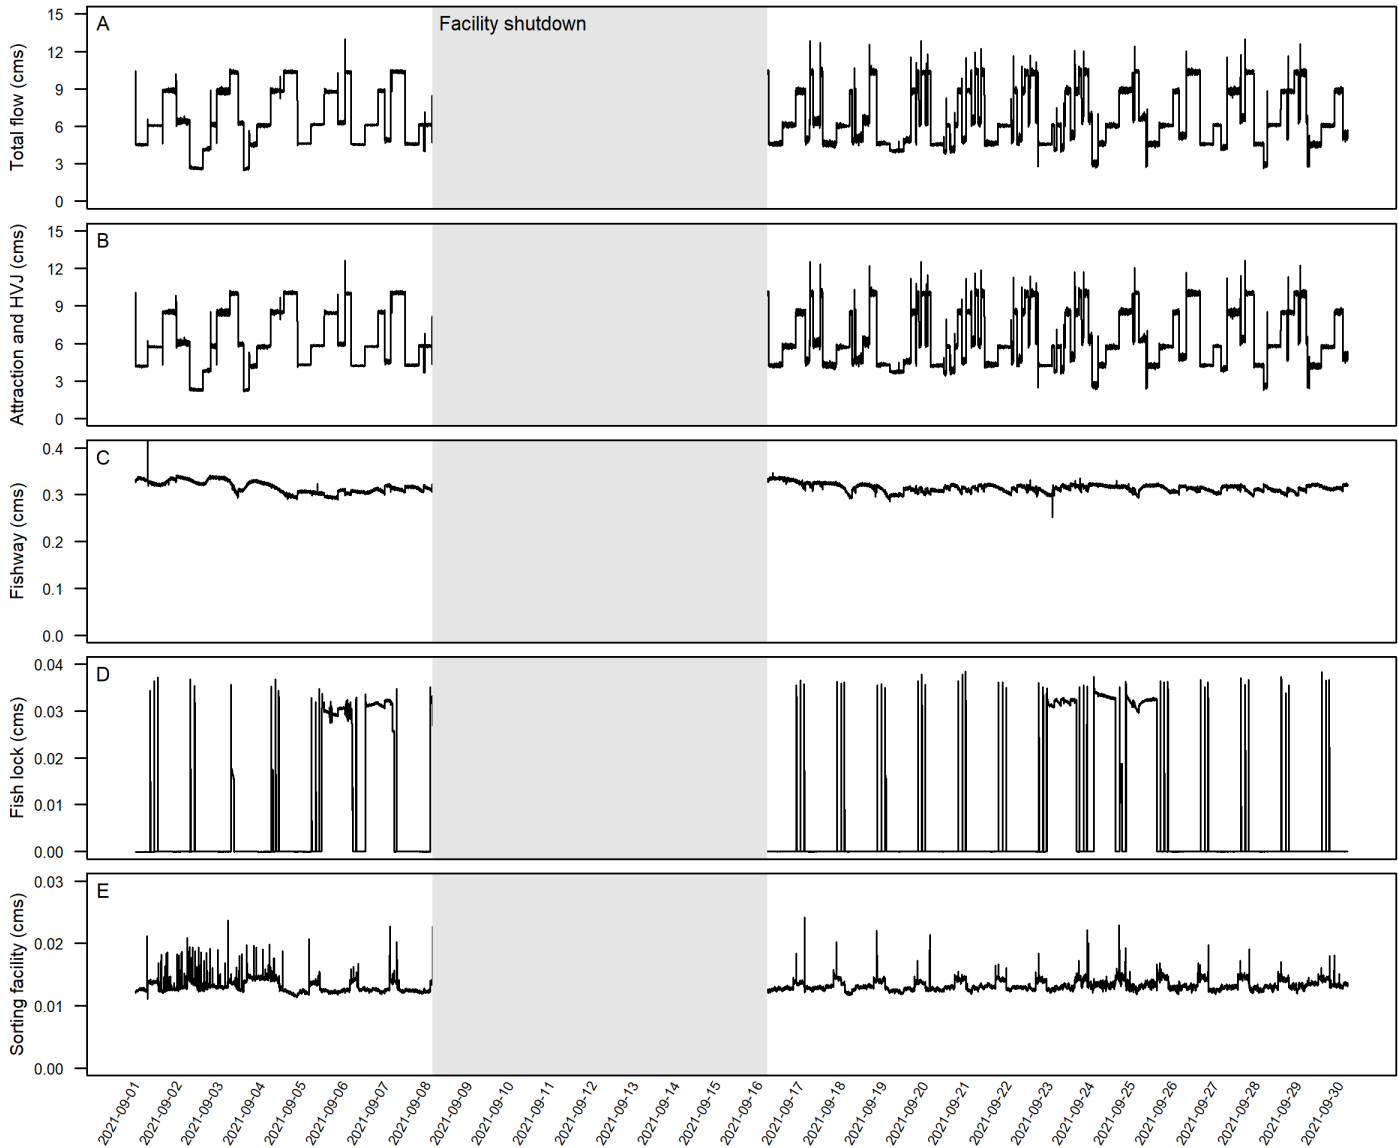
Appendix II. (A) Total flow (cms) diverted from the Peace River to operate the temporary facility during the reporting period. Total flow is a combination of flows used for the attraction flows and high velocity jet (B), fishway (C), fish lock (D), and sorting facility (E), as described in T023 Plan for Measurement of Flow. Under Conditional Water Licence 133987⁶, BC Hydro is authorized to divert up to 15 cms of flow from the Peace River to operate the temporary facility; this authorized quantity was not exceeded during the reporting period (A).
