Site C Clean Energy Project

Temporary Upstream Fish Passage Facility Operations Report

Reporting Period: May 1 to 31, 2023

Prepared by BC Hydro

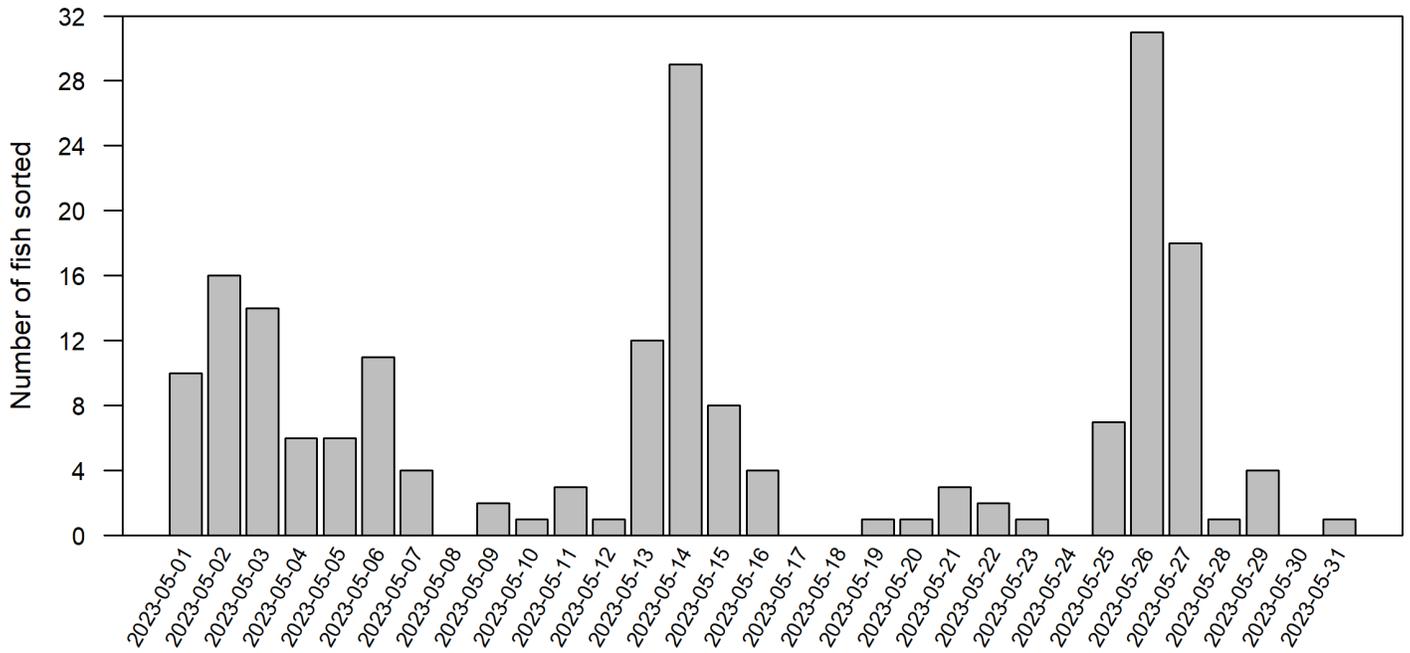
Figure 1. Daily number of fish sorted in the temporary facility during the reporting period.

In total, 197 fish were sorted in the temporary facility during the reporting period (Table 1; Figure 1). Nine mortalities – 3 Longnose Sucker, 2 Mountain Whitefish, 1 Largescale Sucker, 1 White Sucker, 1 Burbot, and 1 Spoonhead Sculpin – were observed during the reporting period (3.7% of all fish sorted in 2023), which is in-line with the anticipated levels of mortality during operations³.

Between zero and 31 fish were sorted daily during the reporting period (Figure 1).

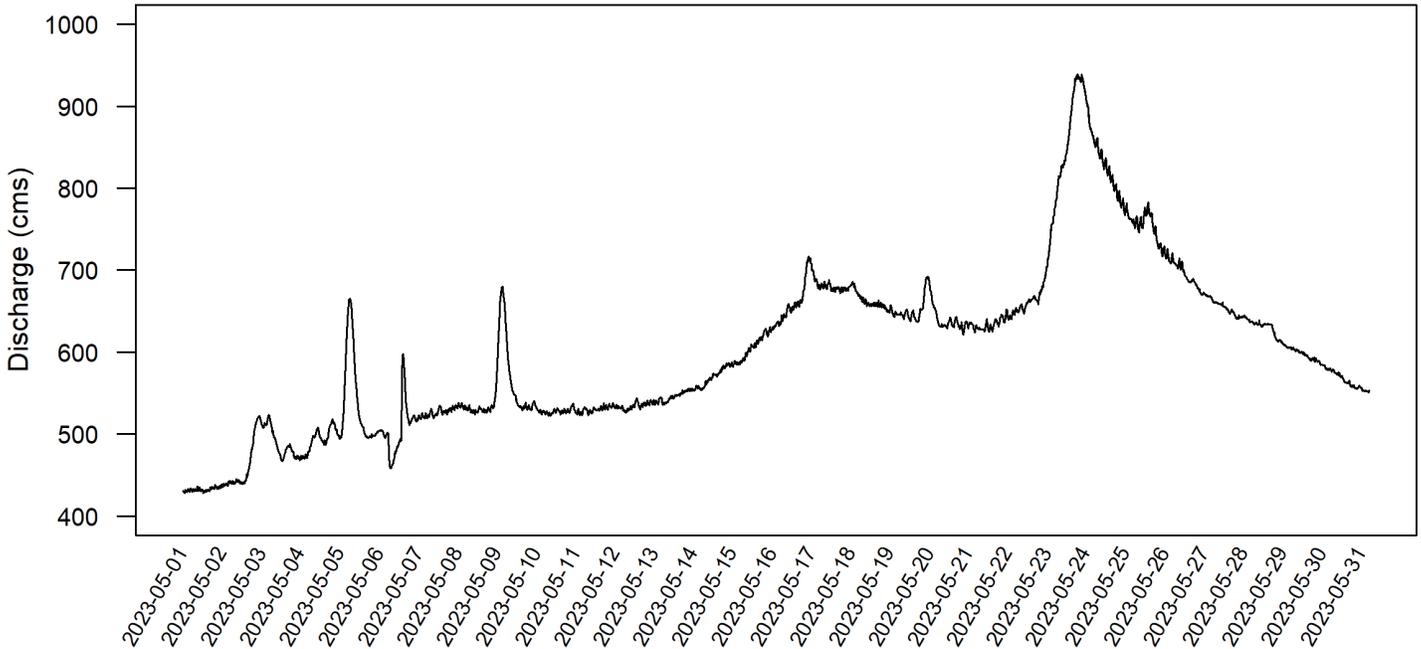
Figure 2. Discharge in the Peace River during the reporting period as measured at the Peace River above Pine River (07FA004) Water Survey of Canada (WSC) hydrometric station. Data were downloaded from the WSC on June 12; the downloaded data were provided at 5-minute intervals and were listed as provisional by the WSC.

Discharge in the Peace River fluctuated during the reporting period from a low of 428 cms on May 1 to a high of 939 cms on May 24 (Figure 2).

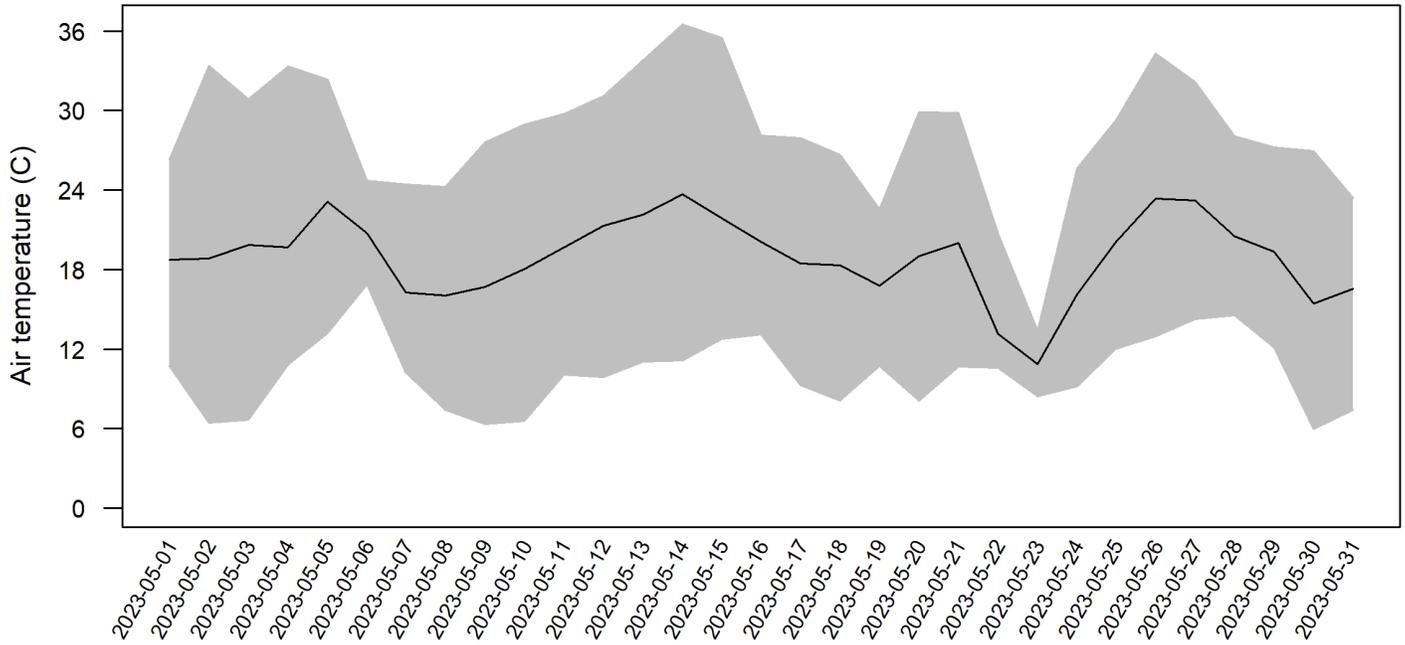
Figure 3. Mean daily air temperature (black line; °C) during the reporting period as measured by a temperature sensor at the temporary facility (TT-602). Shaded area represents the minimum and maximum daily air temperatures.

Air temperature fluctuated during the reporting period from a low of 6.0°C on May 30 to a high of 36.5°C on May 14 (Figure 3).

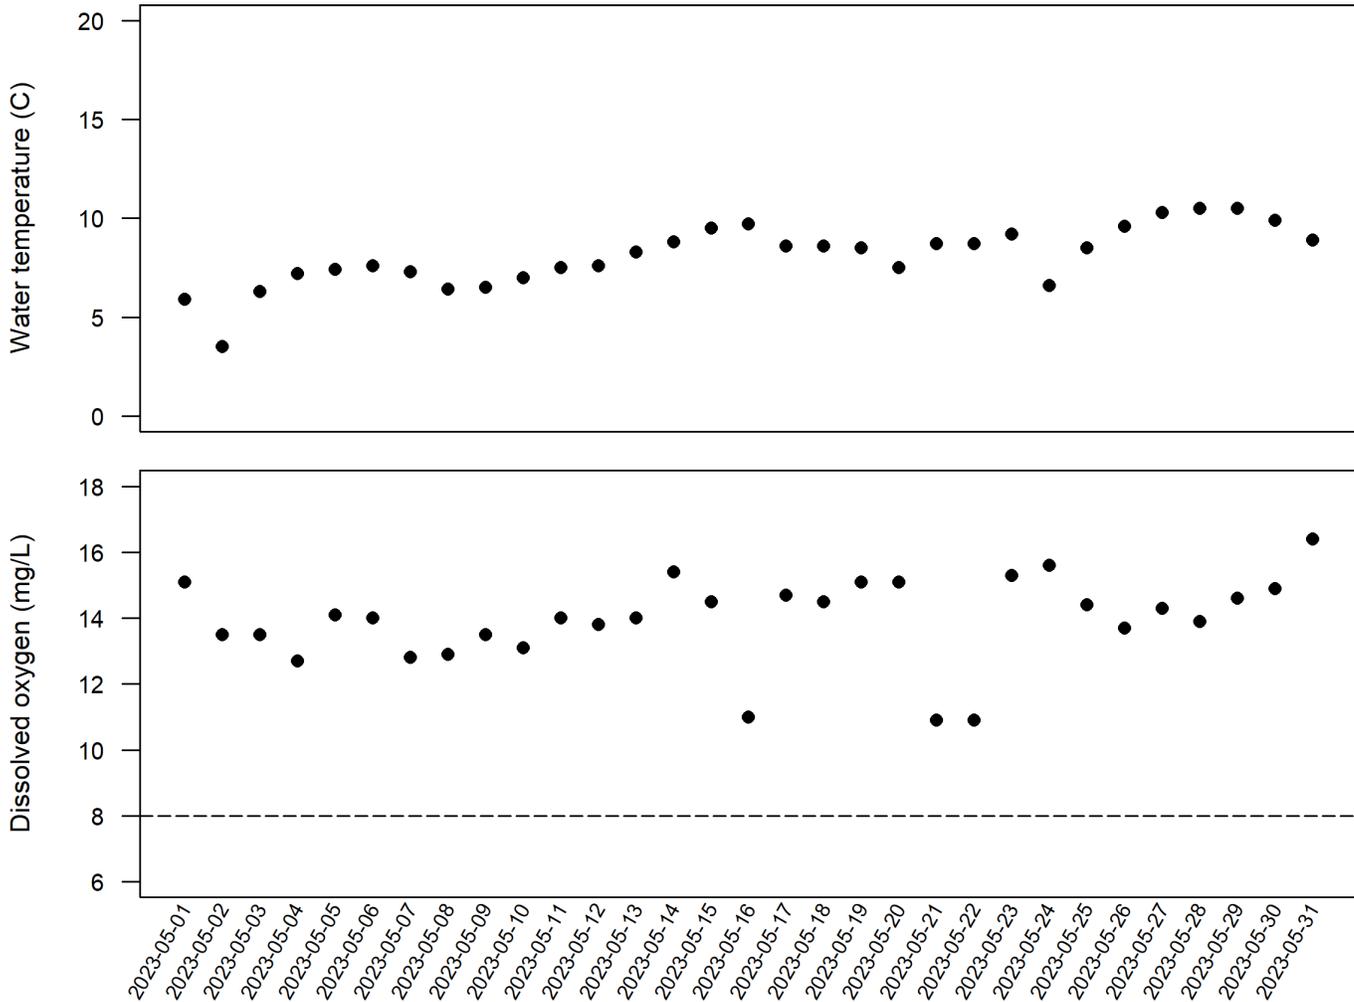
Figure 4. Daily water temperature (°C) and dissolved oxygen (mg/L) during the reporting period as measured in the pre-sort holding pool of the temporary facility.

Water temperature steadily increased during the reporting period (Figure 4). Dissolved oxygen remained above the minimum dissolved oxygen level (8.0 mg/L) described in the design report of the temporary facility.

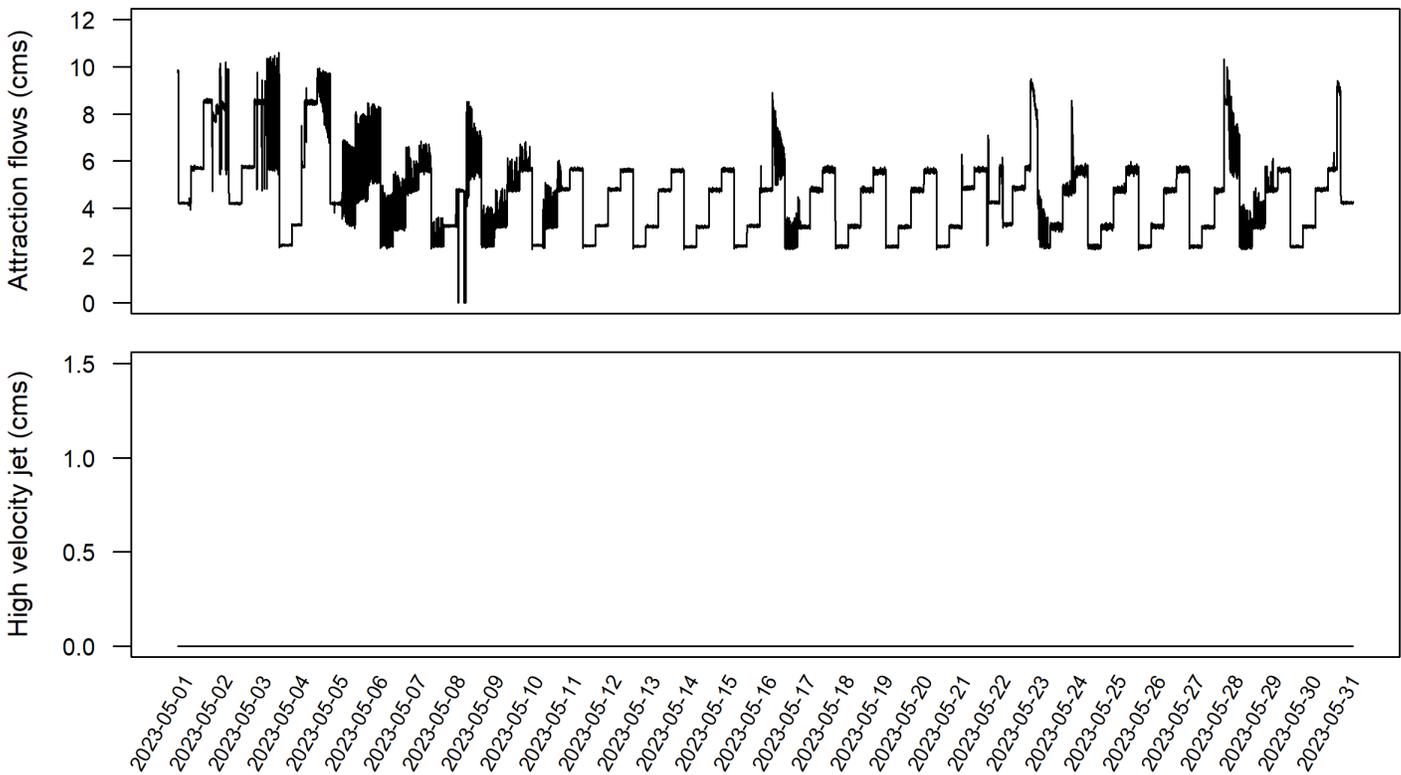
Figure 5. Operation of the attraction flows and high velocity jet during the reporting period.

BC Hydro operated the attraction flows as described in Section 3.2.1.3 of the OPP, whereby conditions were changed every 8 hours during the reporting period (Figure 5). BC Hydro did not operate the high velocity jet during the reporting period as monitoring data from 2022 suggested that the high velocity jet (1) did not improve the ability of fish to approach and enter the facility and (2) interfered with the ability of monitoring equipment to detect tagged fish and determine the biological effectiveness of the facility.

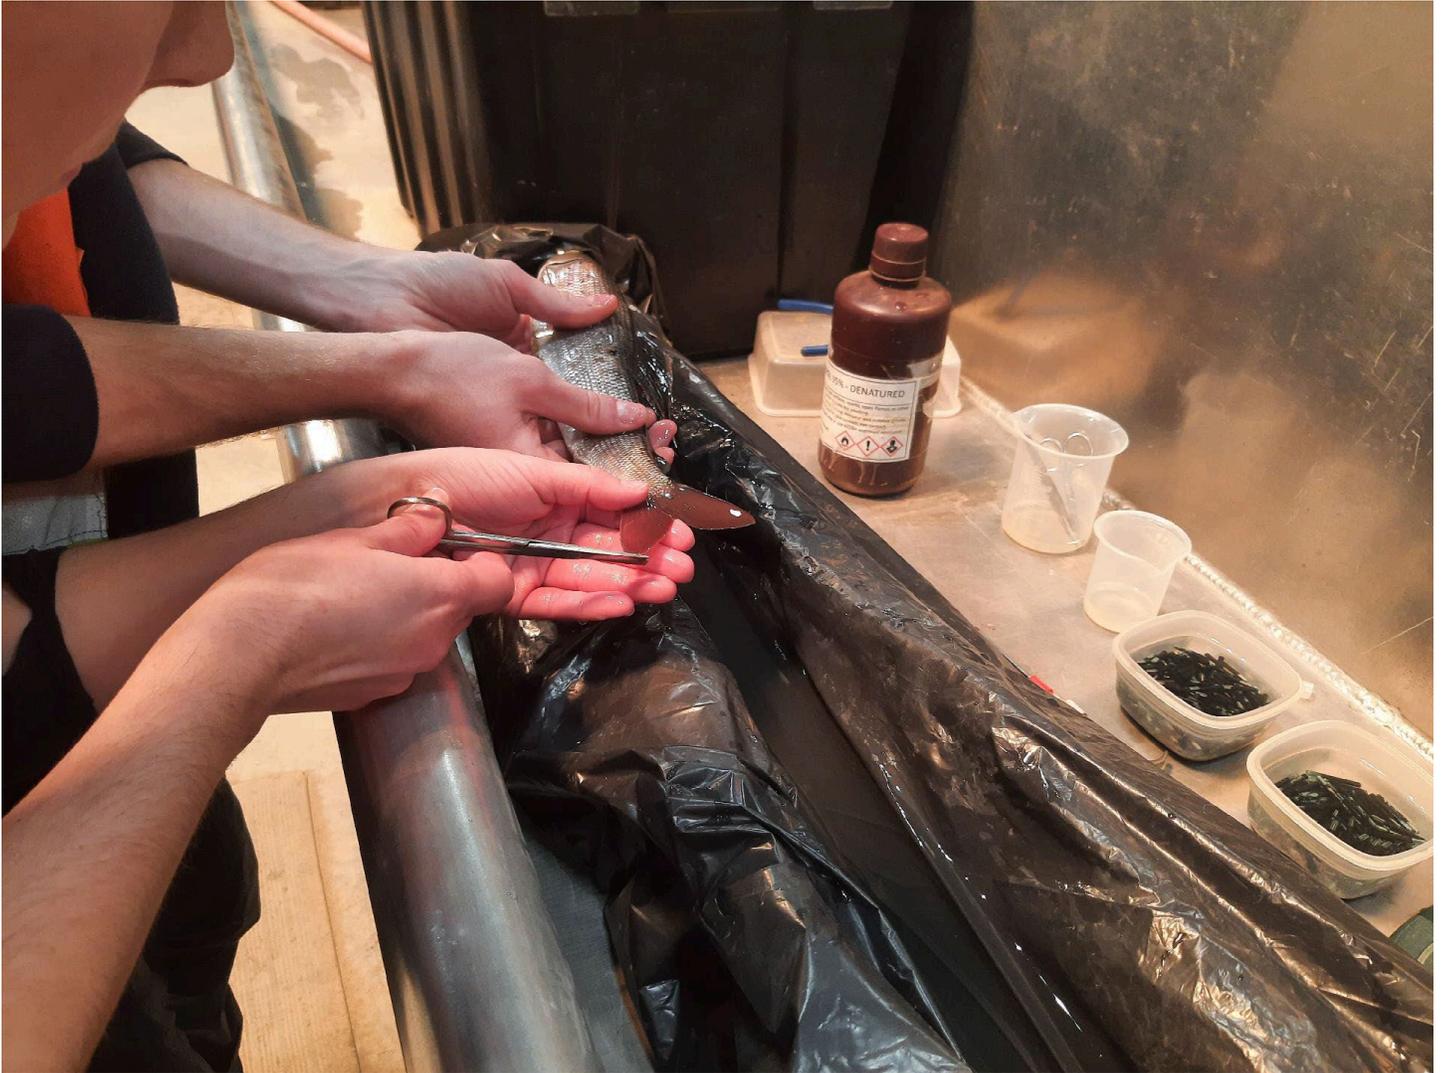
Photo 1. Biologists collect a small tissue sample from the caudal fin of an Arctic Grayling to determine genetic origin (May 2, 2023).

One hundred and ninety seven fish – 63 Largescale Sucker, 61 Longnose Sucker, 37 Mountain Whitefish, 12 Arctic Grayling, 12 White Sucker, 9 Rainbow Trout, 2 Burbot, and 1 Slimy Sculpin – were sorted and sampled at the temporary facility, and transported and released into the Peace River upstream of the Project (Table 1, Photos 1 and 2).

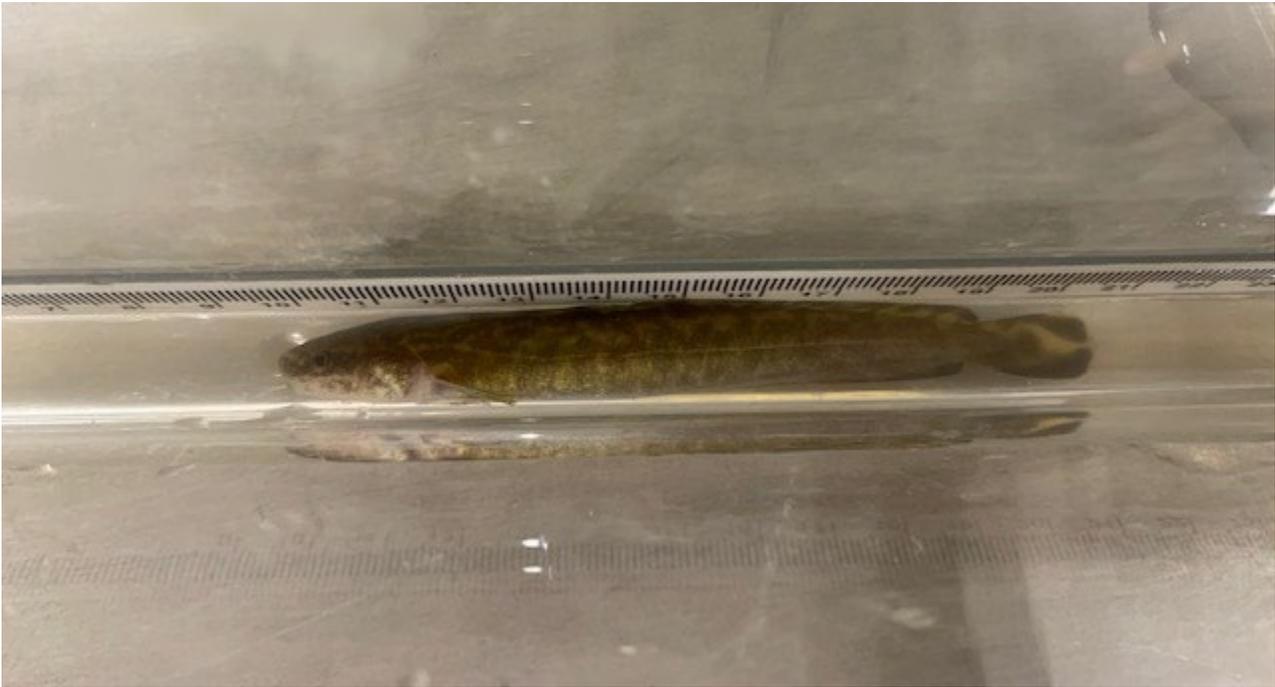
Photo 2. Biologists sample a Burbot in the sorting facility (May 16, 2023).

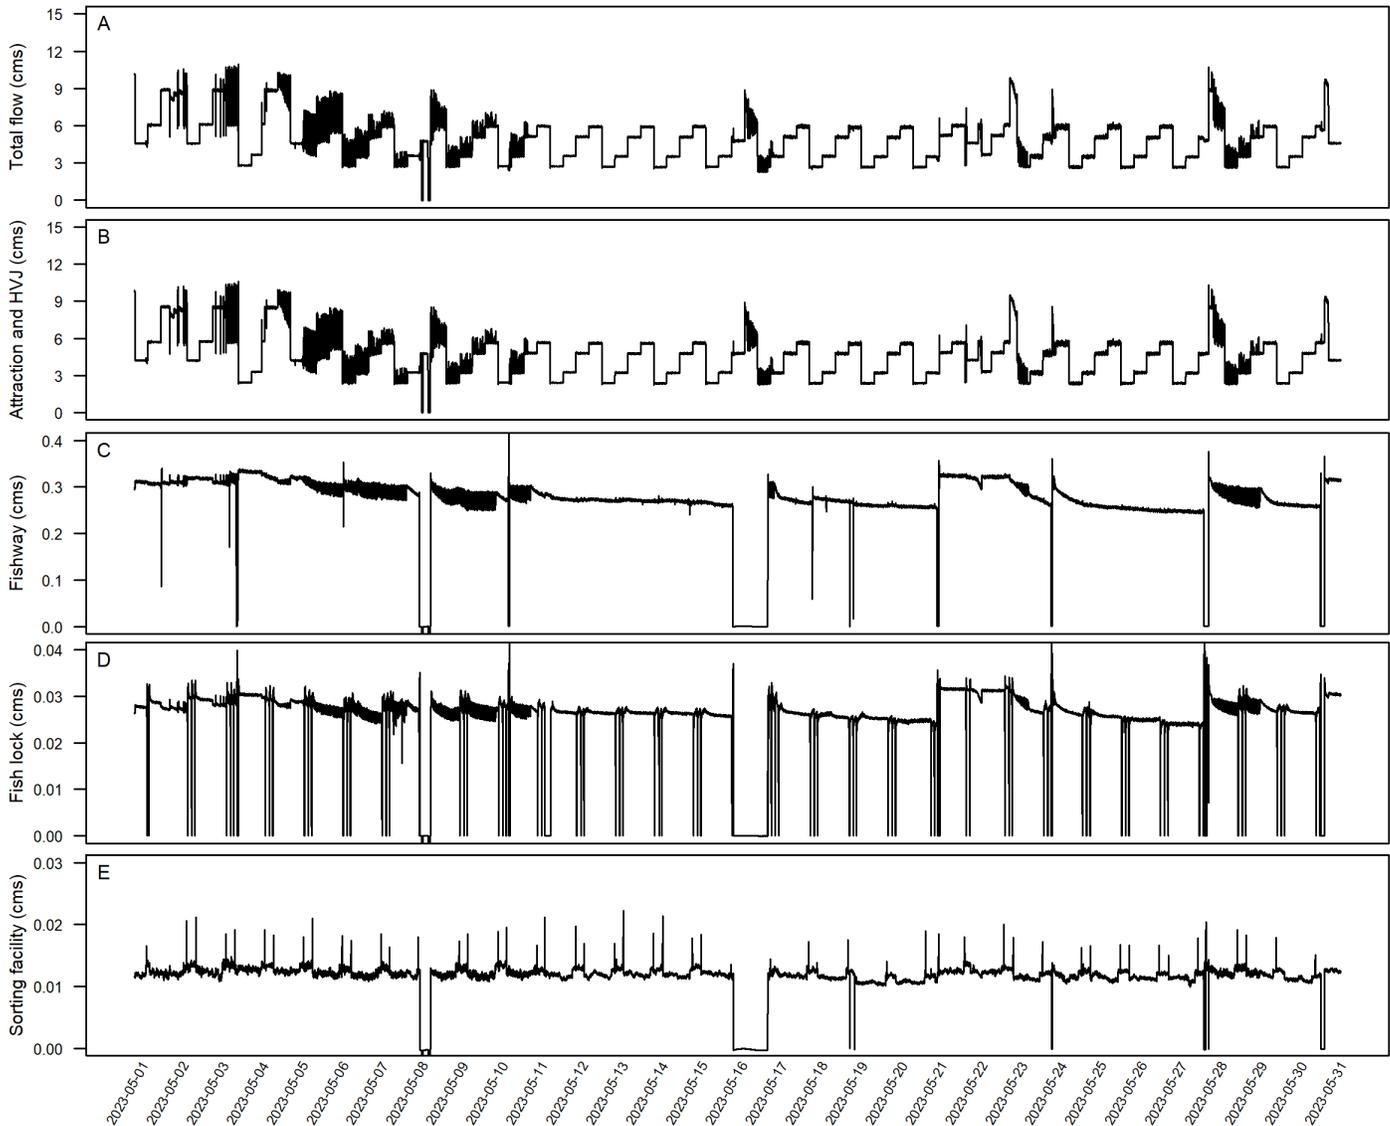
Appendix II. (A) Total flow (cms) diverted from the Peace River to operate the temporary facility during the reporting period. Total flow is a combination of flows used for the attraction flows and high velocity jet (B), fishway (C), fish lock (D), and sorting facility (E), as described in T023 Plan for Measurement of Flow. Under Conditional Water Licence 133987⁴, BC Hydro is authorized to divert up to 15 cms of flow from the Peace River to operate the temporary facility; this authorized quantity was not exceeded during the reporting period (A).

Appendix II summarizes the total flow diverted from the Peace River to operate the temporary facility during the reporting period.
