Site C Clean Energy Project

Quarterly Progress Report No. 31

F2024 Second Quarter

July 1, 2023 to September 30, 2023

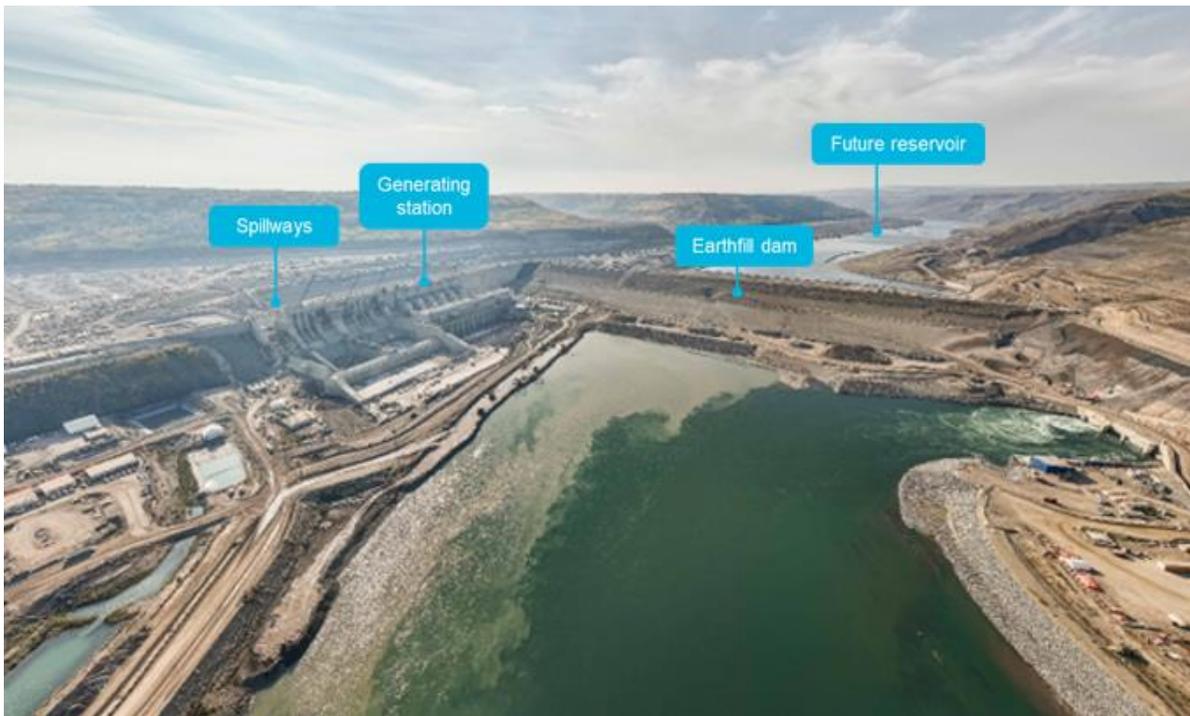
The Site C dam site as seen in September 2023.

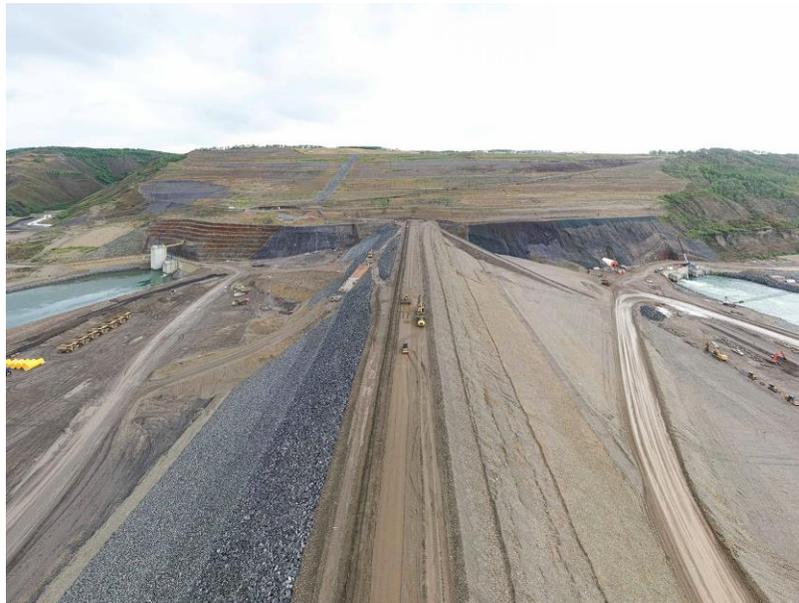
Figure A-1 The earthfill dam is complete to the elevation required to enable reservoir filling. The dam is about 20 storeys, or 60 metres, tall. It stretches one kilometre across the Peace River. Picture is looking north along the crest of the dam | July 2023

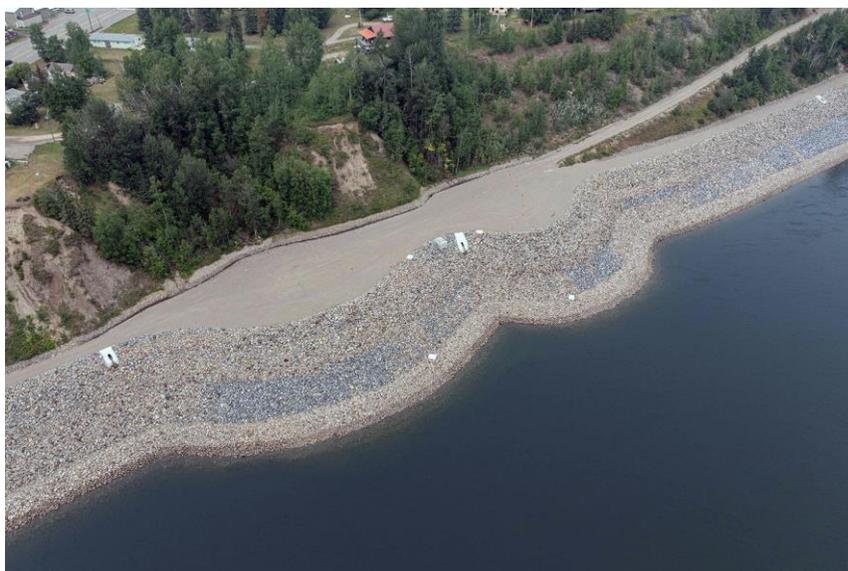
Figure A-3 The Lynx Creek boat launch and day use area is being built near Hudson's Hope on Highway 29. A breakwater will be installed to protect the launch against waves | July 2023

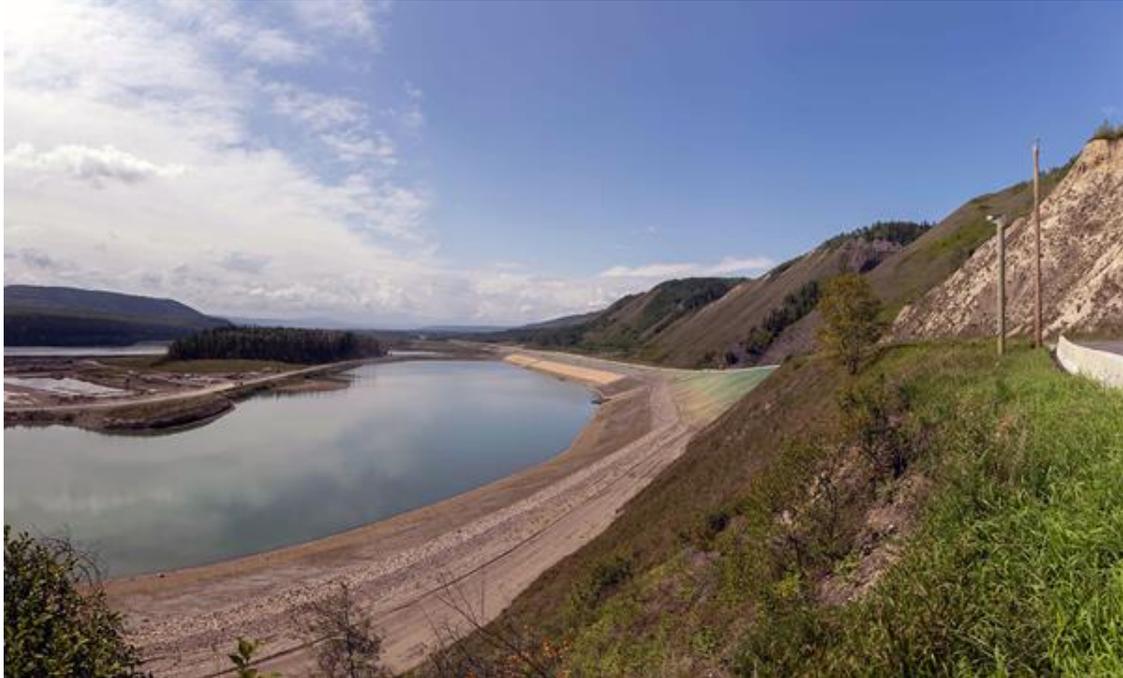
Figure A-5 The highway realignment at Lynx Creek is complete. Shoreline armouring is in place in preparation for reservoir filling | August 2023

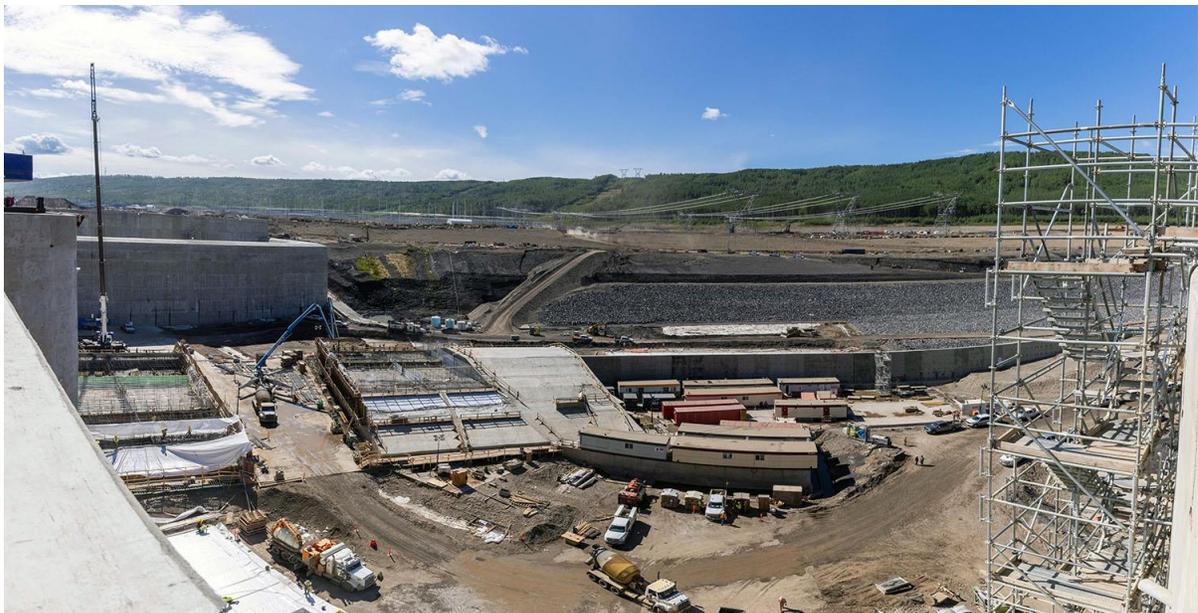
Figure A-6 Construction continues on the approach channel that directs the flows from the Peace River to the powerhouse and spillways | August 2023

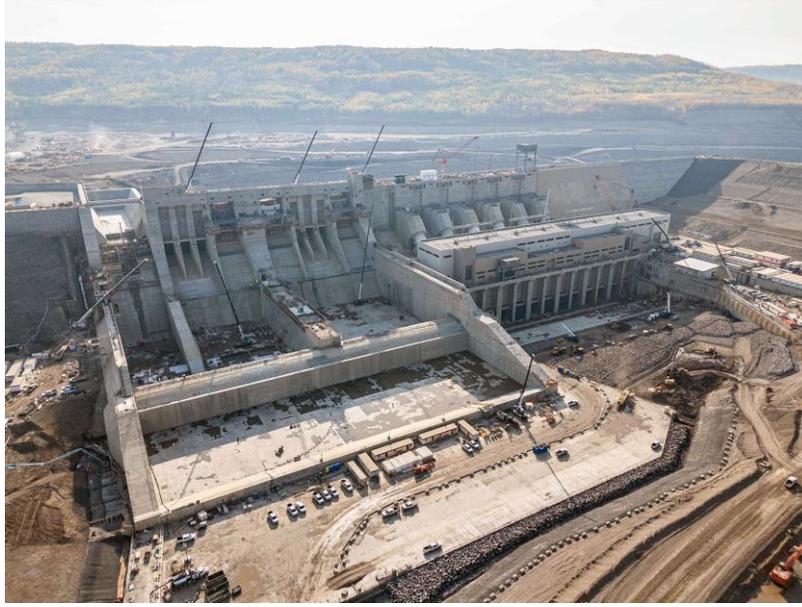
Figure A-7 In the future, water will go through six penstocks into the powerhouse (on right side of picture), then exit through the tailrace. The spillways on the left will safely pass flows from the reservoir | September 2023

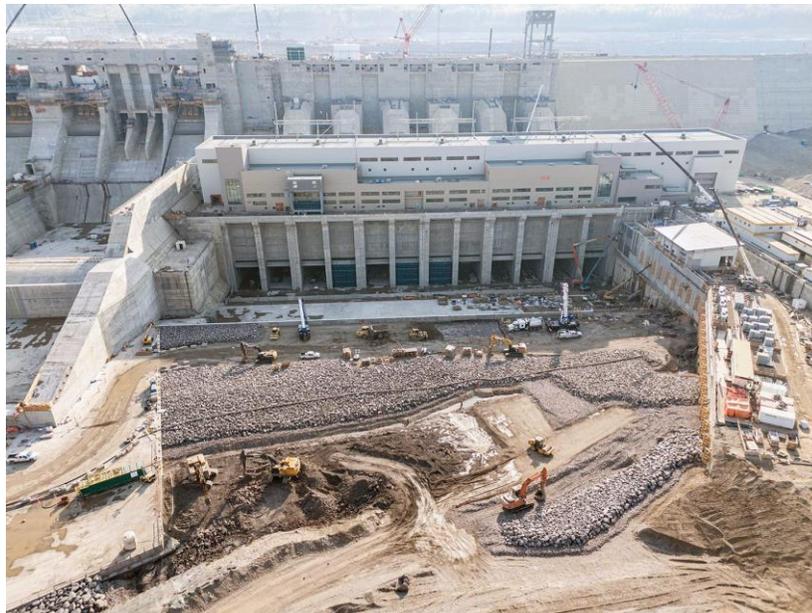
Figure A-8 Crews are finishing concrete placement for the tailrace erosion protection slabs below the powerhouse. Workers are also excavating the interior of the right bank cofferdam and placing riprap | September 2023

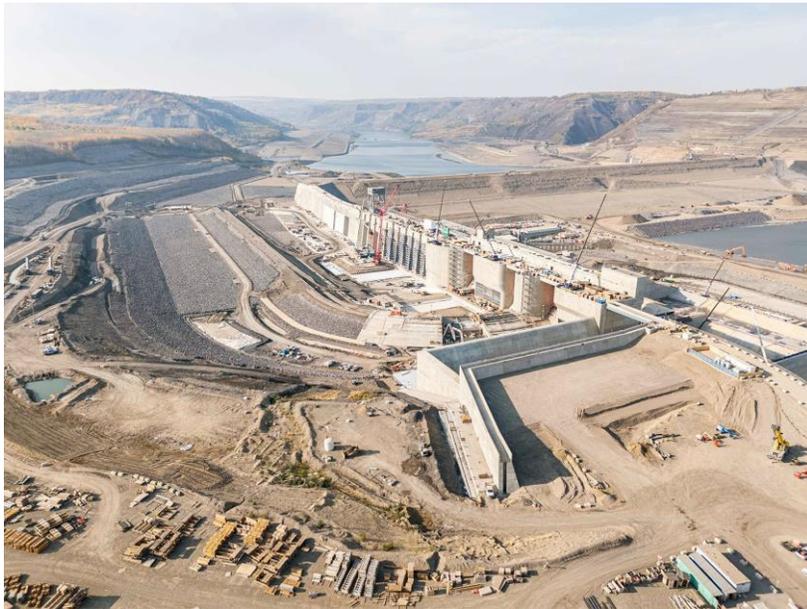
Figure A-9 When the Site C reservoir is filled, water will flow down the approach channel and enter the powerhouse through the intakes, or the entrances to the spillways | September 2023

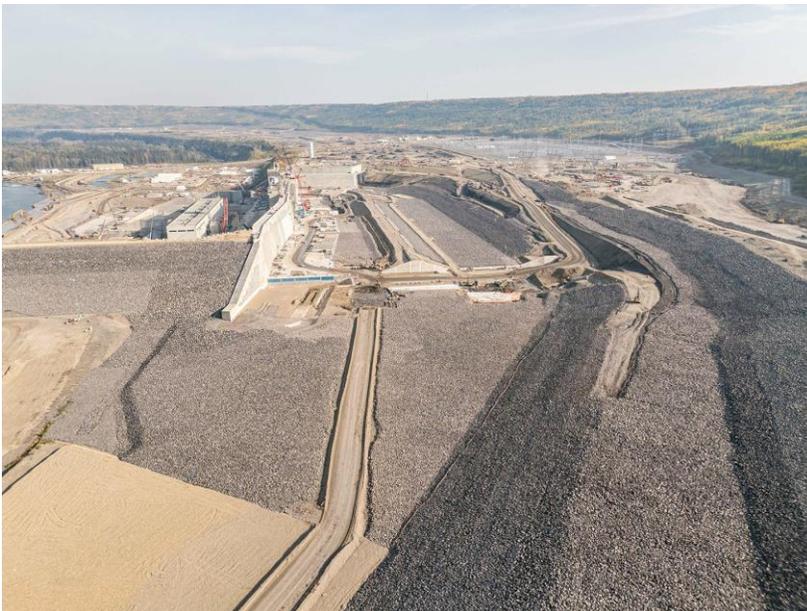
Figure A-10 Riprap is one of the many protective layers in the approach channel where water will flow from the reservoir into the powerhouse and spillways | September 2023

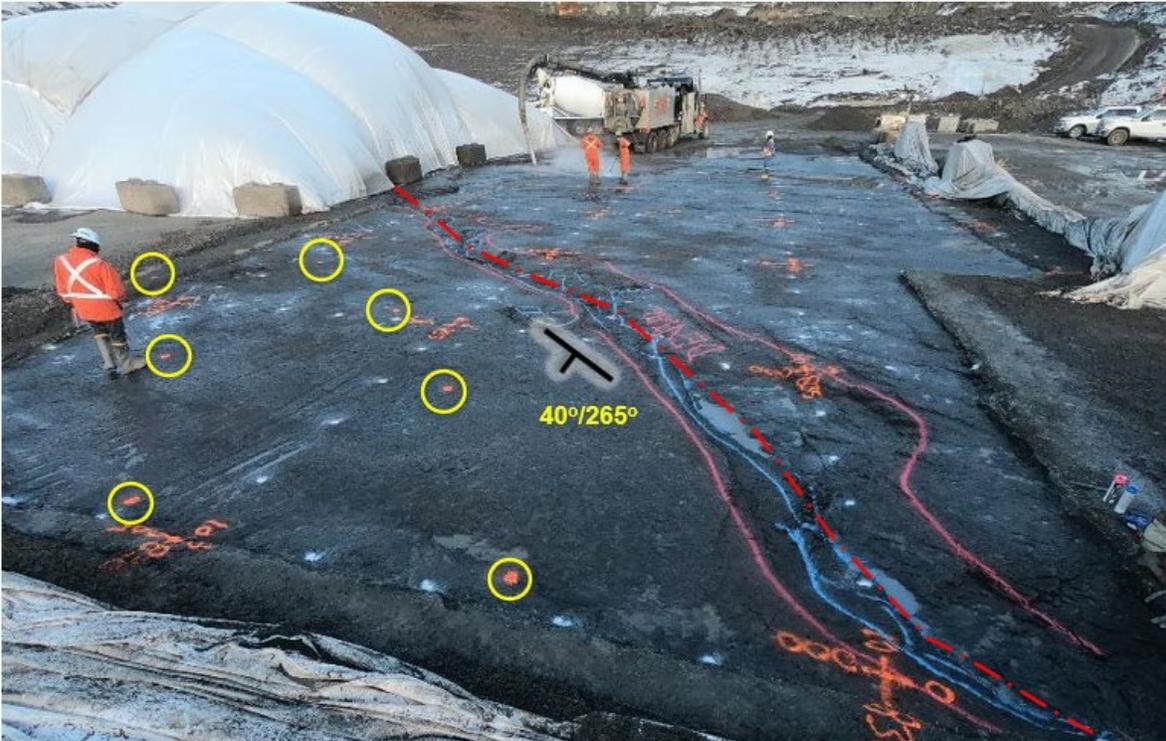
The findings of the geological logging of the core foundation justified the decision to grout the foundation. This treatment comprised up to three deep, central lines, a grid of

consolidation holes, staggered in depth plus specific treatment concentrating on the shear zones.

Figure 4.2 - Foundation Cleaning and Prescriptions (7 January 2020)

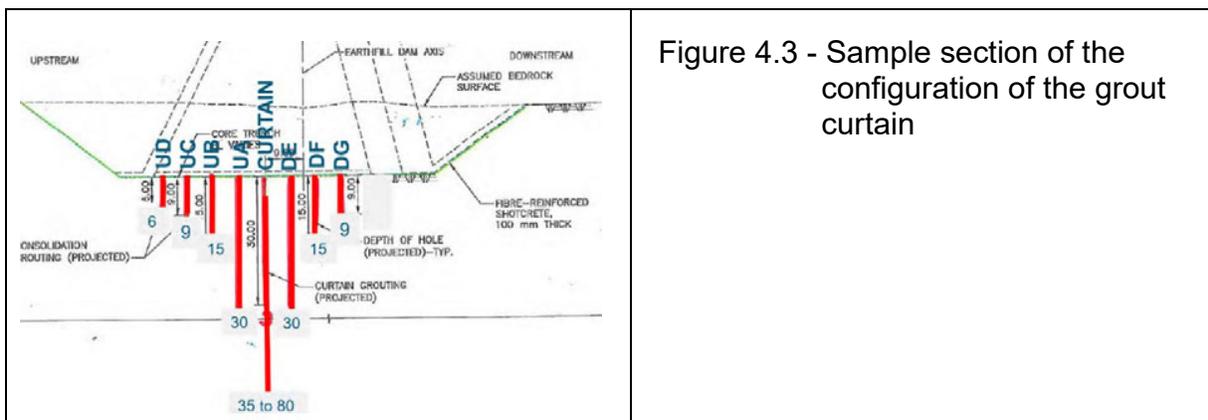
Figure 4.3 - Sample section of the configuration of the grout curtain

Although, as originally anticipated, the rock in general did not accept much grout, local takes reaching to more than 500 kg/m of cement clearly established the need for and the success of this work.

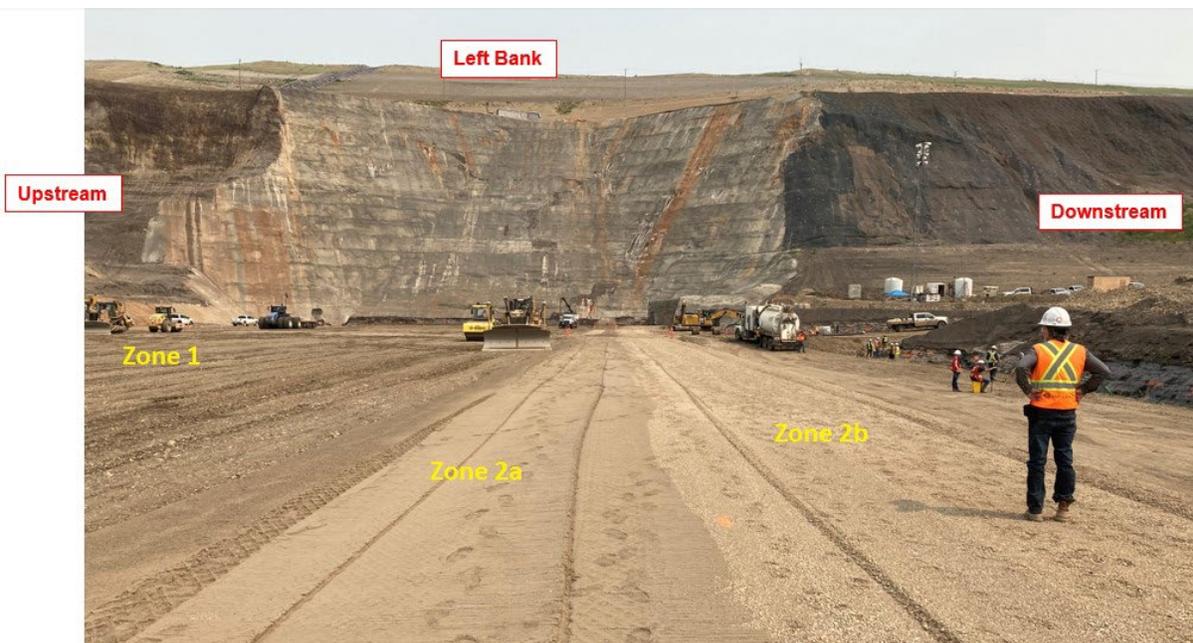
Particular attention was given to the quality control and quality assurance of the fill by the Contractor's program. Satisfactory compliance with the specified grain size distribution and compaction of the different zones of the embankment has been obtained. Independent quality assurance testing was also conducted by BCH's designers and confirmed these results.

Figure 4.4 - Fill Zones

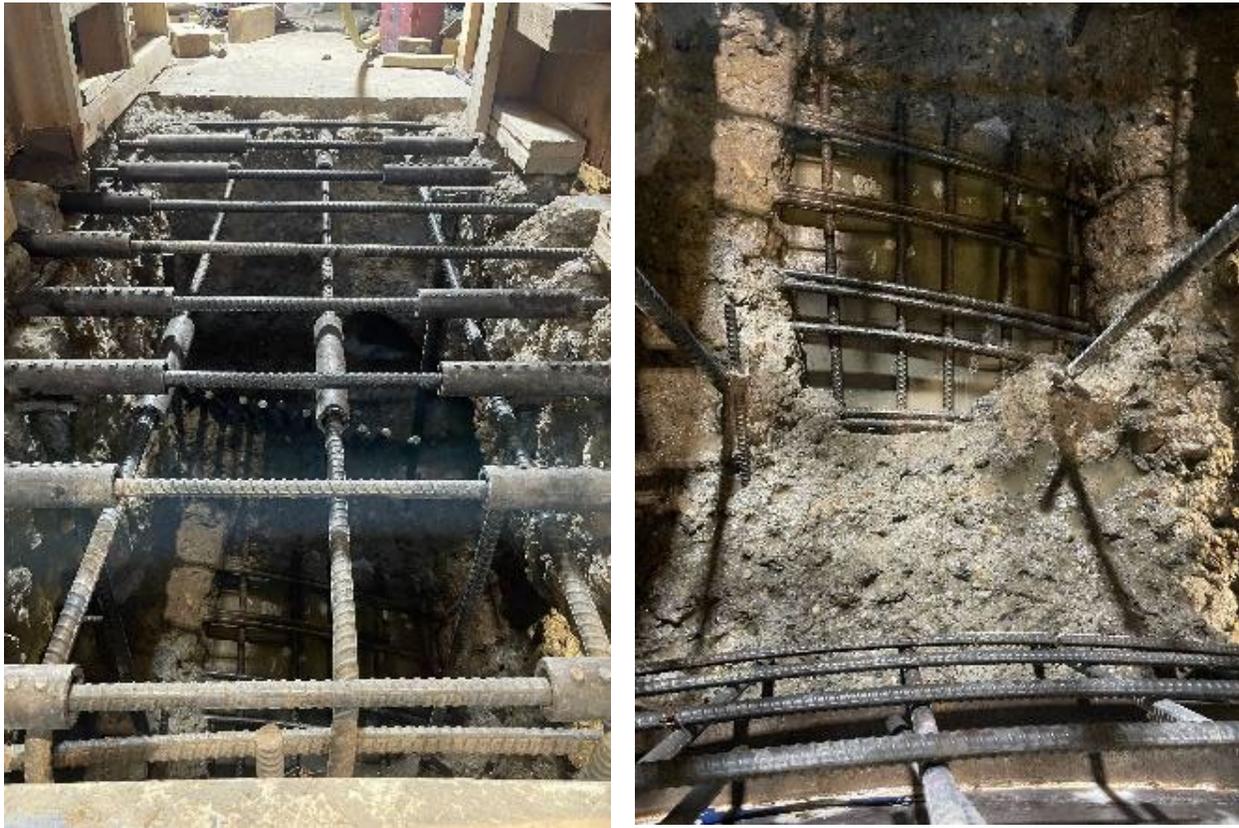
On December 14, 2022, the second of three concrete placements was made as part of the Unit 4 turbine spiral case embedment. Seven day concrete cylinders (samples) were tested and indicated non-conforming concrete during a limited period of the placement. In early January 2023, once BC Hydro and the GSS Contractor personnel had returned to the site from the winter shut down, areas of loose and soft concrete were observed on the top surface of the concrete, indicating that there was nonconforming concrete in the placement. Further dismantling of the formwork around the placement confirmed that there was nonconforming concrete throughout the placement. A review of the concrete batch tickets and compressive test results from the placement was performed, and it was concluded that during the batching process, a delivery of fly ash was erroneously unloaded into the batch plant cement silo, resulting in approximately 100 cubic metres of concrete with low cement content being produced and placed into the 1,500 cubic metre placement. Engineering and procedural controls were immediately implemented at the batch plant to prevent a recurrence of this issue, and Non-Conformity Report 1482 was raised by the Contractor, to document the root cause and corrective actions.

With close supervision from BCH, the Contractor undertook an extensive mapping and coring program. Core results showed that there was non-conforming concrete at varying depths throughout the west end of the placement, the northeast end, in between the spiral casing and the turbine pit liner, and underneath the servomotor pockets. Over the course of six months, the Contractor accessed the non-conforming concrete from the top of the placement and through cut-outs in the servomotor pockets and turbine pit steel liner with the intention of removal of all the non-conforming concrete. Using jackhammers and hydro demolition, the non-conforming concrete was accessed and removed. Where rebar was cut to access the concrete, replacement bars were either spliced (where splice length was available) or coupled using barlock couplers. Throughout the rectification of this non-conformity, the spiral case internal embedment pressure was maintained to ensure that the design gap between the spiral case and adjacent concrete was not compromised. Once BCH was satisfied that all the non-conforming concrete had been removed and the rebar and spiral case surfaces cleaned, the Contractor was authorized to replace the concrete (June 2023).

Figure 4.5 – Unit 04 – Non-conforming Concrete

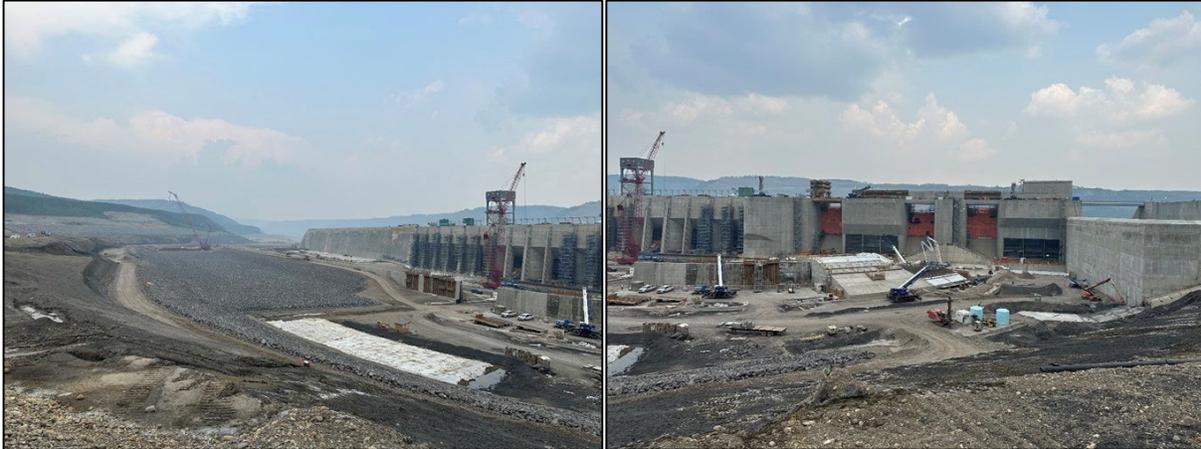
Figure 4.6 presents two recent photos of the approach channel, one to the west and one to the north.

Figure 4.6 - Photos of the approach channel (west view is the photo on the left and north view is the photo on the right)

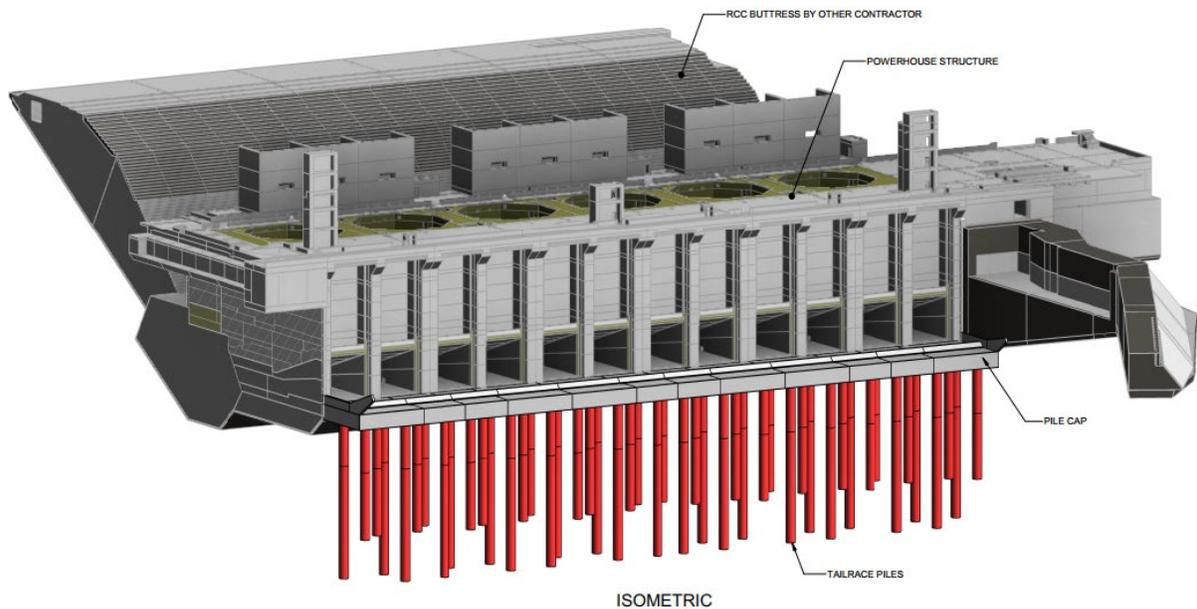
As a result of small movements having been identified on bedding shears below the depth of the shear key at the base of the RCC buttress, it was decided to install piles to minimize the potential for future movements. At the time of the last TAB Report No. 25, 48 steel piles filled with concrete had been installed which completed the program for the spillway. For completion of the RBFE, it remained that for the powerhouse an additional 48 piles would be drilled from the top of the rock and subsequently a concrete pile cap would be cast connecting the piles to the powerhouse. This required excavation to a working bench for the enhancements to be executed.

Figure 4.7 illustrates the work required at this time while Figure 4.8 is the setting in the field at the end of June 2022. Figure 4.9 illustrates the advance of the work prior to winter shutdown. The tight workspace and careful sequencing are noteworthy. An overview of the works in February 2023 is shown in Figure 4.10 that illustrates progress under winter conditions.

Figure 4.7 - RBFE Sequence of Events

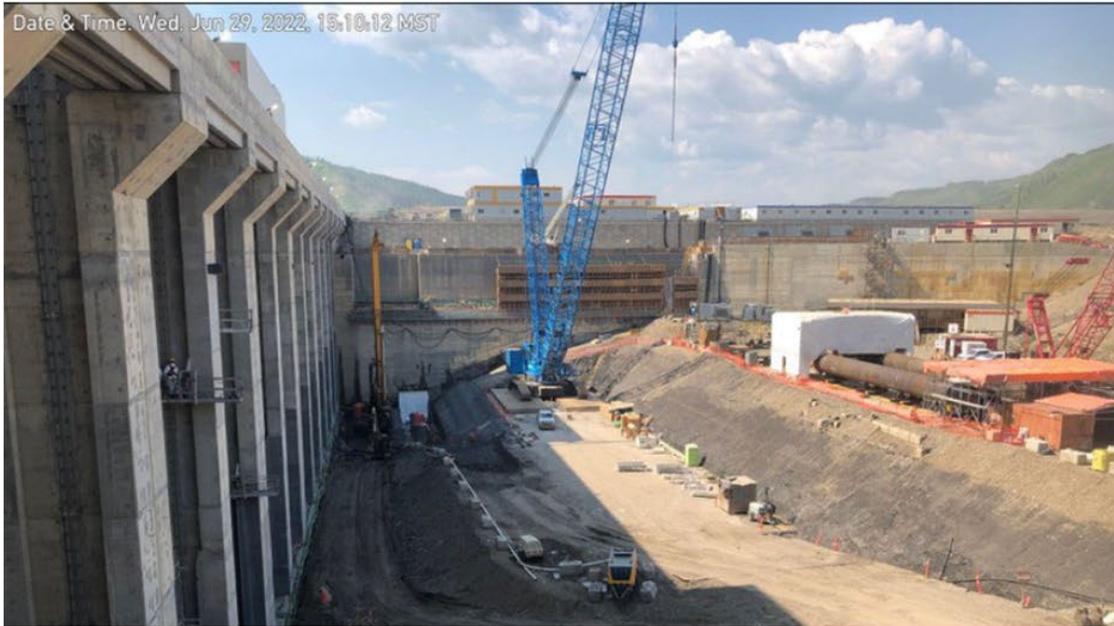
Figure 4.8 - Piles Installation Process, June 2022

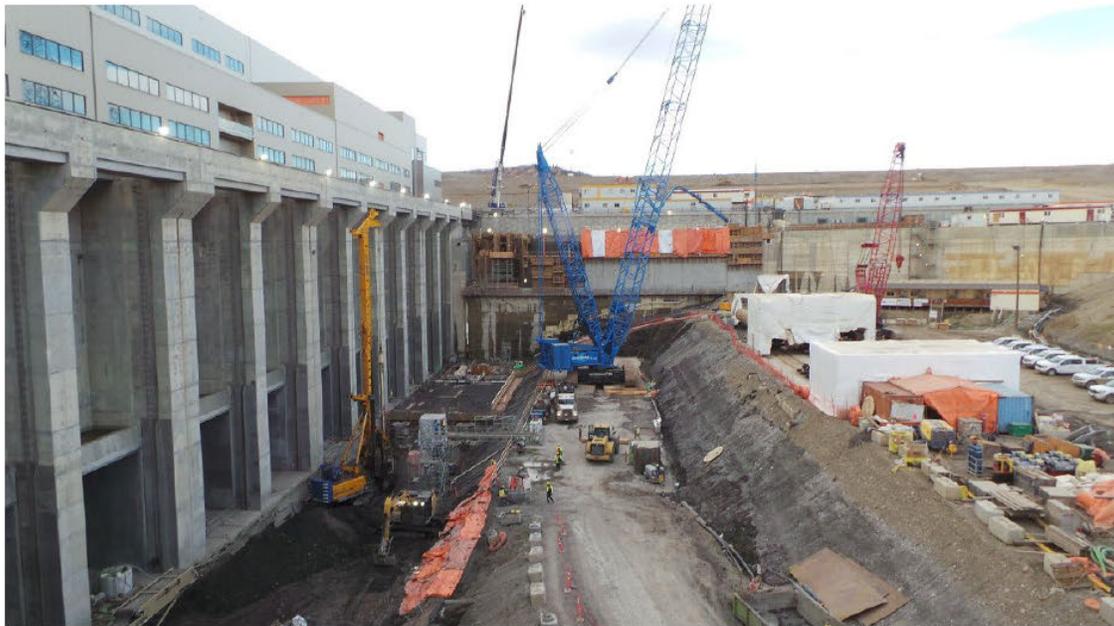
Figure 4.9 - RBFE Tailrace Overview, October 2022

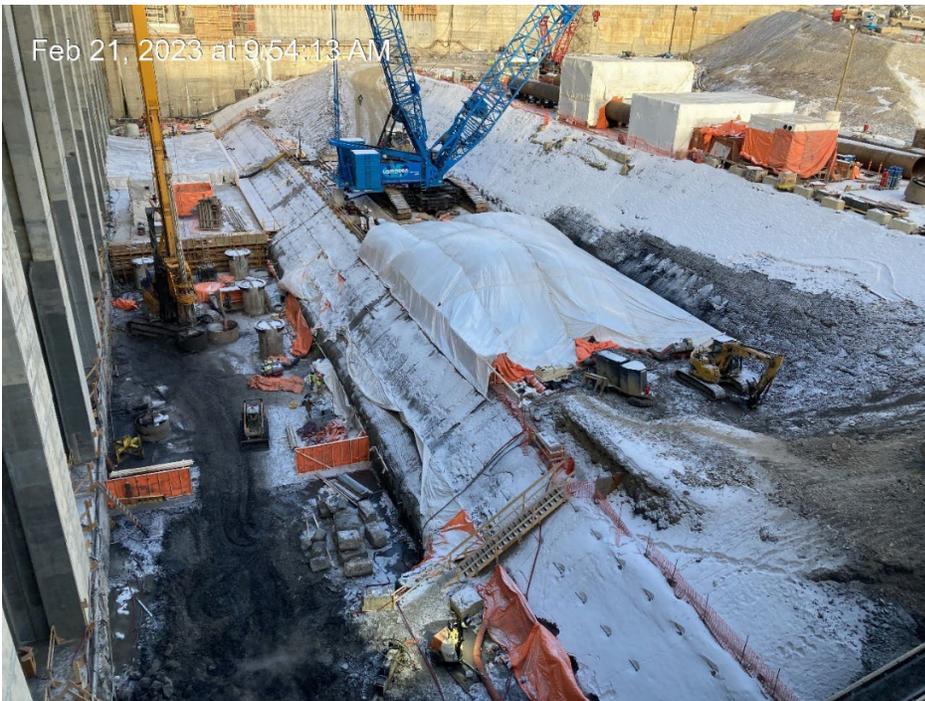
Figure 4.10 - RBFE Tailrace Overview, February 2023

The RBFE piling works are complete. The construction satisfied all of the quality control measures and the success of this installation under difficult construction conditions is noteworthy.

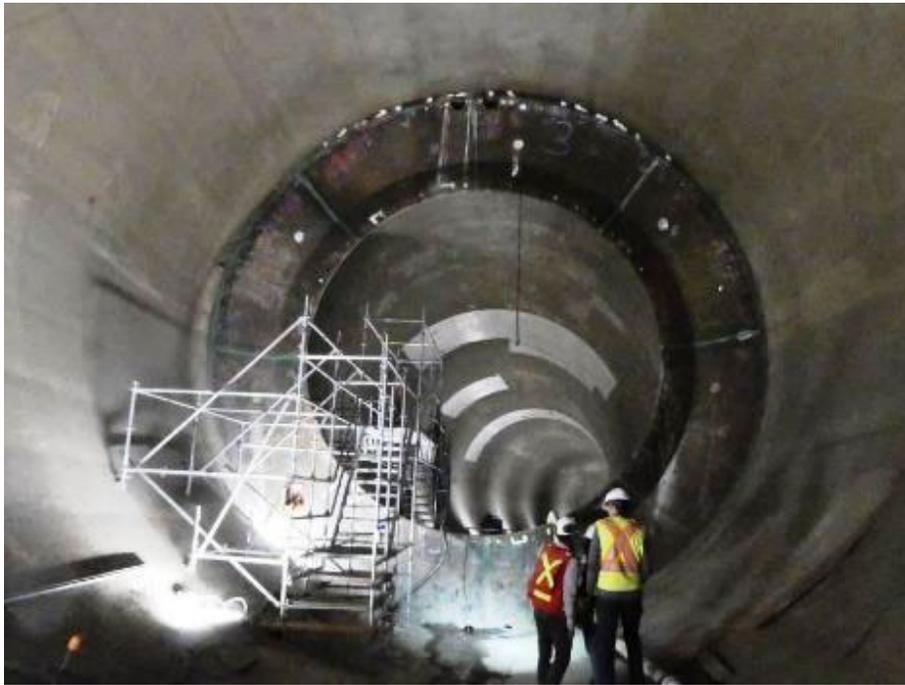
During the site visit, the length of DT2 was walked and the walls found to be in remarkably good condition especially given that the tunnel has sustained prolonged and continuous discharge for some years. Some invert erosion and degradation has occurred over a width of approximately 3 metres; however, it is a more of a surface roughening than anything significant.

Figure 4.11 – Diversion Tunnel Orifice

All four steel orifices have now been assembled in position and three have been concreted. Work on concreting the last orifice was in preparation during the site visit and it was possible to inspect the concrete anchorages through an access and inspection hole. The installation of the orifices has been done to a very efficient and good standard.

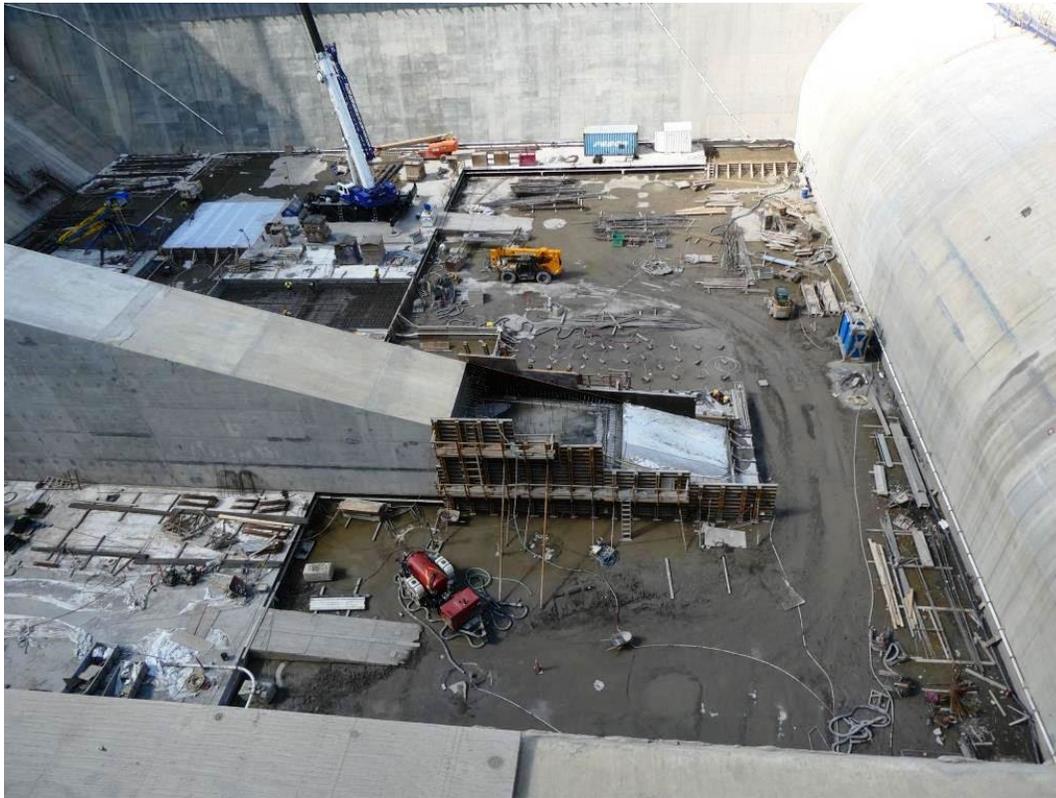
Other directly related works to be completed in this area prior to start of reservoir impoundment include a number of stilling basin apron slabs together with their anchoring arrangements, and two sections of end sill. The completion of the apron slabs and their anchorages is particularly important to ensure security against uplift from an external raised tailwater elevation. Also, in this general area, the auxiliary spillway chute is only partially constructed at present. Discussions with staff on the site indicate that all these works should be completed by early October. The certification of the completion of the work by the Engineering Design Team is addressed by project plans before impounding and the TAB will be informed if any material future variances in the design are required.

Figure 4.12 – Spillway Apron

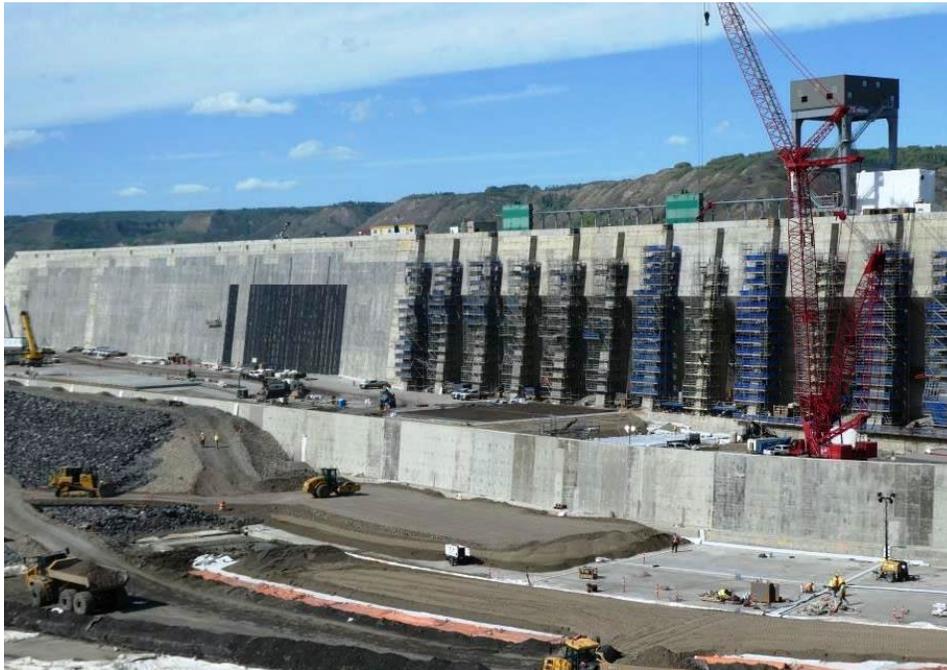
Immediately downstream of the power station, sections of concrete slabbing remain to be completed for the tailrace outfall channel. Associated areas of riprap protection also need to be placed prior to the eventual removal of the downstream cofferdam and the inundation of both the tailrace and the spillway stilling basin. Clearly the draft tube gates for the power station will need to be in place before this happens and it is understood that this should not prove to be a constraint.

Temporary pumping arrangements for the power station are also currently being arranged in readiness for tailrace inundation and prior to the permanent pumps being commissioned. It is understood that the temporary arrangements including backup power and temporary backup pumps will all be managed by dedicated subcontractors.

Figure 4.13 – Intakes and RCC Tailrace Wall

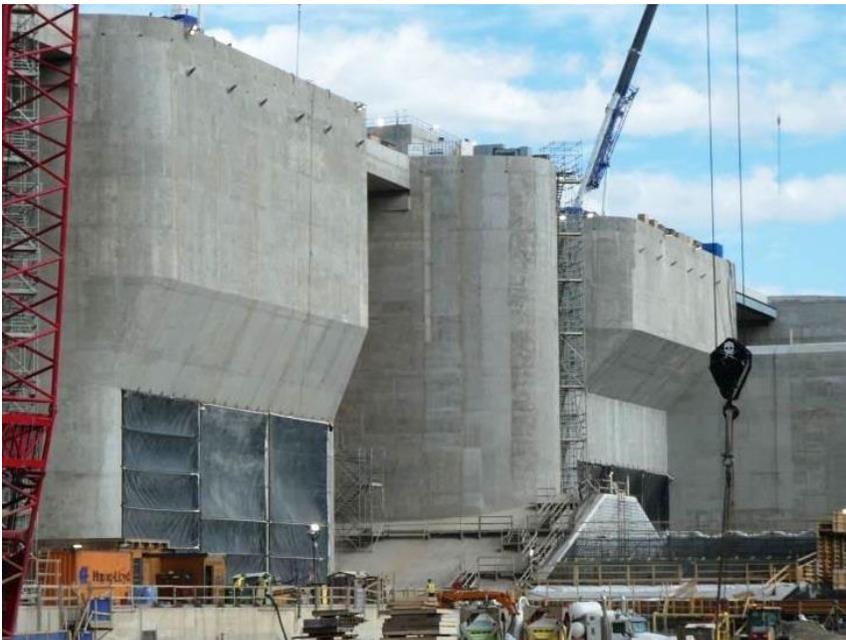
flow and defects here should be made good to the required F4 shutter finish. However, these areas will be accessible in the long term for inspection and maintenance. The defects in upper parts of the central weir are largely cosmetic. Nevertheless, as the area will not later be easily accessible, the TAB recommends that efforts be made to make them good to the extent reasonably possible.

Several of the gate guide arrangements were also inspected in some detail. The works are being overseen by the gate manufacturer ATB Riva but based on a standard BCH design concept with which BCH have had good corporate success. Again, the TAB considers that a good quality product is being achieved and that where adjustments and amendments have been required, these have also been done to a good standard.

Figure 4.14 – Achieved Construction Quality on the Structures

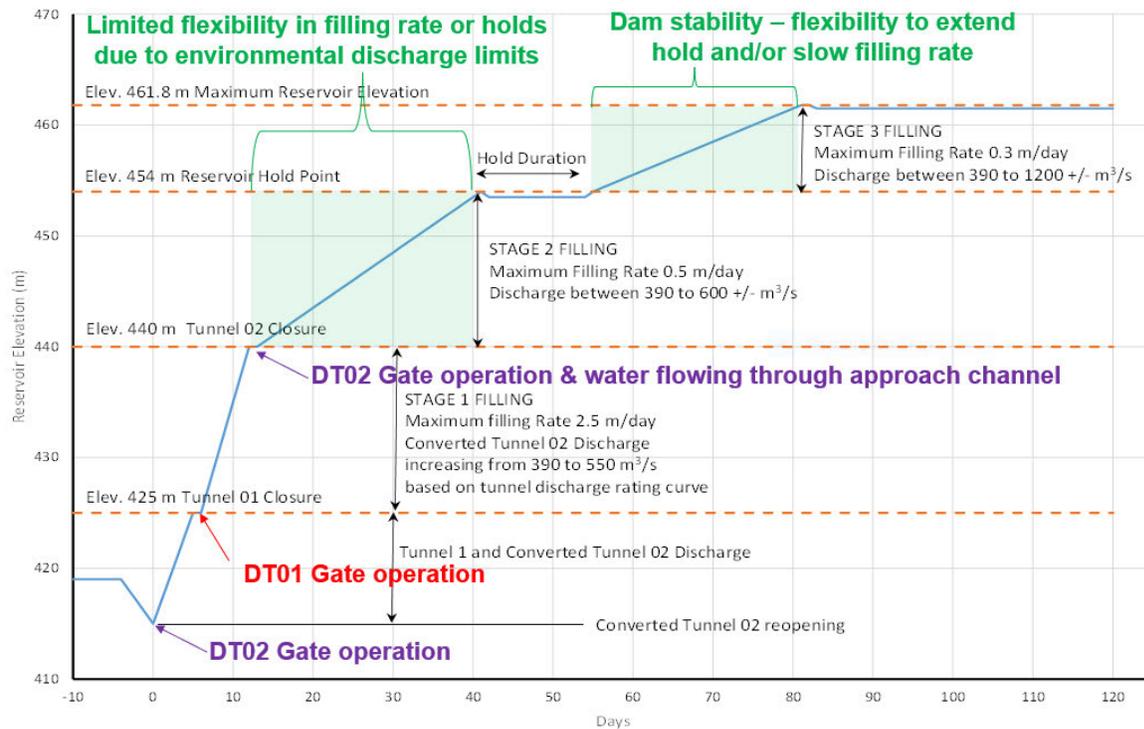
The plan for filling the reservoir, that is impounding it for the first time, has been introduced in subsection 4.2.1. Here it is discussed in more detail. Visually the intended sequence is best explained by reference to BCH Figure 4.15.

Figure 4.15 – Intended Reservoir Filling Sequence

The river is currently being diverted through Diversion Tunnel No. 1 (DT1) while large circular steel orifices are being installed in Diversion Tunnel No. 2 (DT2). When the works in DT2 are completed, it will be re-opened, and flows will resume through both tunnels. The rate of subsequent reservoir rise will be dependent on releases from upstream plants and on natural inflows but is targeted at 2.5 m/day. When the reservoir reaches El. 425 m, DT1 will be permanently closed, and the gate operating system removed. Flows will continue though just the converted DT2 and again with a targeted reservoir rise rate of 2.5 m/day, depending on inflows. During this time excess energy in the flow will be dissipated by the orifices embedded in DT2.

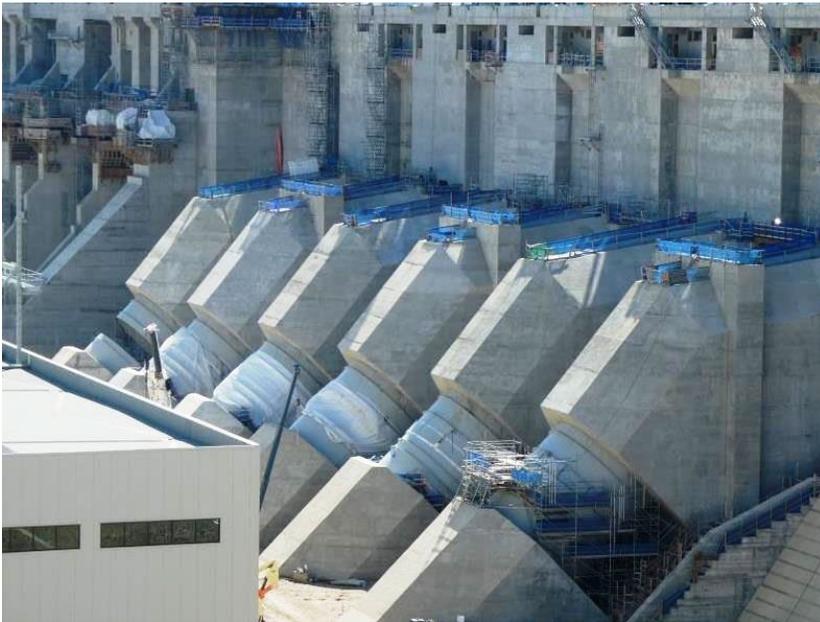
As noted elsewhere, while the flexible joints do need to be operating satisfactorily for power production and machine commissioning, the couplings and units do not need to be operational or even watered-up for reservoir impounding to proceed. These issues do not affect dam safety.

Figure 5.1 – Penstock Flexible Joints
