**RE: British Columbia Utilities Commission (BCUC or Commission)
British Columbia Hydro and Power Authority (BC Hydro)
Site C Clean Energy Project
PUBLIC Quarterly Progress Report No. 15 – January to March 2019 (Report)**

Site C Clean Energy Project

Quarterly Progress Report No. 15

January 2019 to March 2019

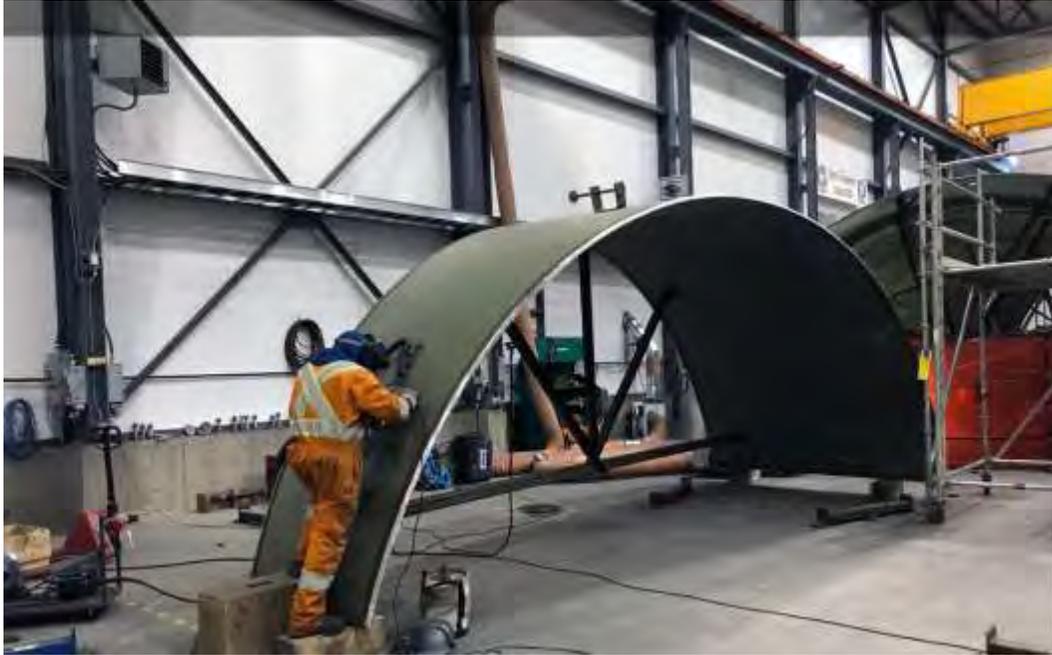
Figure A-1 A welder works on part of the spiral case in the on-site turbines and generators manufacturing facility (January 2019)

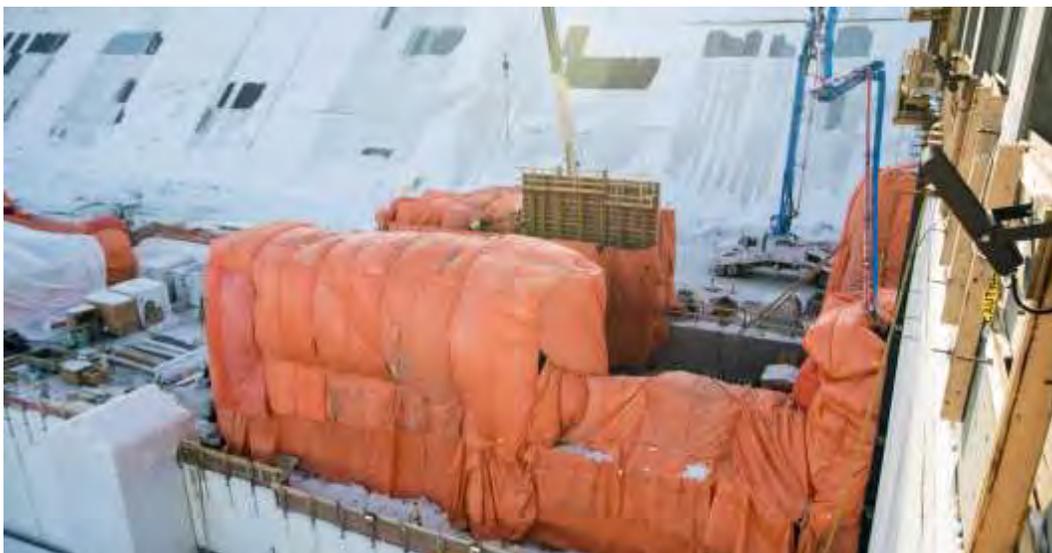
Figure A-2 Hoarding and heating protects concrete from the cold as it is placed at the generating station's double chamber walls (January 2019)

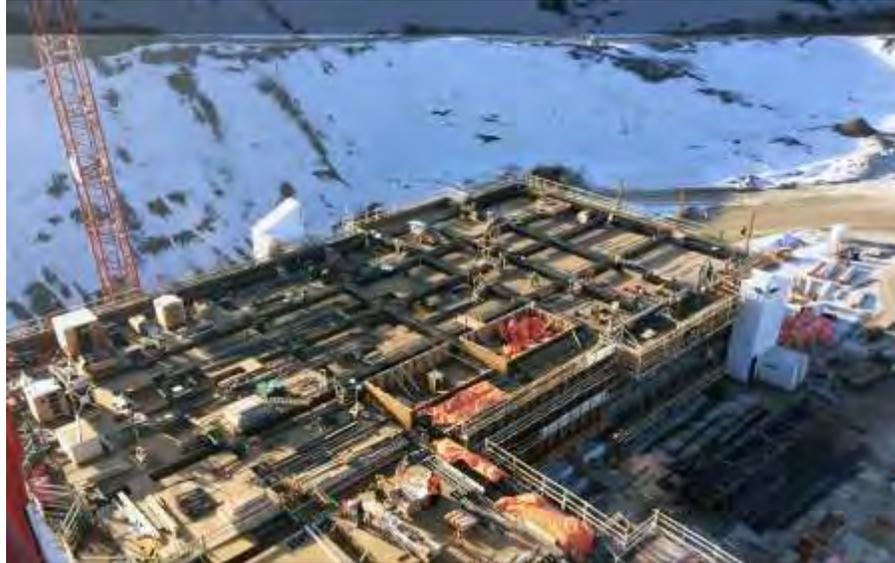
Figure A-3 General view of concrete placement at the main service bay (January 2019)

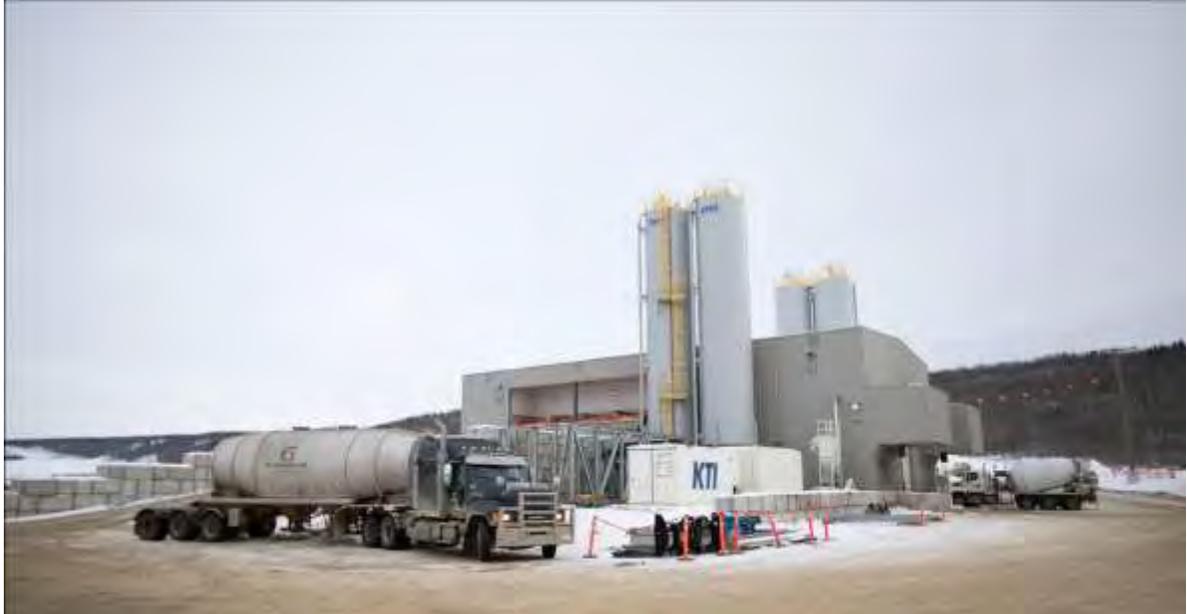
Figure A-5 On-Site Concrete batch plant is used to mix concrete for the generating station and spillways (February 2019)

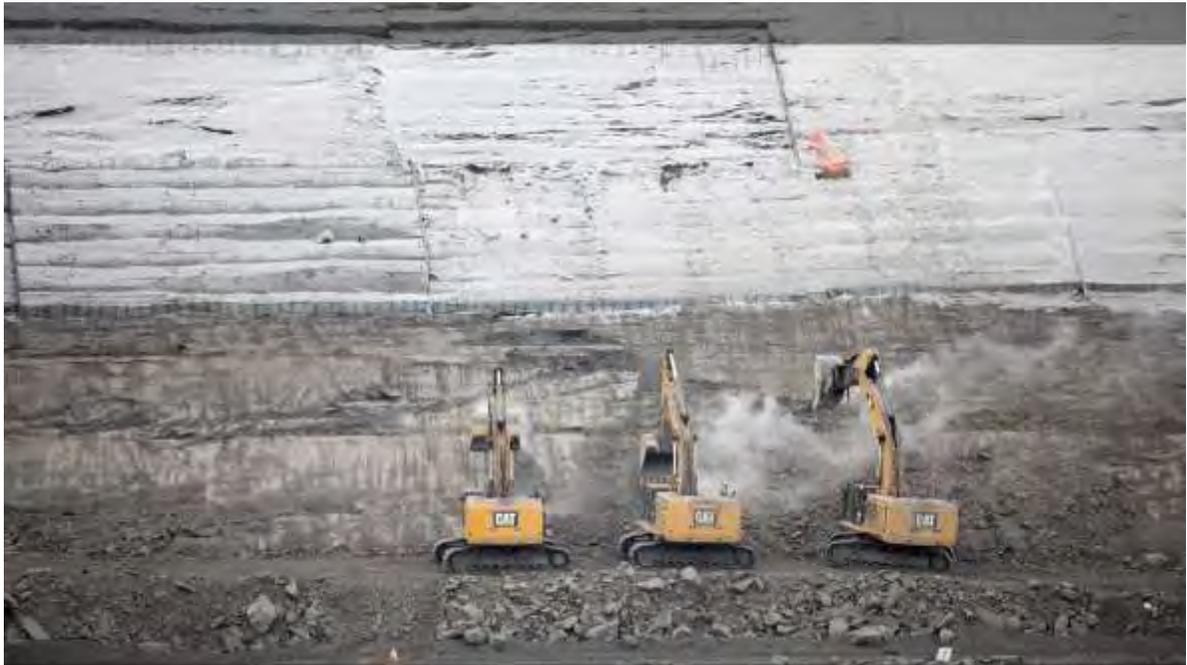
Figure A-6 Excavation continues on the foundation for the three concrete spillways on the south bank (February 2019)

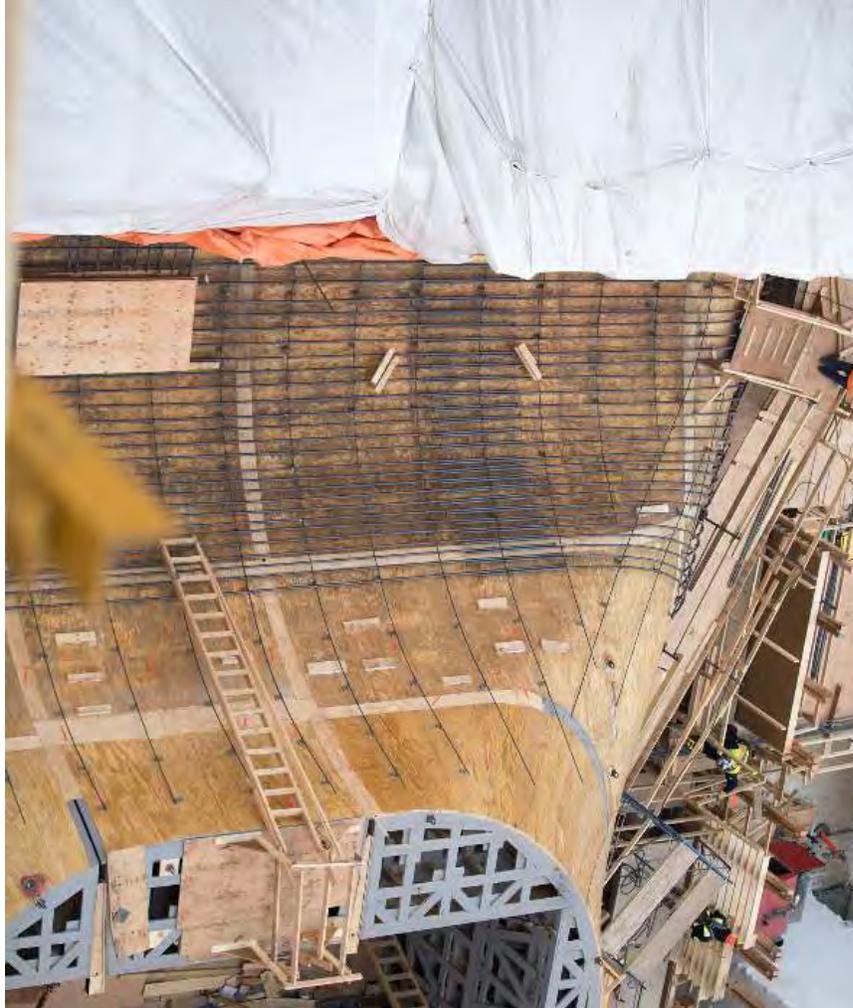
Figure A-7 A view of the unit #3 draft tube formwork (February 2019)

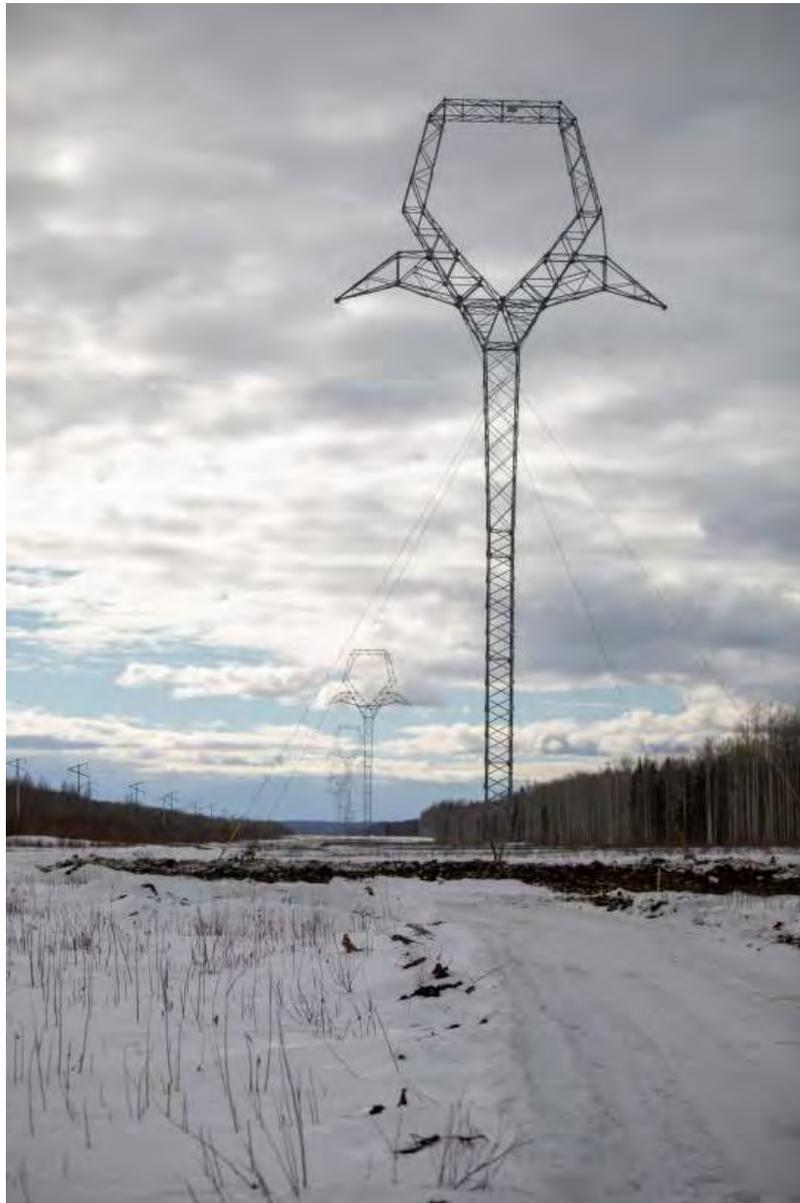
Figure A-8 As of March 31, 2019, 51 towers had been raised along the 75-kilometre-long transmission line corridor. In total, 405 towers will hold up two new 500 kV transmission lines, which will connect Site C power to the rest of BC Hydro's grid (February 2019)

7 The installation of transmission towers on foundations started in February 2019 and
8 51 towers were erected (compared to a plan of 120 towers) prior to work pausing in
9 March 2019 due to road access restrictions during the spring break up period.

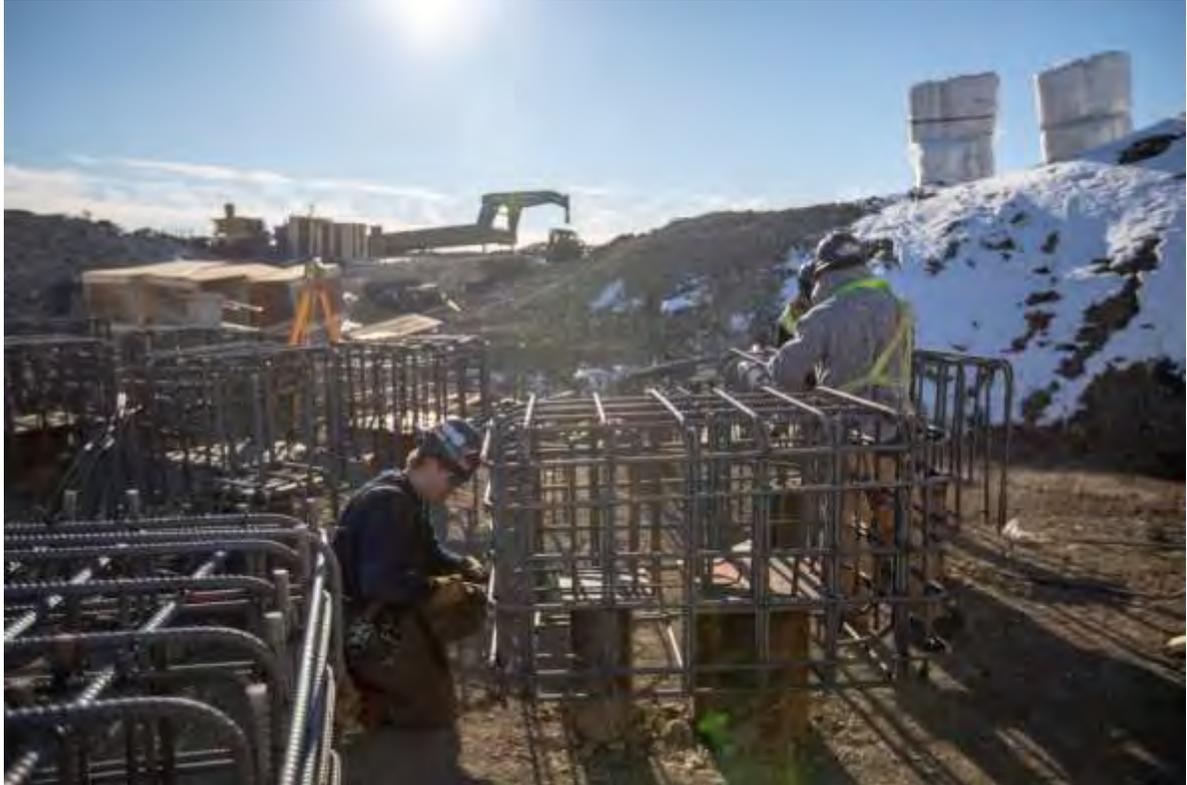
Figure A-9

Work is underway on the 5-kilometre-long electric conveyor system that will move excavated till material from the 85th Avenue Industrial Lands to the dam site for construction of the Site C dam. Piles have concrete caps with bolt settings onto which the conveyor structure is bolted (March 2019)

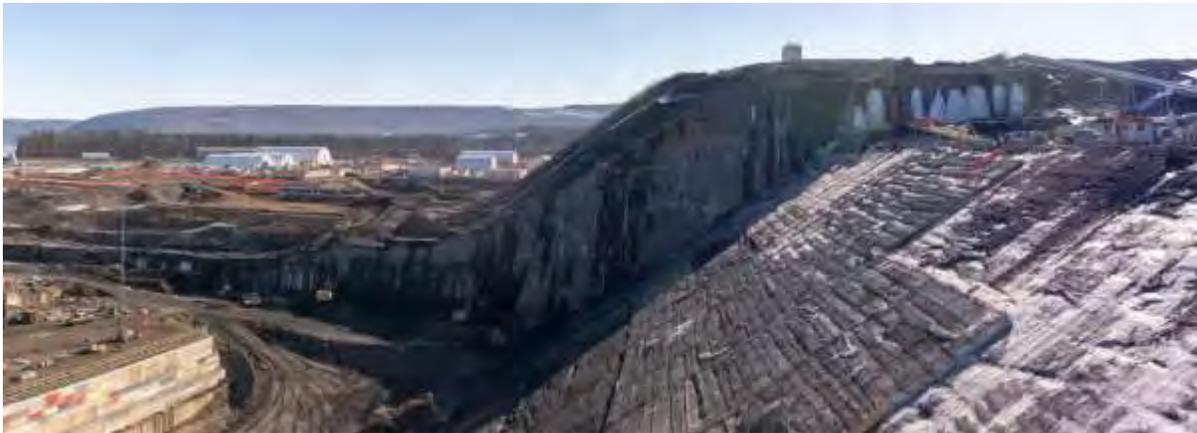
Figure A-10 Looking east over the spillway buttress excavation. Once excavation is complete, construction of the spillways buttress will commence. Site C will have two mechanical spillways and one auxiliary spillway, which will allow water to pass safely in the unlikely event of power loss (March 2019)

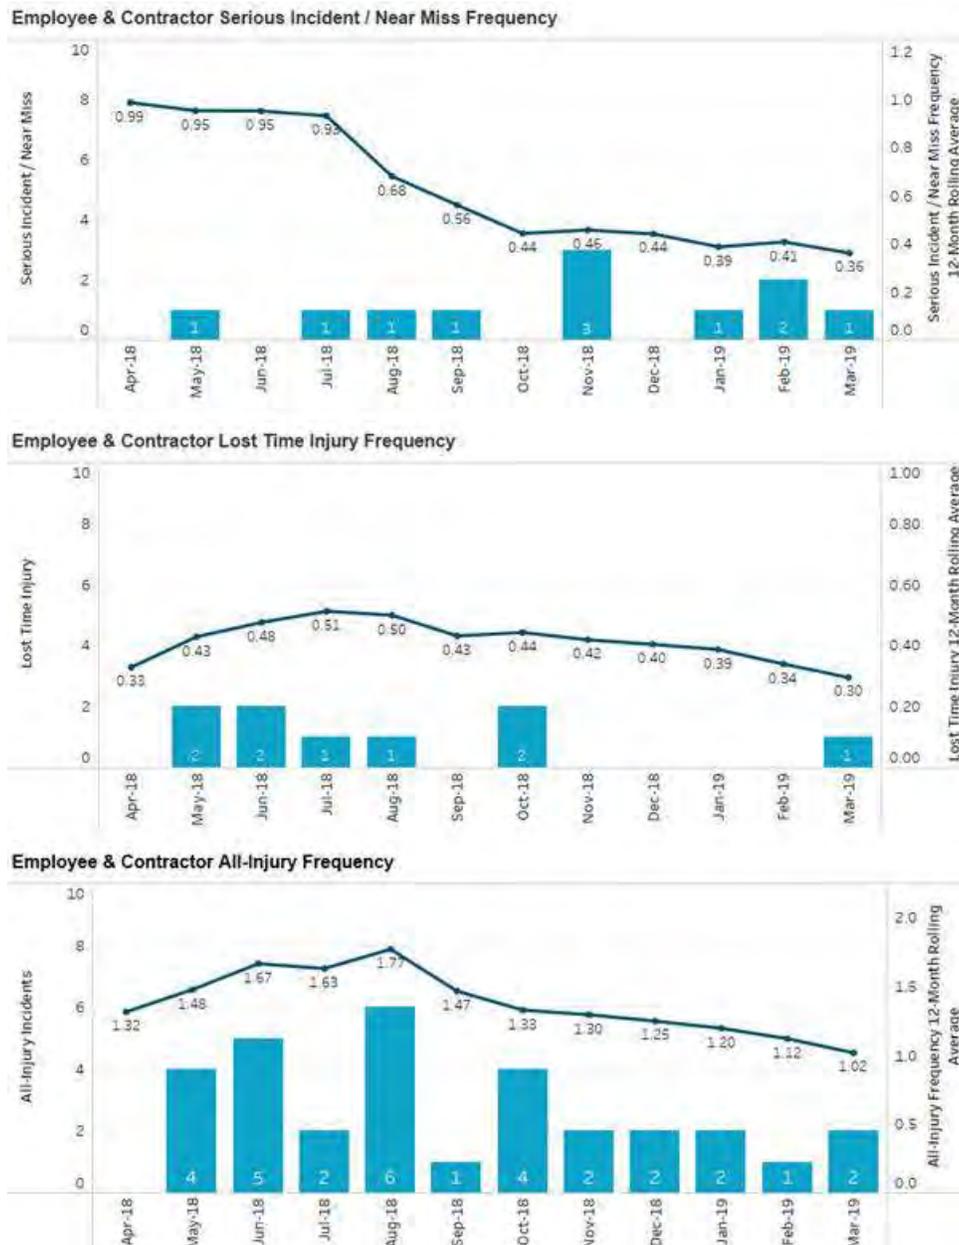
Figure B-1 Employee and Contractor Serious Incidents/Near Miss Frequency, Lost Time Injury Frequency and All Injury Frequency
