**RE: British Columbia Utilities Commission (BCUC or Commission)  
British Columbia Hydro and Power Authority (BC Hydro)  
Site C Clean Energy Project  
PUBLIC Quarterly Progress Report No. 17 –  
July to September 2019 (Report) – Errata No. 1**

**RE: British Columbia Utilities Commission (BCUC or Commission)  
British Columbia Hydro and Power Authority (BC Hydro)  
Site C Clean Energy Project  
PUBLIC Quarterly Progress Report No. 17 – July to September 2019 (Report)**

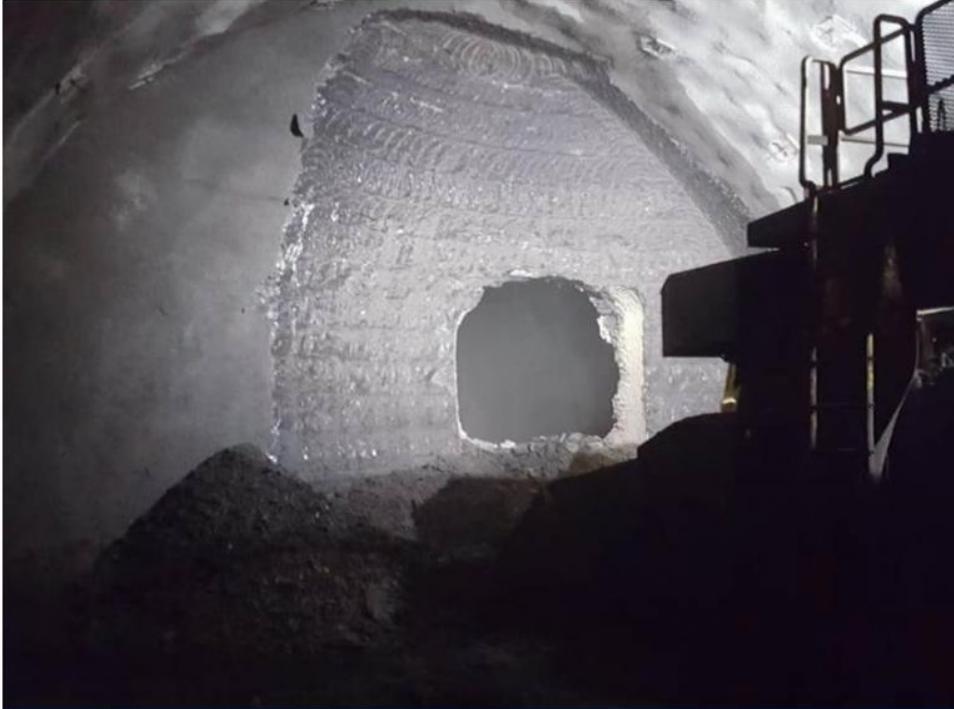
**Figure A-1**    **Diversion Tunnel No. 2 Breakthrough**  
**(July 2019)**

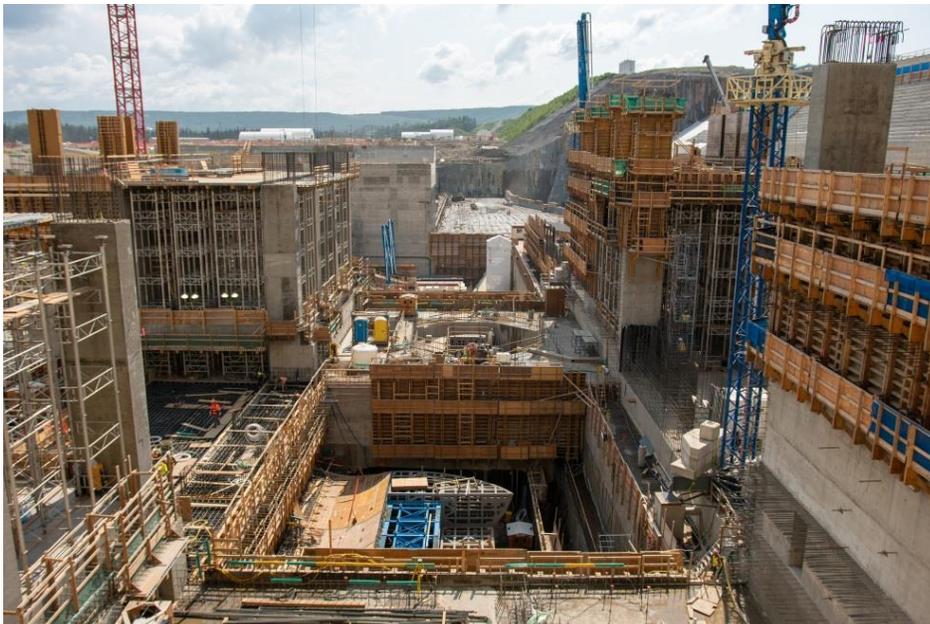
**Figure A-2**    **Construction Continues on the**  
**Powerhouse (July 2019)**

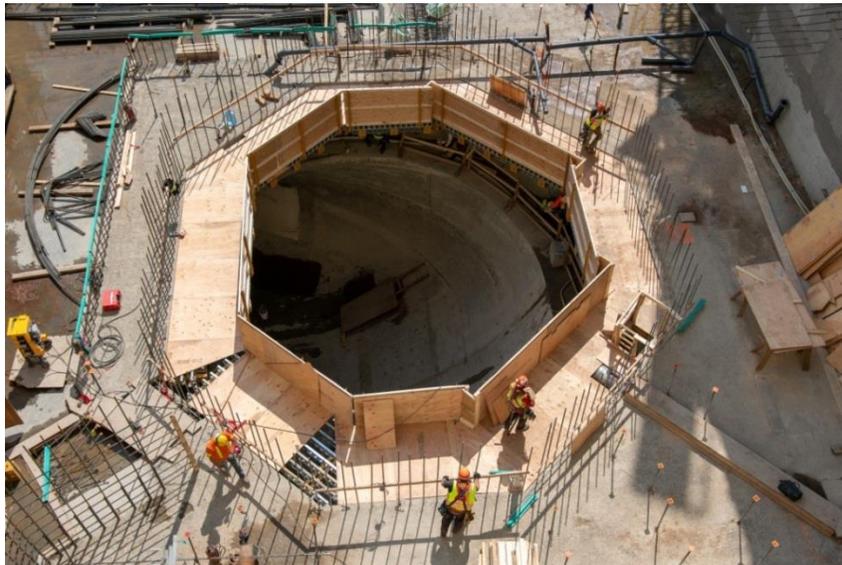
**Figure A-3** View of Inside Unit 1 Draft Tube in the Powerhouse. Once Site C is Operational, Water will Enter the Penstocks, Move through the Turbines and Generators and then be Released into the Draft Tubes prior to Exiting through the Tail Race (July 2019)

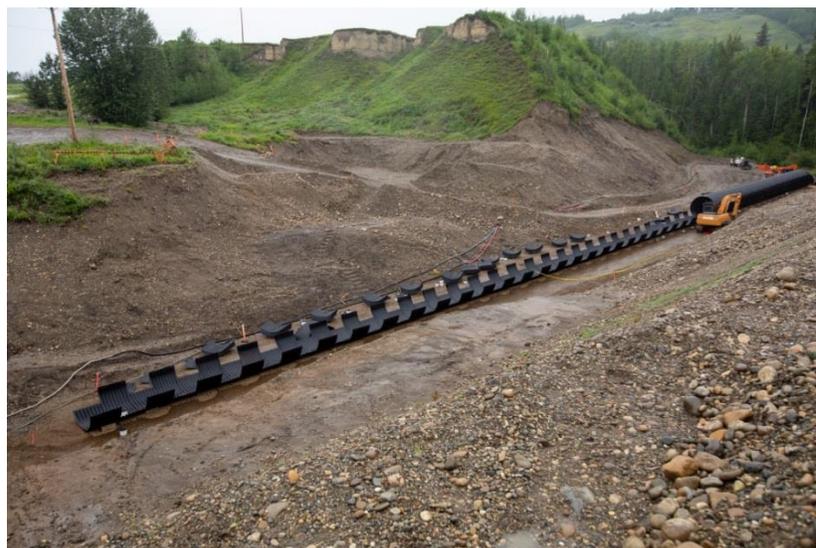
**Figure A-4** Assembly of a Multi-plate Culvert that will Provide Drainage under a Realigned Segment of Highway 29 in the Cache Creek Area. A variety of Culverts are being Installed as Part of the Highway 29 Realignment (July 2019)

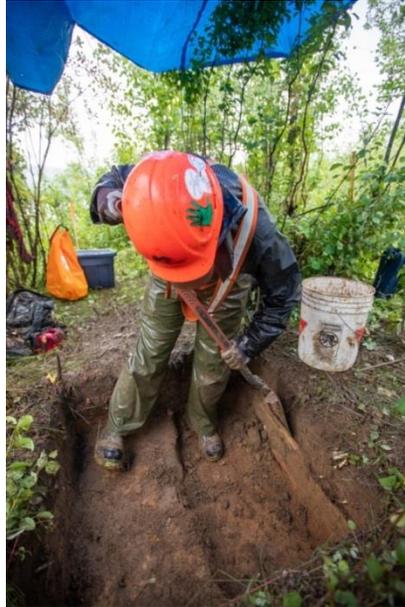
**Figure A-5 A Worker Conducts Archaeological Excavations near Farrell Creek, in Support of the Highway 29 Realignment Work (July 2019)**

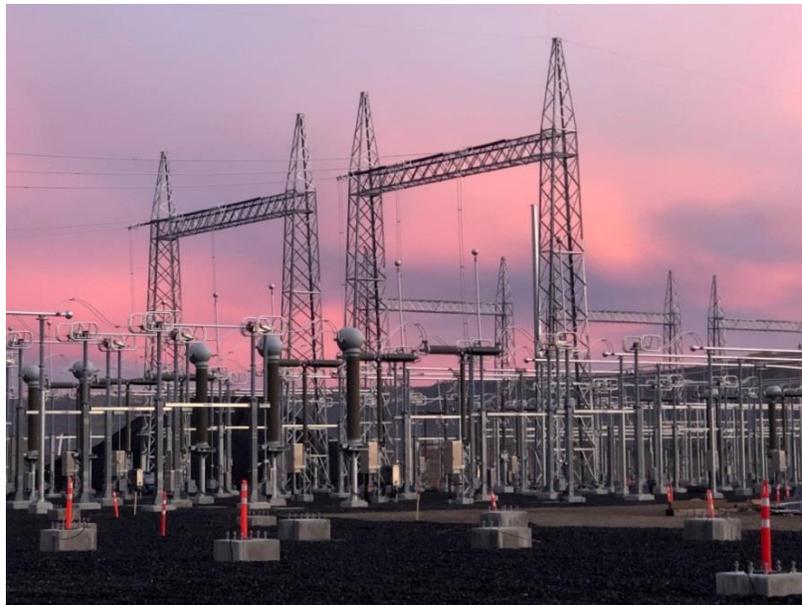
**Figure A-6 The Site C Substation will be the Largest in BC Hydro's System. The Substation is 80 per cent Complete and Scheduled to go into Service in October 2020 (August 2019)**

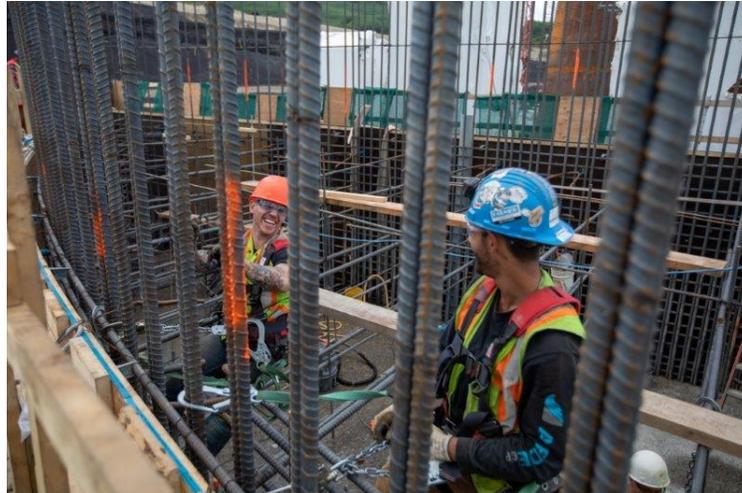
**Figure A-7 Installing Rebar at the Powerhouse (August 2019)**

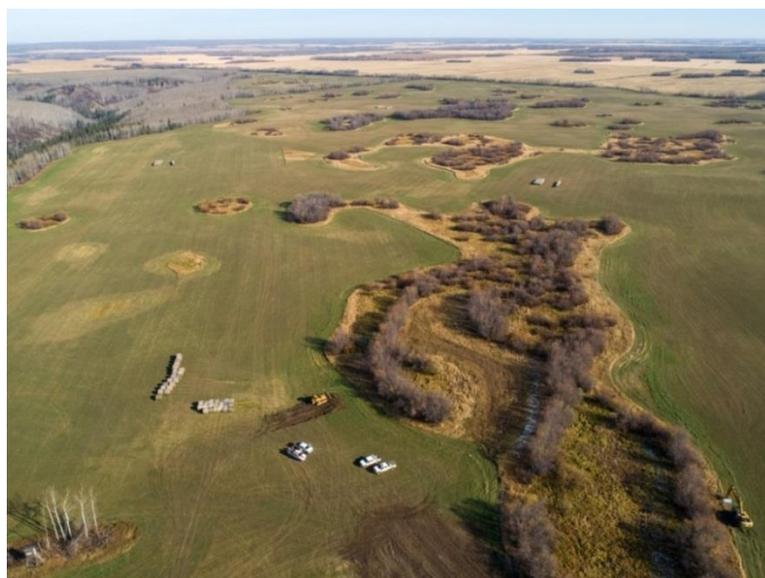
**Figure A-8 To Compensate for the loss of Wetland Habitat resulting from the Project, we are Working with Ducks Unlimited to Construct and Restore over 500 hectares of Wetlands. The First of these is at a 50-acre Wetland Project at Golata Creek, a Complex System of 15 Ponds Retained with a Dam and Berms. These Wetlands provide Important Habitat for a Wide Range of Plants and Animals, including Fish, Invertebrates, Bats, Birds, and Rare Plants (September 2019)**

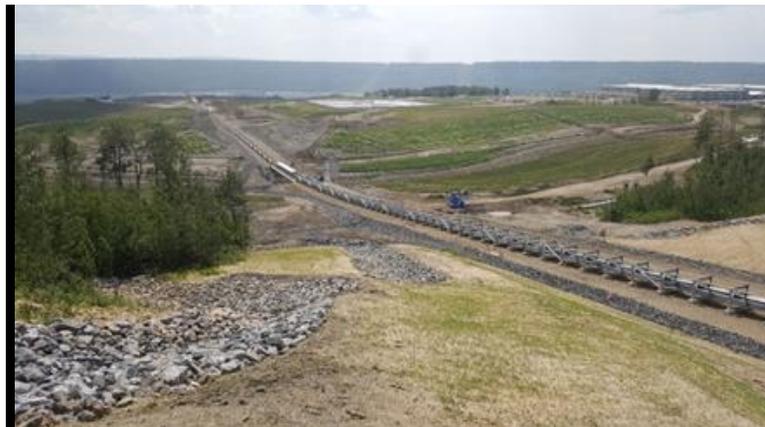
**Figure A-9** The 5km Conveyor System, which Runs from the 85<sup>th</sup> Avenue Industrial Lands to the Dam Site, will Carry Glacial Till, an Impervious Clay-like Material that will Form the Core of the Dam. The Conveyor System was Chosen as the Primary Form of Transport because it will Reduce Traffic on Local Roads, Create Fewer Greenhouse Gas Emissions, and Result in Less Noise and Dust (September 2019)

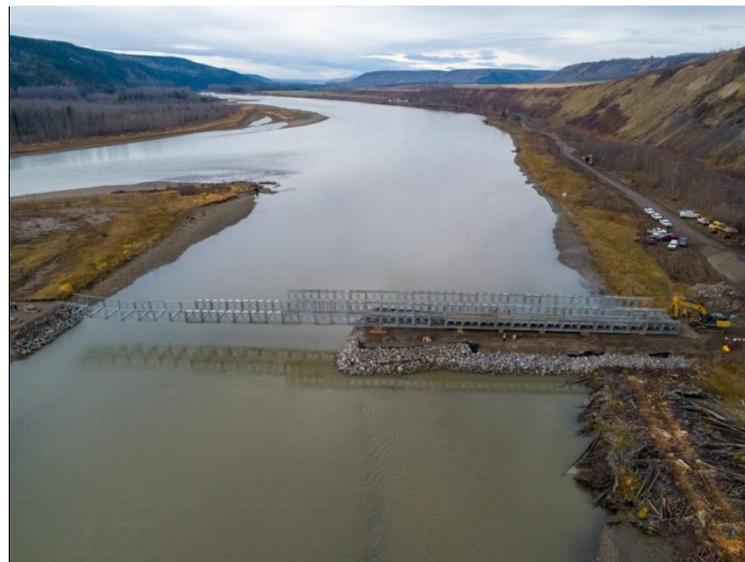
**Figure A-10** Construction Started on a Temporary Bridge to an Island in the Peace River near Halfway River, as Part of Clearing Activities for the Project. The Bridge allows Workers to Remove Vegetation from the Island and Prepare for the Creation of the New Reservoir (September 2019)

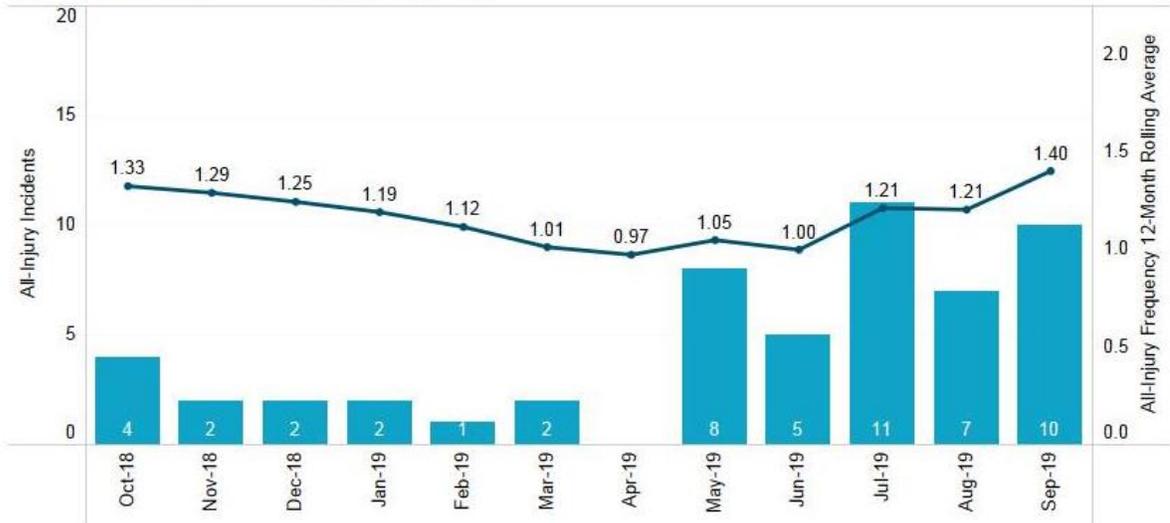
4 **Figure B-1 Employee and Contractor Serious**  
5 **Incidents/Near Miss Frequency, Lost Time**  
6 **Injury Frequency and All-injury Frequency**

1 [Figure B-1](#) below provides information on employee and contractor serious  
2 incidents/near miss frequency, lost time injury frequency and all-injury frequency  
3 from July 1, 2018 to September 30, 2019.
