Site C Clean Energy Project

Quarterly Progress Report No. 23

F2022 Second Quarter

July 1 to September 30, 2021

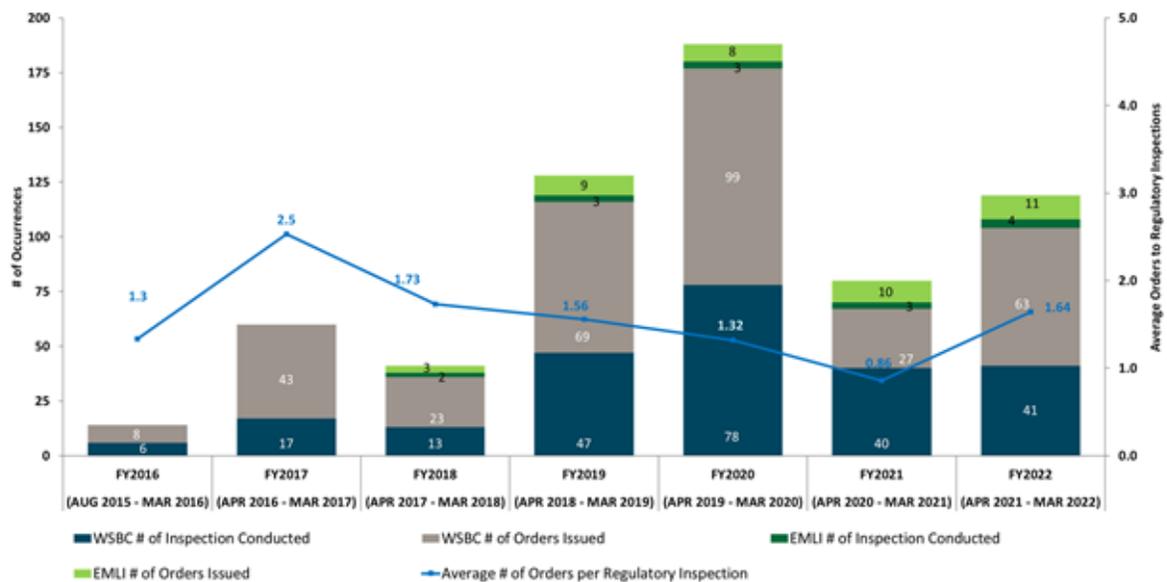
8 **Figure 1** Number of Orders to Regulatory
9 Inspections, August 2015 to
10 September 2021

3 The Project monitors an additional metric – average number of orders per regulatory
4 inspection. As shown in [Figure 1](#), between April 2021 and September 2021, the
5 average number of orders per inspection was 1.64, which is trending higher than
6 fiscal 2021 when WorkSafeBC did not attend site as much due to COVID-19. This
7 metric is consistent with fiscal 2019 and 2020.

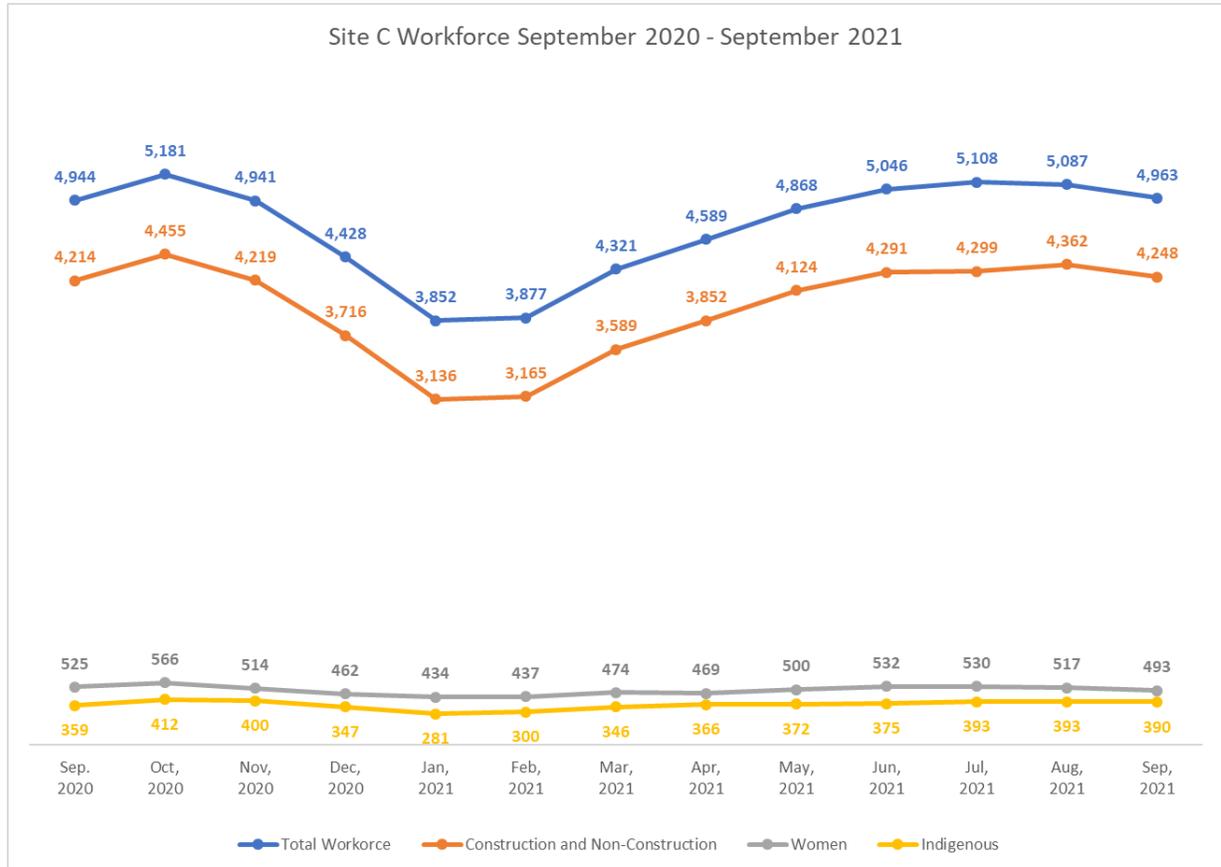
Figure 2 Site C Workforce September 2020 to September 2021

3 Note: The Indigenous and women numbers are a subset of the construction and non-construction
4 workforce number.

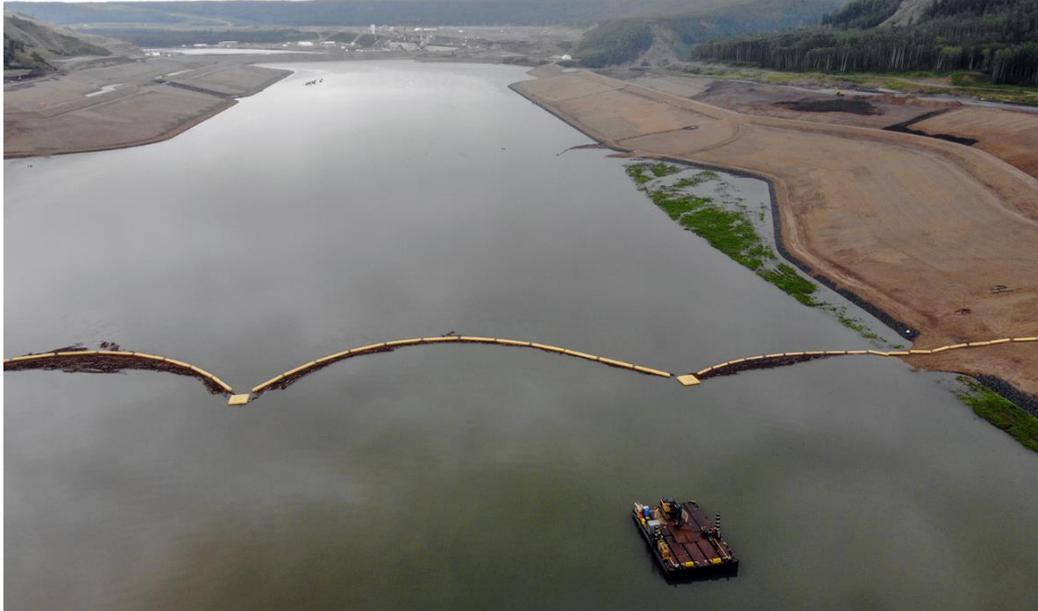
Figure A-1 An aerial view of the headpond and debris boom where a barge is used for clearing debris materials from the boom (July 2021)

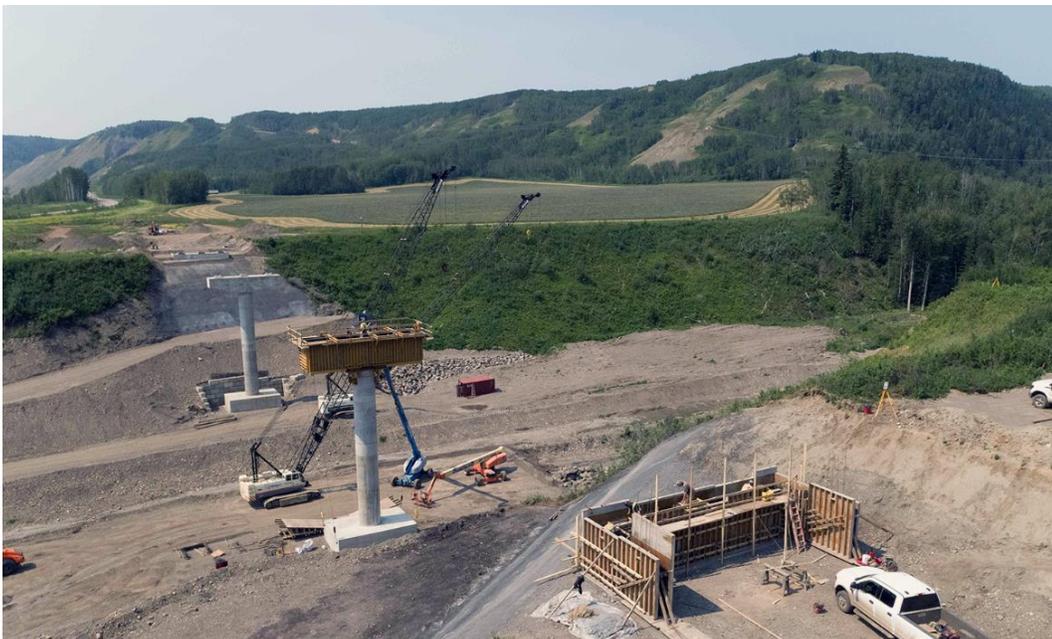
Figure A-2 Bridge formwork is under construction at the Dry Creek section of Highway 29 (July 2021)

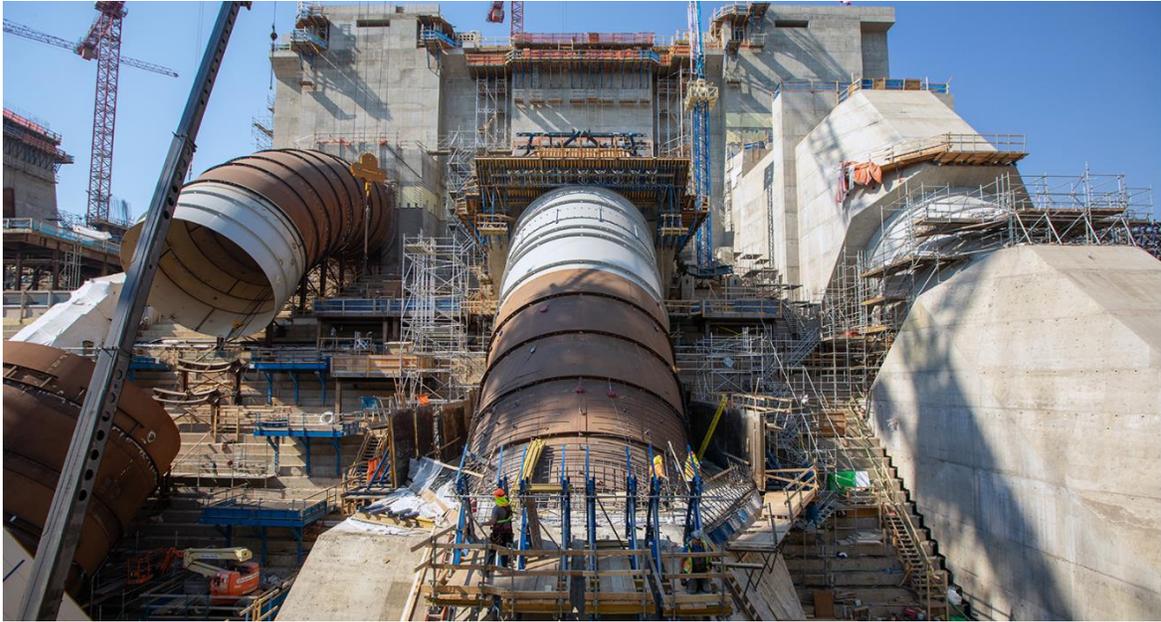
Figure A-3 Penstocks for units 1, 2 and 3 (July 2021)

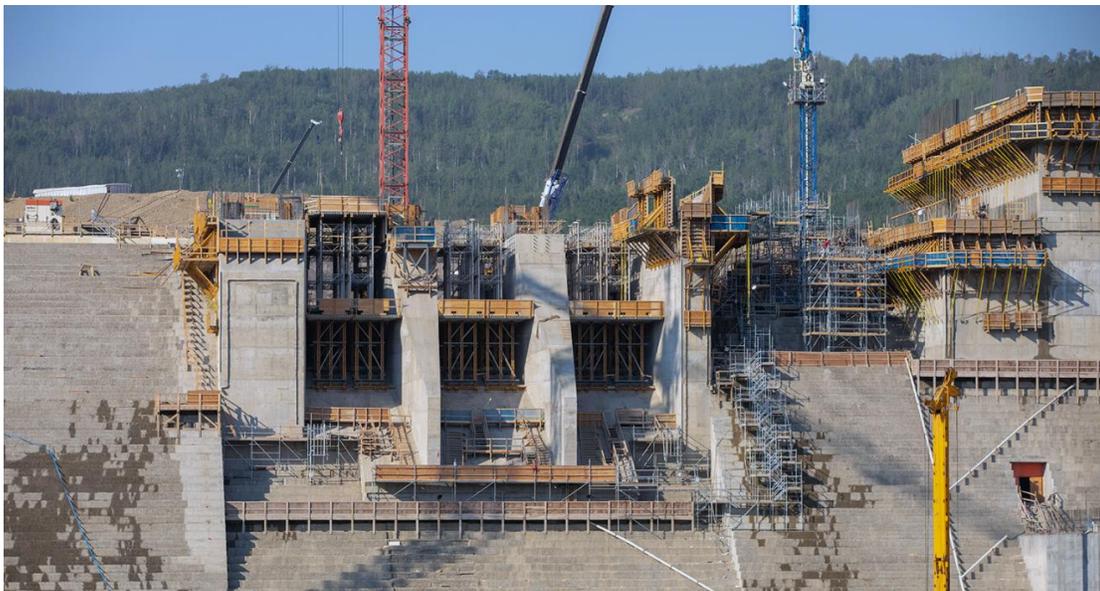
Figure A-4 Construction progresses at the spillway headworks east low-level outlet gate. The spillway will allow the passage of large volumes of water from the reservoir into the river channel downstream (July 2021)

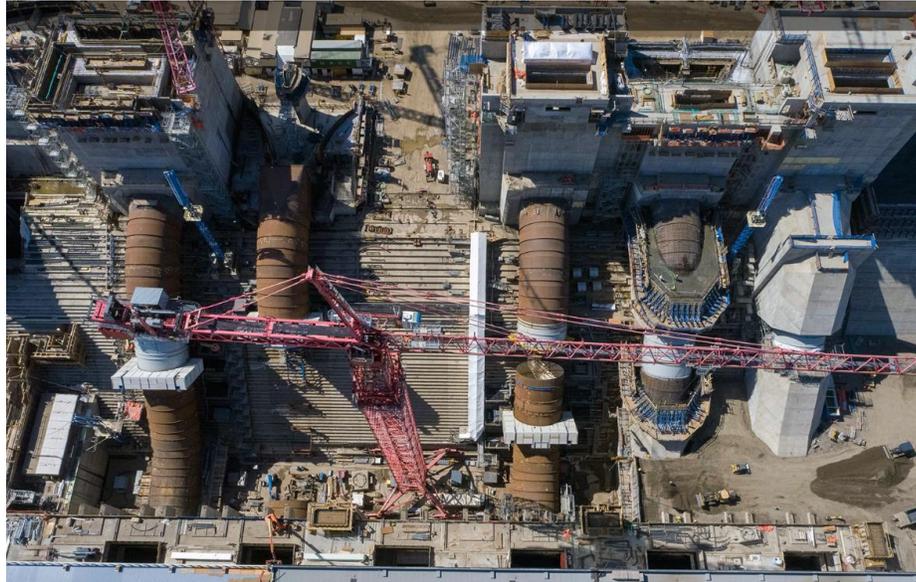
Figure A-5 A top view (from right to left) of the unit 1 to 6 intakes and penstocks in varying stages of construction. Unit 4 is going to be the last to be built (July 2021)

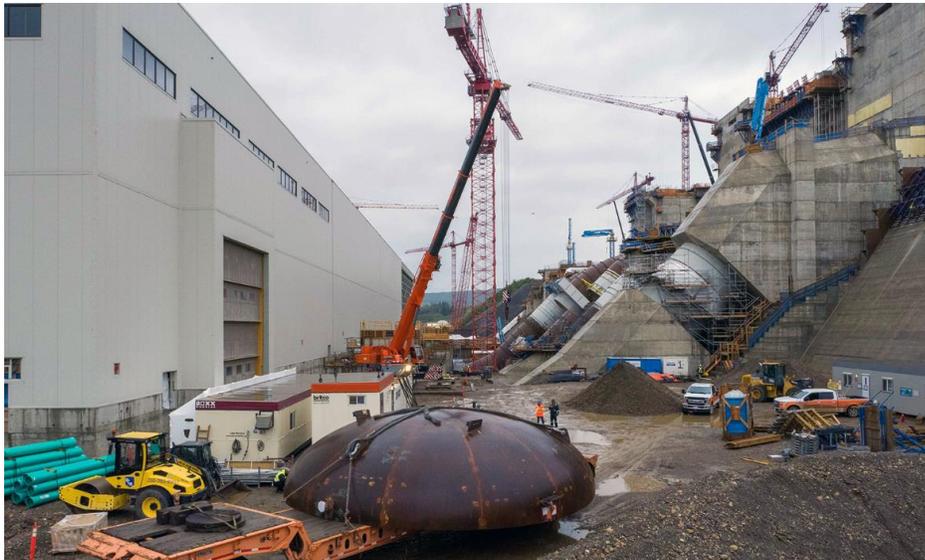
Figure A-6 The first of four spiral case inlet bulkheads is delivered from the Voith warehouse at site to the powerhouse (August 2021)

7 In mid-summer 2021, the Project's main contractor for the turbines and generators
8 sub-project started installing and welding inside the spiral case components of the
9 generating units in the powerhouse. Once the bulkhead is installed into a spiral
10 case, confined spaces are created with the resulting air quality safety hazards for
11 workers. Project team safety verifications identified that the contractor's confined
12 space and ventilation procedures were neither adequate nor compliant with new
13 WorkSafeBC regulations.

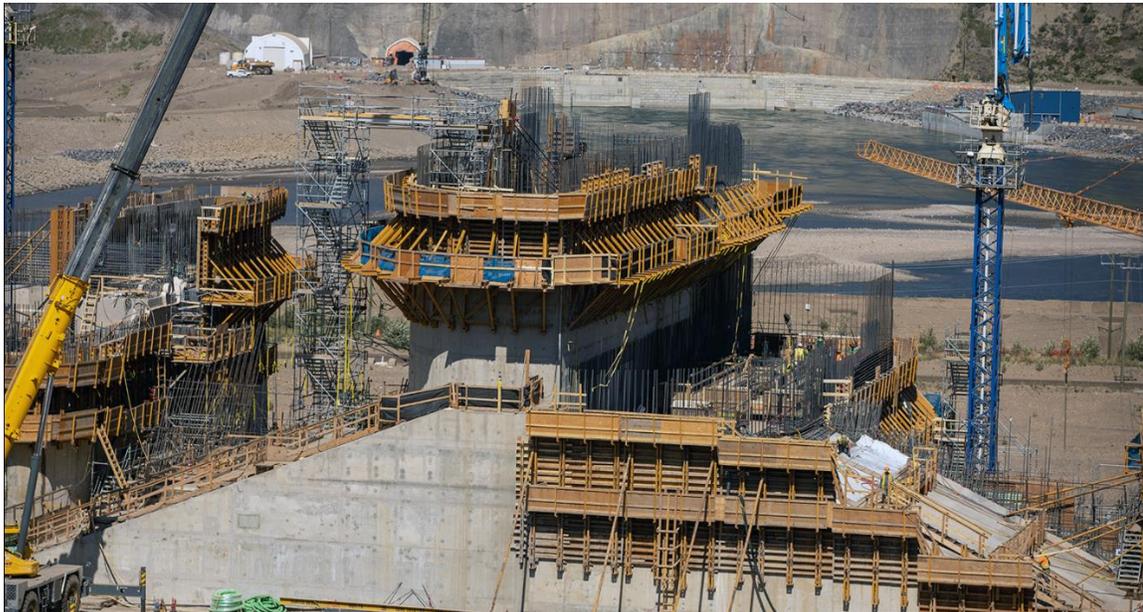
Figure A-7 Construction is ongoing on the spillway headworks centre pier at bay 2 and 3 (August 2021)

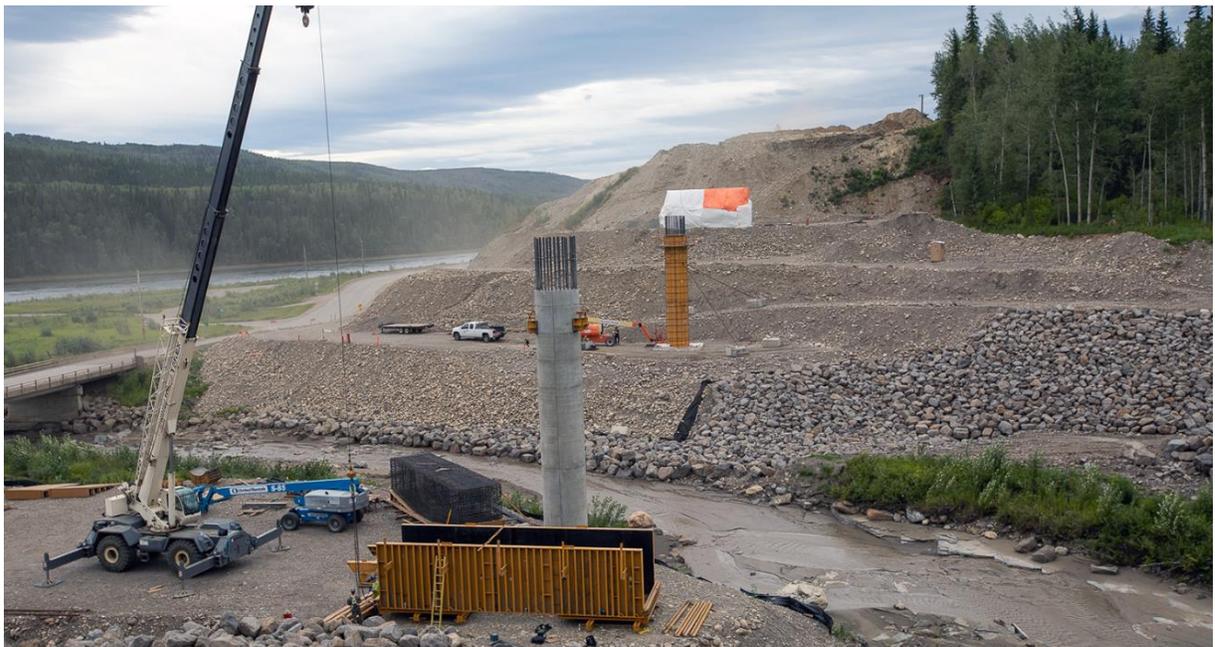
Figure A-8 Construction of the concrete piers for the Lynx Creek bridge along Highway 29 (August 2021)

13 During the reporting period the Lynx Creek contractor continued gravel extraction,
14 hauling and placement along the highway alignment and completed the bridge
15 foundations. The installation of steel bridge girders was started. At the end of the
16 reporting period, the Lynx Creek work was 47 per cent complete.

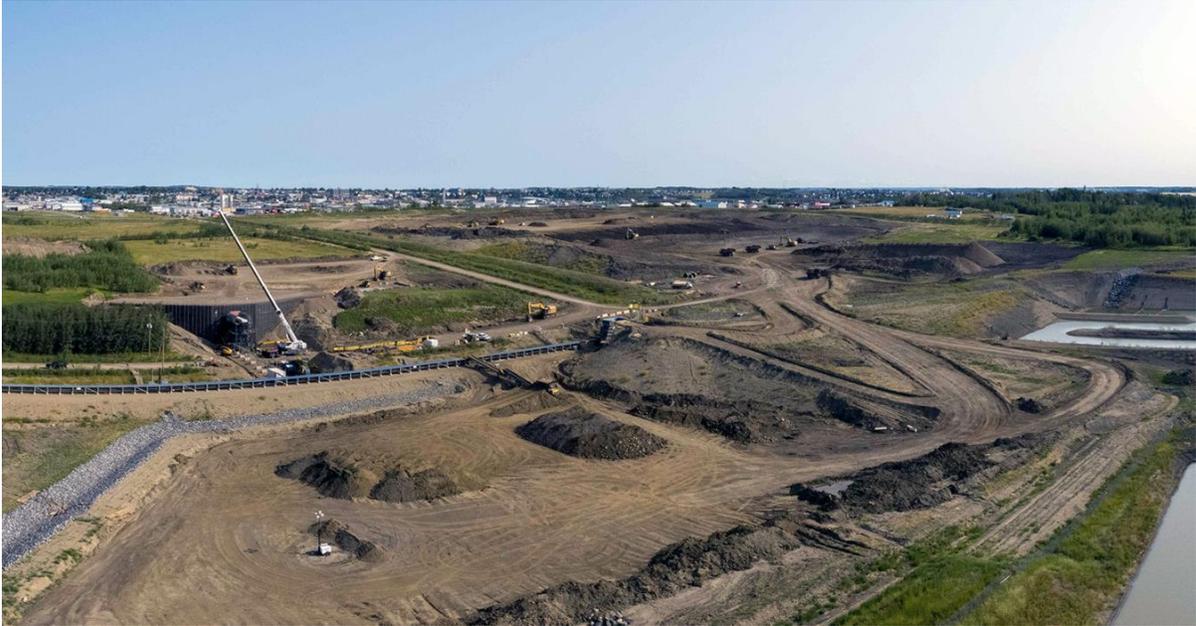
Figure A-9 Glacial till is extracted at the 85th Ave. Industrial Lands and sent by conveyor belt to the dam site (August 2021)

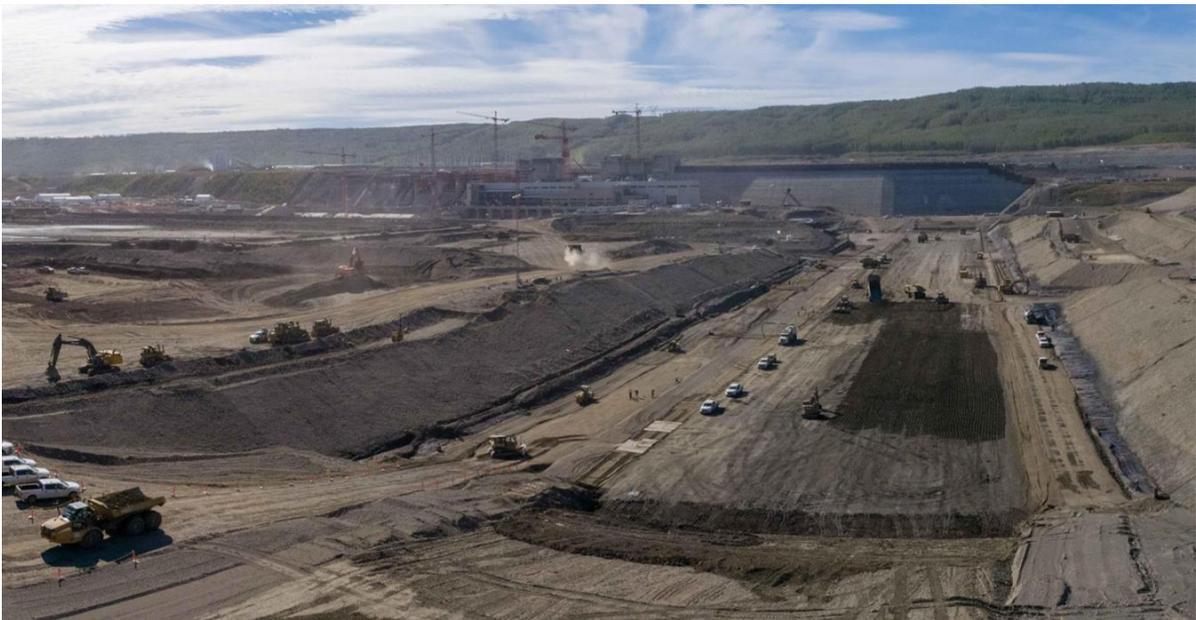
Figure A-10 Crews in the dam core trench are busy placing till, filters and aggregates (September 2021)

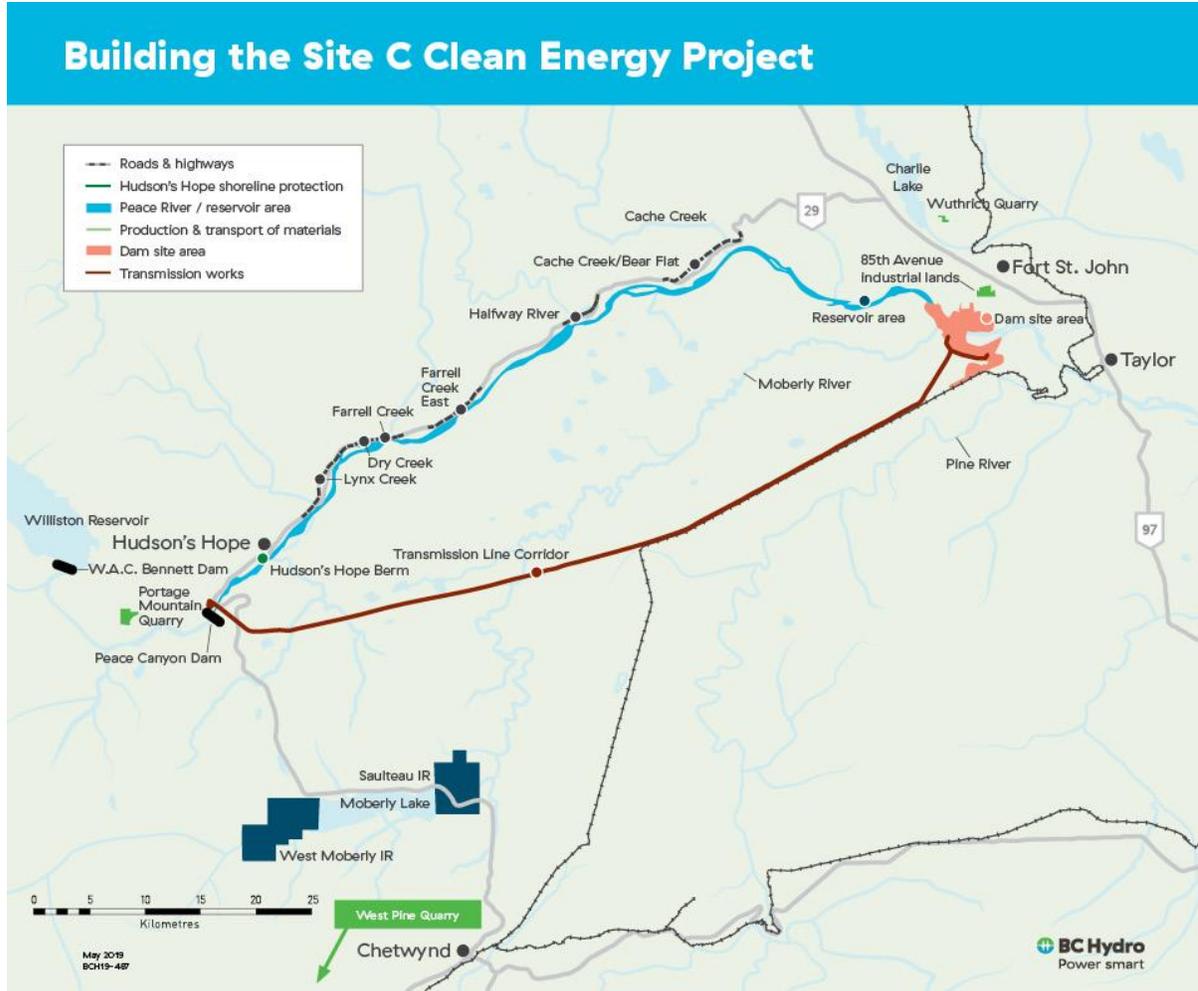
Figure B-1 Site C Project Components

- Completion of the finishing concrete work inside the 454-metre-long left bank drainage tunnel; and
 - Dam and core excavation, and the placement of 450,000 cubic metres of roller-compacted concrete in the dam and core buttress, marking the completion of the Project's overall roller-compacted concrete placement program. In total, nearly 1.7 million cubic metres of roller-compacted concrete has been placed since 2017.

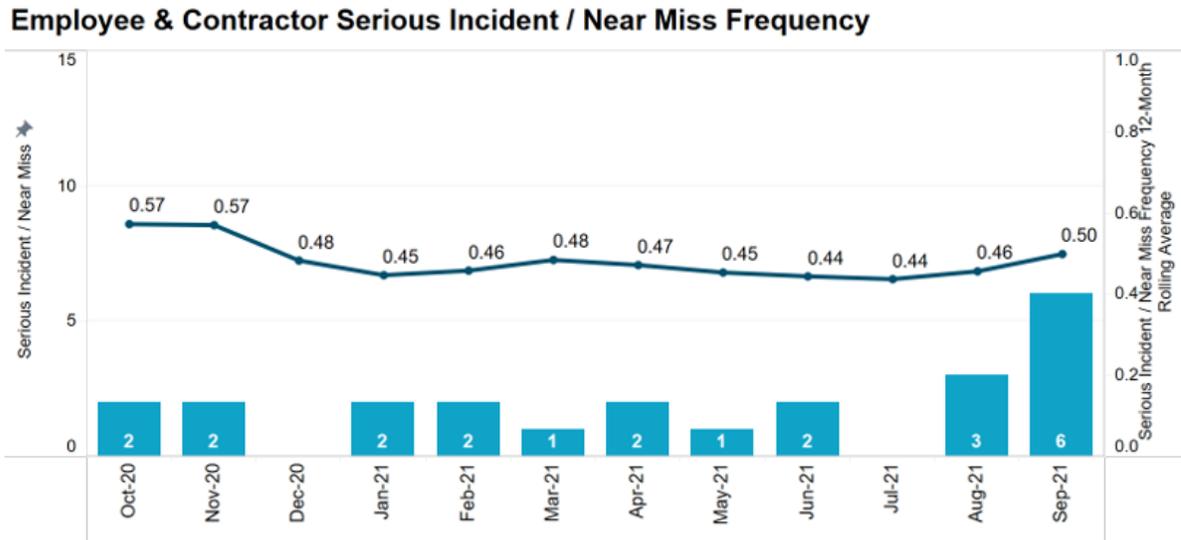
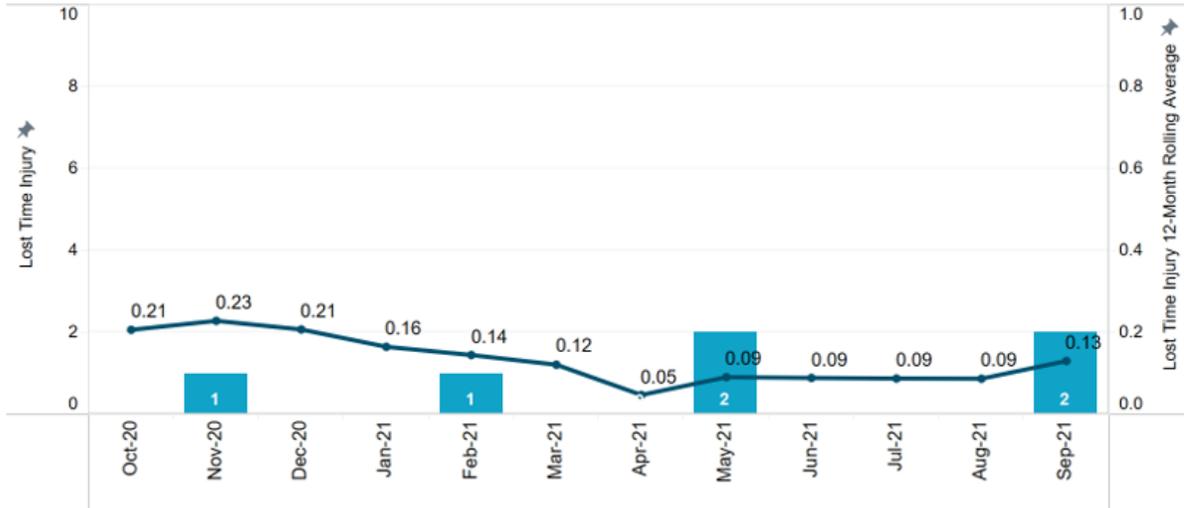
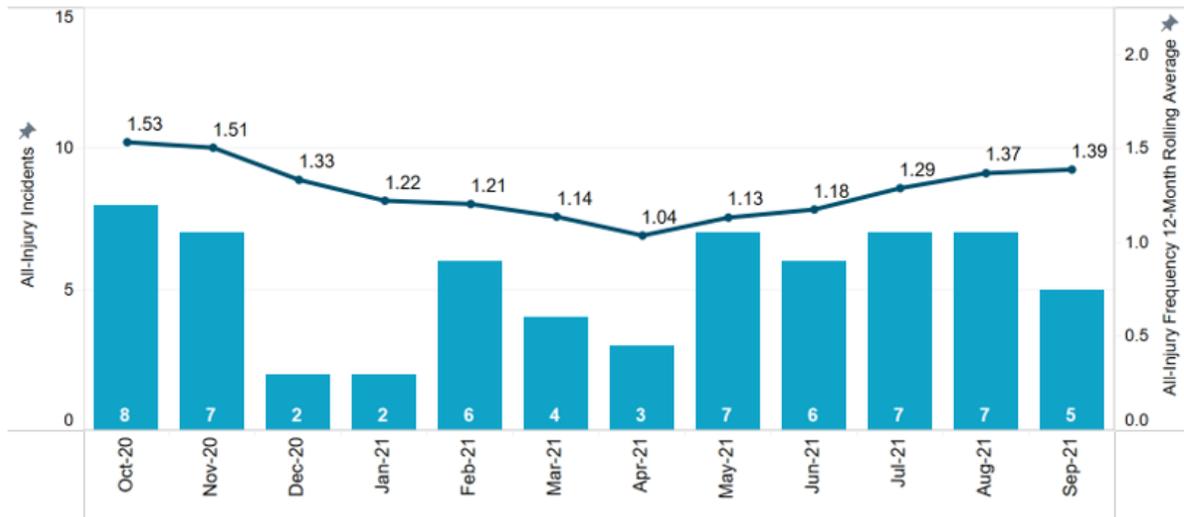
Figure C-1 Employee and Contractor Serious Incidents/Near Miss Frequency, Lost Time Injury Frequency and All-injury Frequency

[Figure C-1](#) below provides information on employee and contractor serious incidents/near miss frequency, lost time injury frequency and all-injury frequency from November 2020 until September 2021.

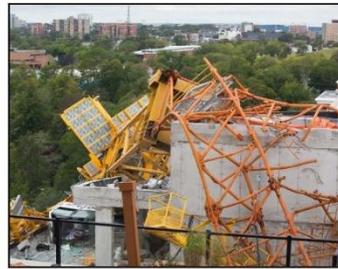
2019 – Halifax, NS

- A 73-metre high crane collapsed due to a weld failure during the high winds of post-tropical storm Dorian.
- There were no deaths or injuries as a result of this incident.

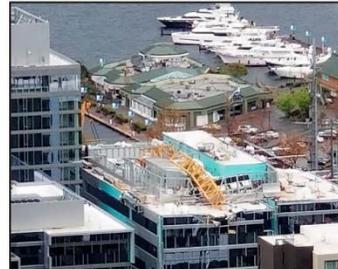
2019 – Seattle, WA

- Four workers were killed when a tower crane collapsed while working on the Google Seattle Campus.
- Investigators find that pins securing sections of the tower crane together were prematurely removed.

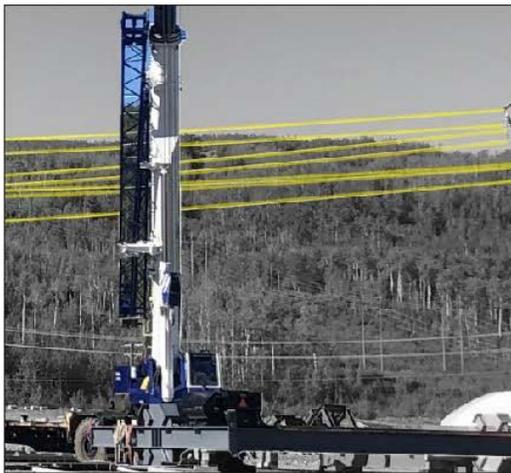
Figure 1 A crane operates near high voltage conductors

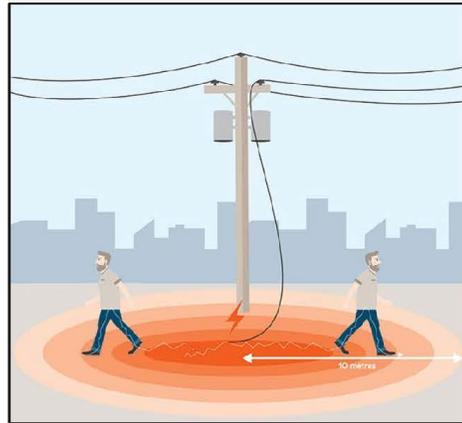
Step potential is the difference in voltage between points contacting the ground.

With a fallen power line, it's important to know that even if you're standing a distance away, you could still be in danger if you're within the range of electrical current travelling through the ground. Each walking step within this distance creates a step potential and a path for the electricity to continue travelling.

Figure 2 There will be a difference in the voltage in each of the person's legs as they walk near the downed wire.

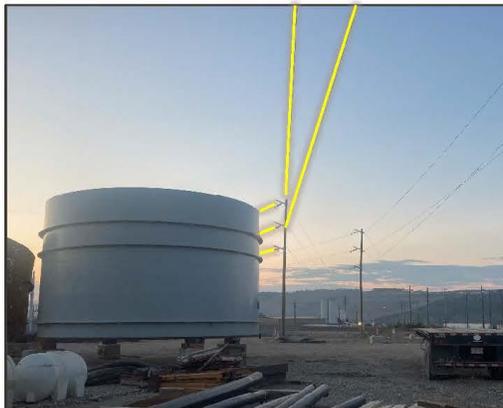
Clearance distances between passing equipment under exposed electrical conductors are limited by table 19-1B in the Regulation. If passing under an overhead conductor with a load, consult this table to ensure safe distances are maintained.

Figure 5 A section of penstock stored adjacent to a high voltage conductor.

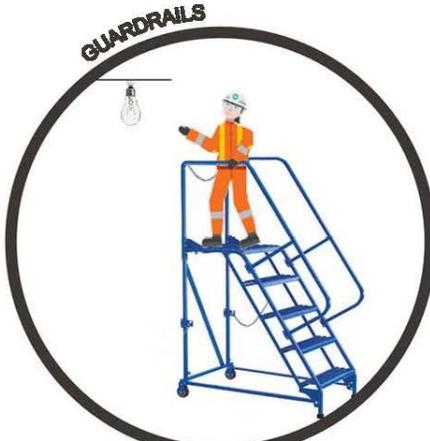
GUARDRAILS

If we must work at height, our first choice of fall protection system is a **guardrail**. Guardrails provide safe means of fall protection with minimal training requirements.

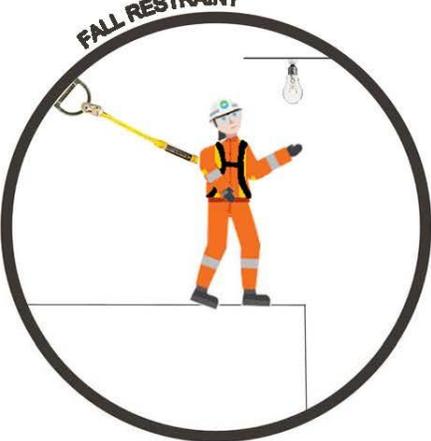
FALL RESTRAINT

If guardrails are impracticable, we can then consider **fall restraint** systems. These systems hold you back from the fall hazard.

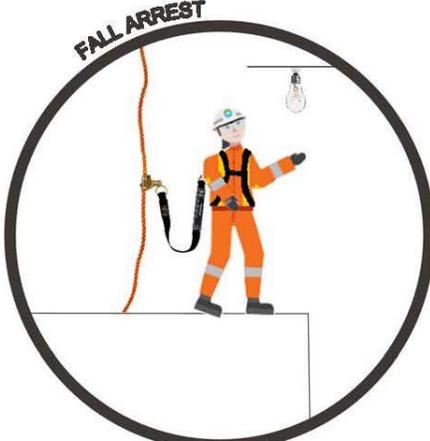
FALL ARREST

If the forms of fall protection shown above are impracticable, only then can we consider using a **fall arrest** system. Fall arrest systems work by stopping a fall after a person has fallen.
