## **Site C Clean Energy Project**

### **Temporary Upstream Fish Passage Facility Operations Report**

**Reporting Period: June 1 to 30, 2021**

Prepared by BC Hydro

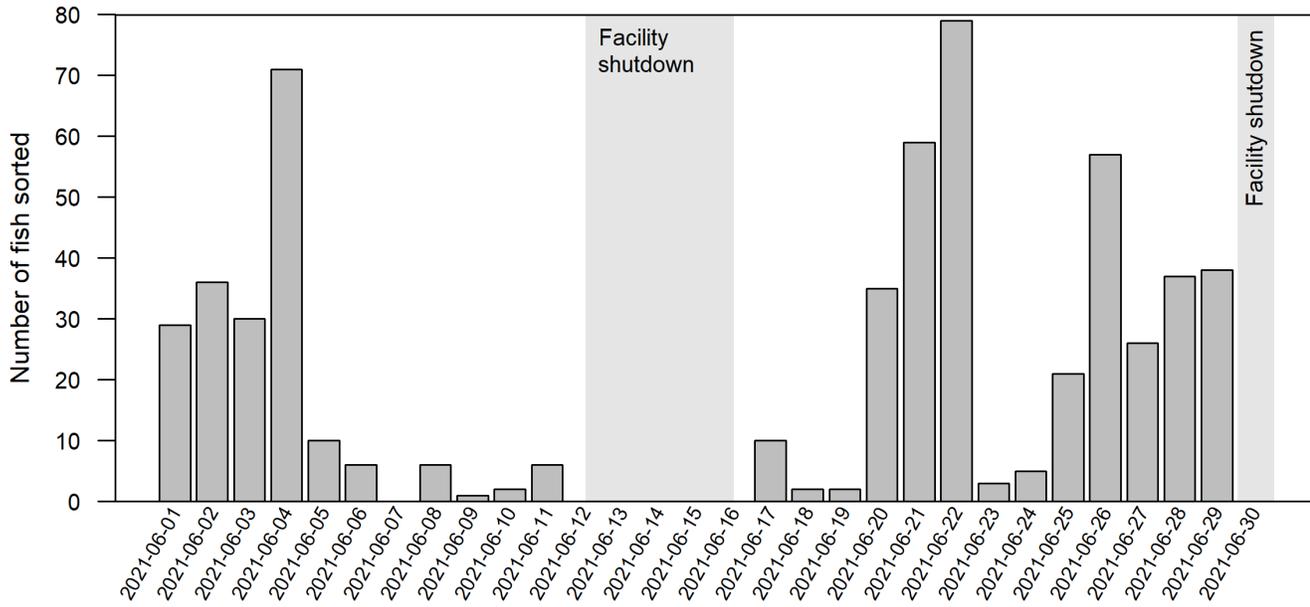
Between zero and 79 fish were sorted daily during the reporting period (Figure 1).

**Figure 1.** Daily number of fish sorted in the temporary facility during the reporting period.

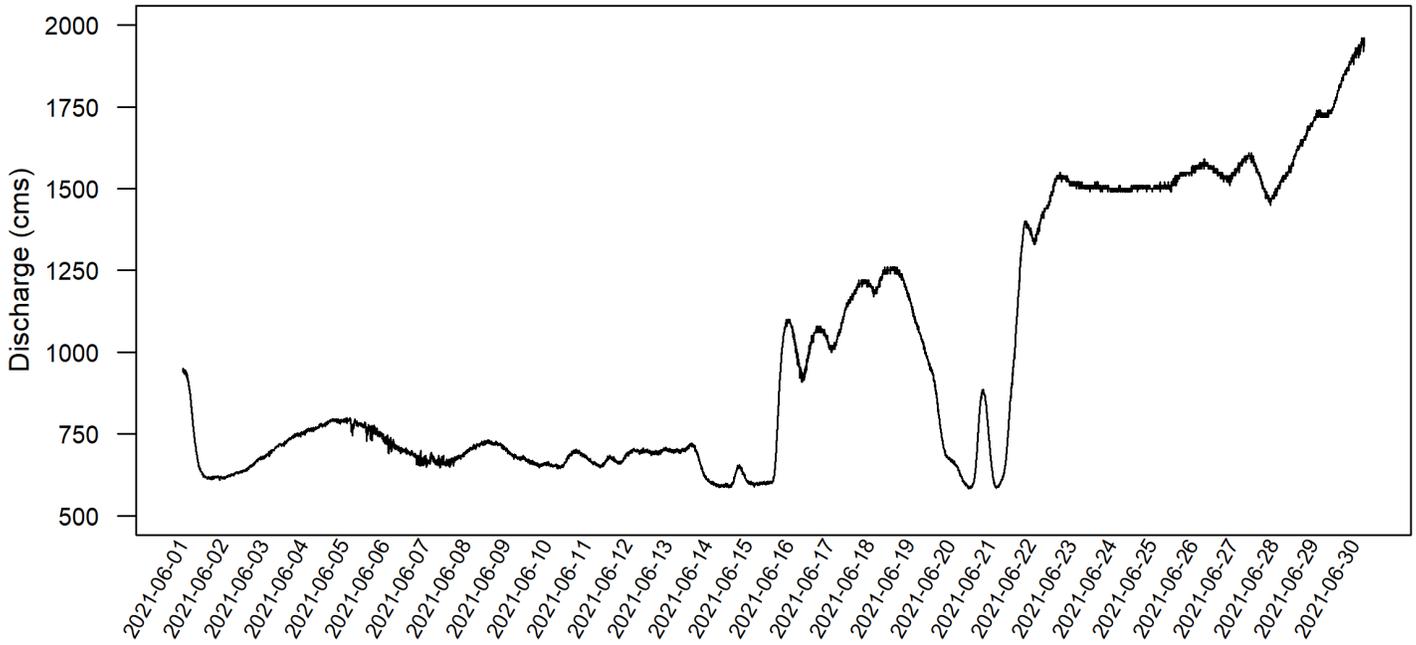
Discharge in the Peace River fluctuated during the reporting period from a low of 582 cms on June 20 to a high of 1960 cms on June 30 (Figure 2).

**Figure 2.** Discharge in the Peace River during the reporting period as measured at the Peace River above Pine River (07FA004) Water Survey of Canada (WSC) hydrometric station. Data were downloaded from the WSC on July 16 at 5-minute intervals and were listed as provisional by the WSC.

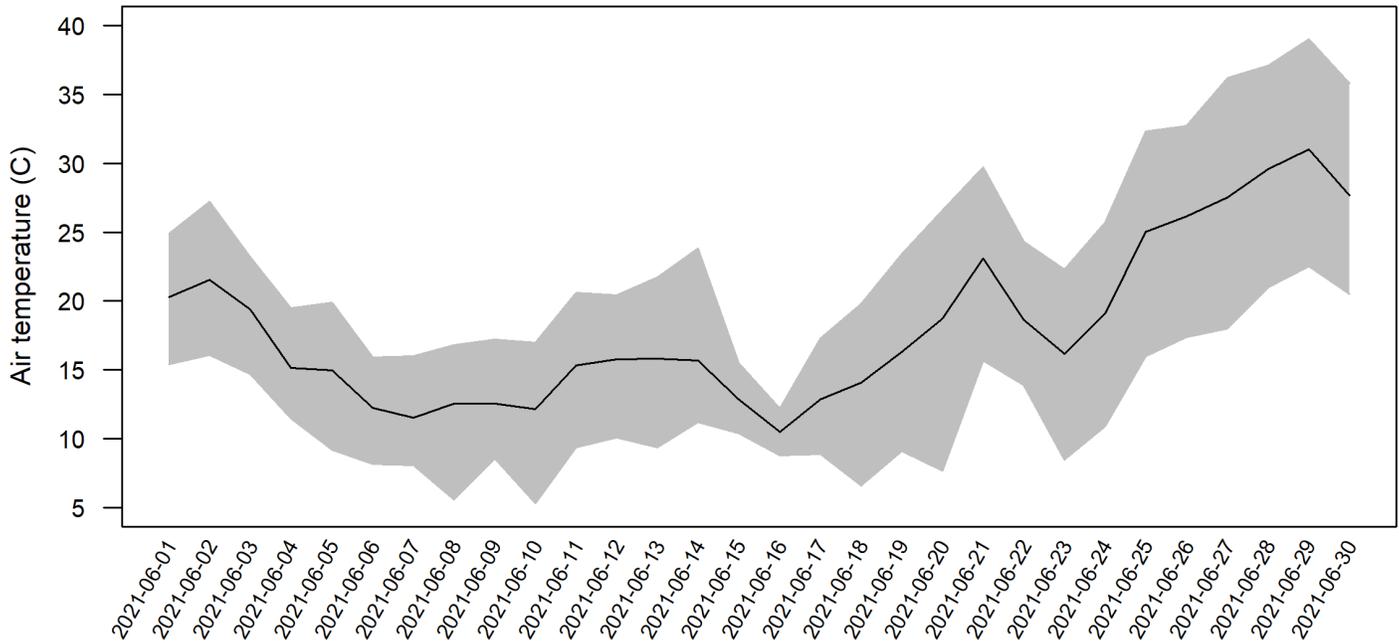
Air temperature fluctuated during the reporting period from a low of 5.3°C on June 10 to a high of 39°C on June 29 (Figure 3).

**Figure 3.** Mean daily air temperature (black line; °C) during the reporting period as measured by the provincial air monitoring station located on the dam site at the Site C Workers Accommodation<sup>7</sup> (E309527). Shaded area represents the minimum and maximum daily air temperatures.

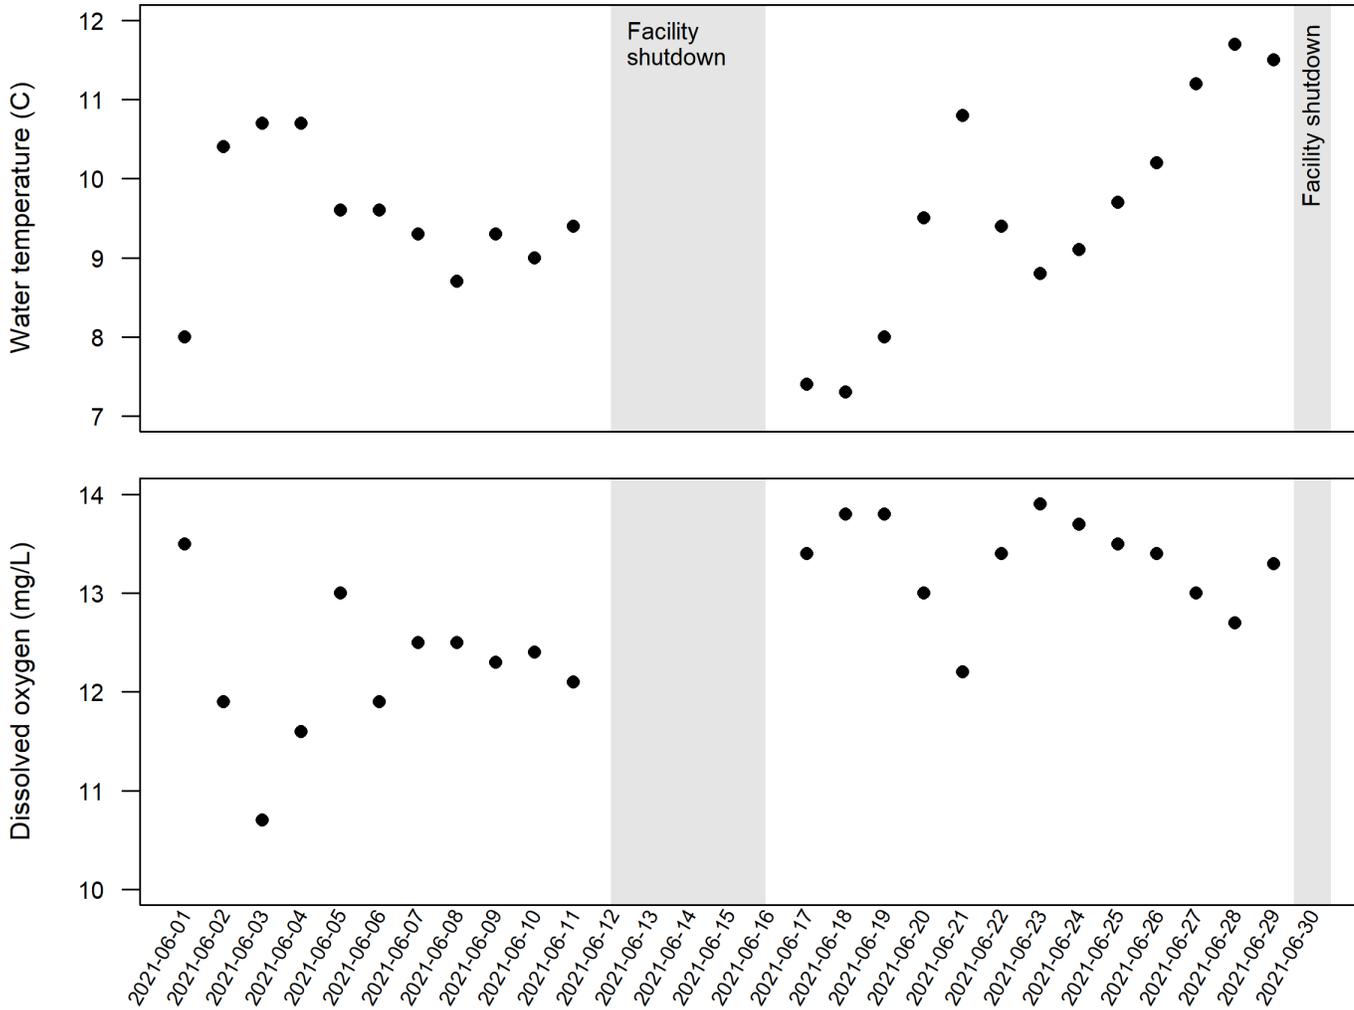
Water temperature fluctuated during the reporting period from a low of 7.3°C on June 18 to a high of 11.7°C on June 28 (Figure 4). Dissolved oxygen remained above the minimum dissolved oxygen level (8.0 mg/L) described in the design report of the temporary facility.

**Figure 4.** Daily water temperature (°C) and dissolved oxygen (mg/L) during the reporting period as measured in the pre-sort holding pool of the temporary facility.

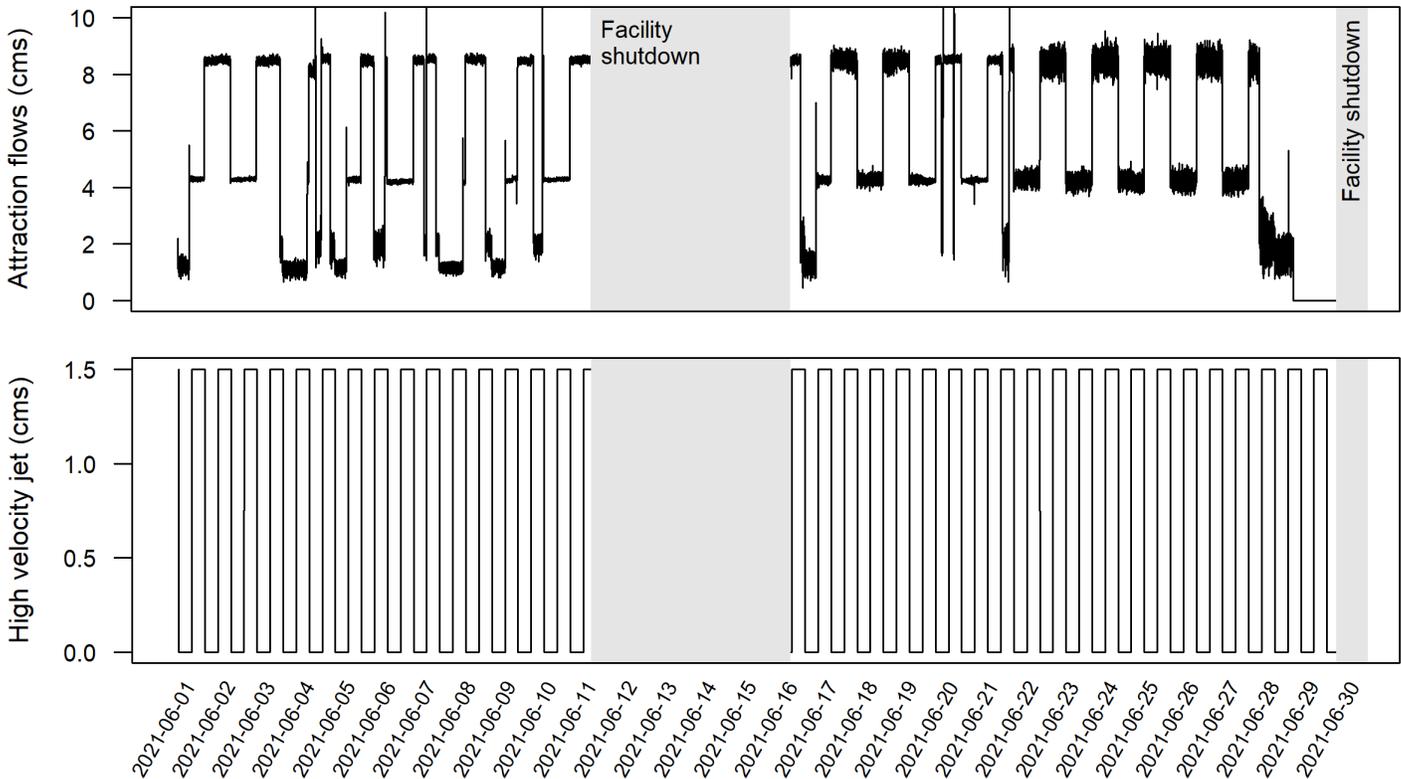
BC Hydro operated the attraction flows and high velocity jet as described in Section 3.2.1.3 of the OPP, whereby conditions were changed every 8 hours during the reporting period (Figure 5). Attraction flow pumps continued to fault throughout June (Table 4), and the facility was shutdown between June 11 and 16 and June 29 and 30 (Table 3).

**Figure 5.** Operation of the attraction flows and high velocity jet during the reporting period.

| <b>Date</b> | <b>Malfunction, breakdown or damage</b> | <b>Description</b> | <b>Root cause</b> | <b>Corrective action</b> |
|---|---|--|--|---|
| Several | Malfunction | Attraction flows dropping and spiking on occasion. | Variable frequency drive faulting due to debris accumulation on the outside of the wet well creating a large differential in hydraulic head. | Variable frequency drive manually reset following each fault. |

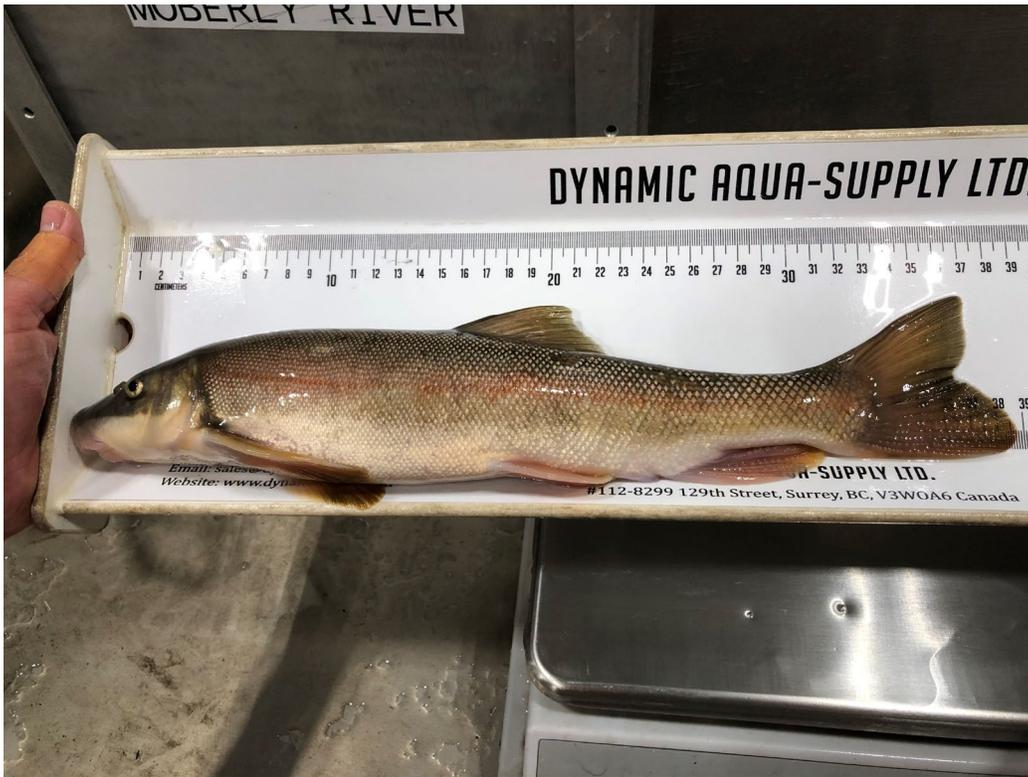
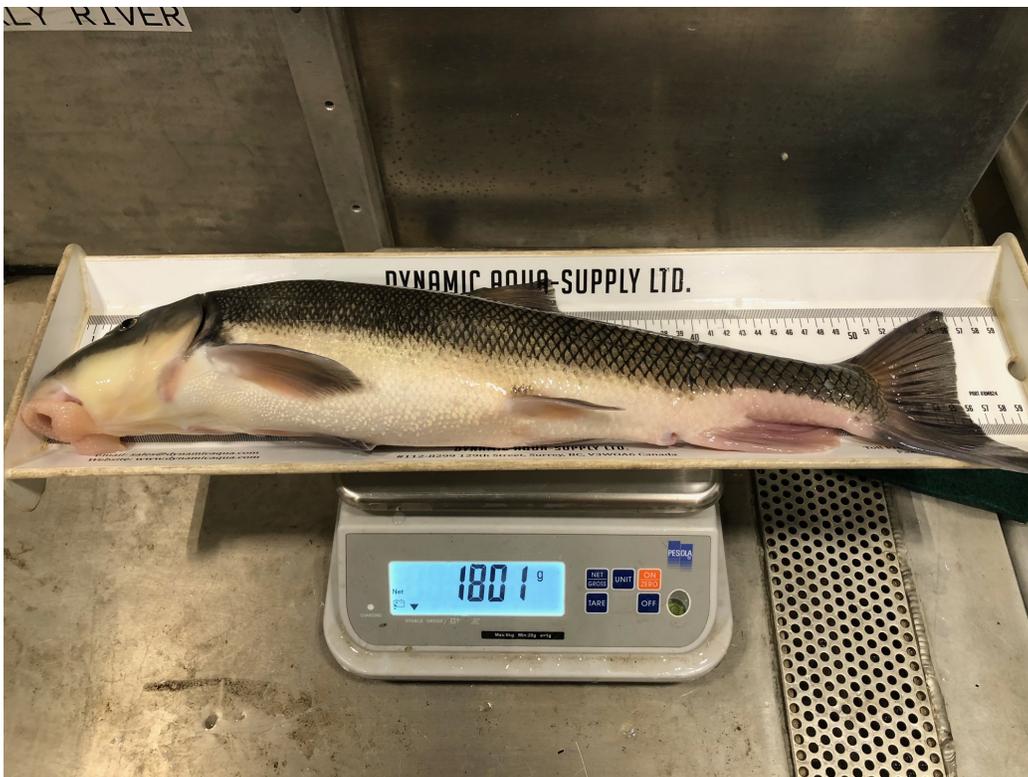
**Photo 1.** Processing Longnose Sucker (top: June 4, 2021) and Largescale Sucker (bottom: June 11, 2021) in the sorting facility. Spawning colouration can be seen on the Longnose Sucker.

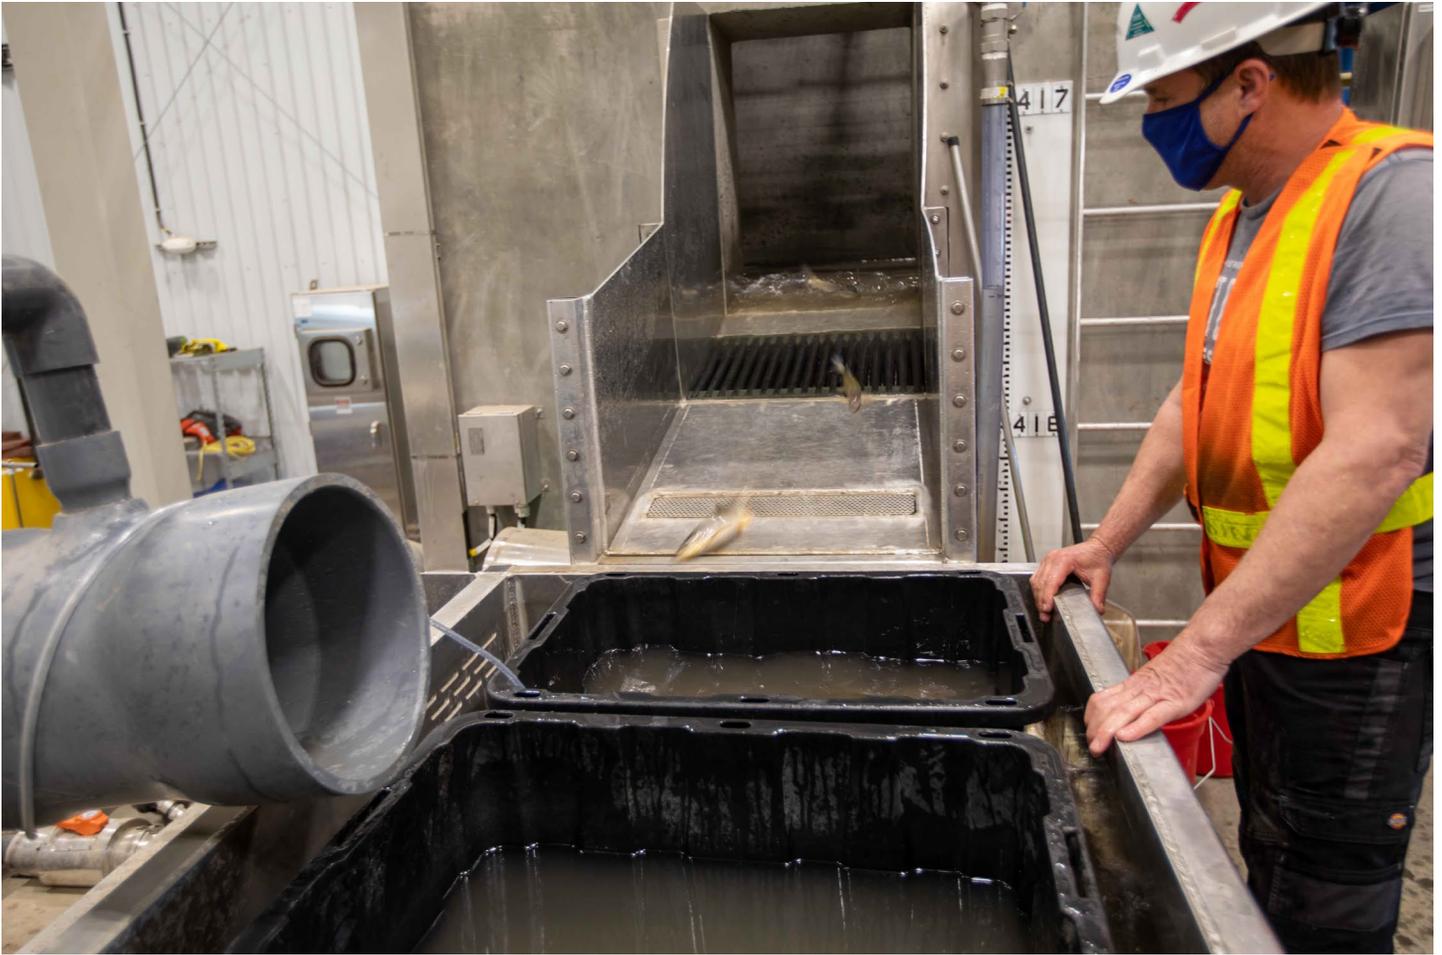
**Photo 2.** Fish exit a lock into an anaesthetic tank prior to sampling and tagging in the sorting facility (June 21, 2021).

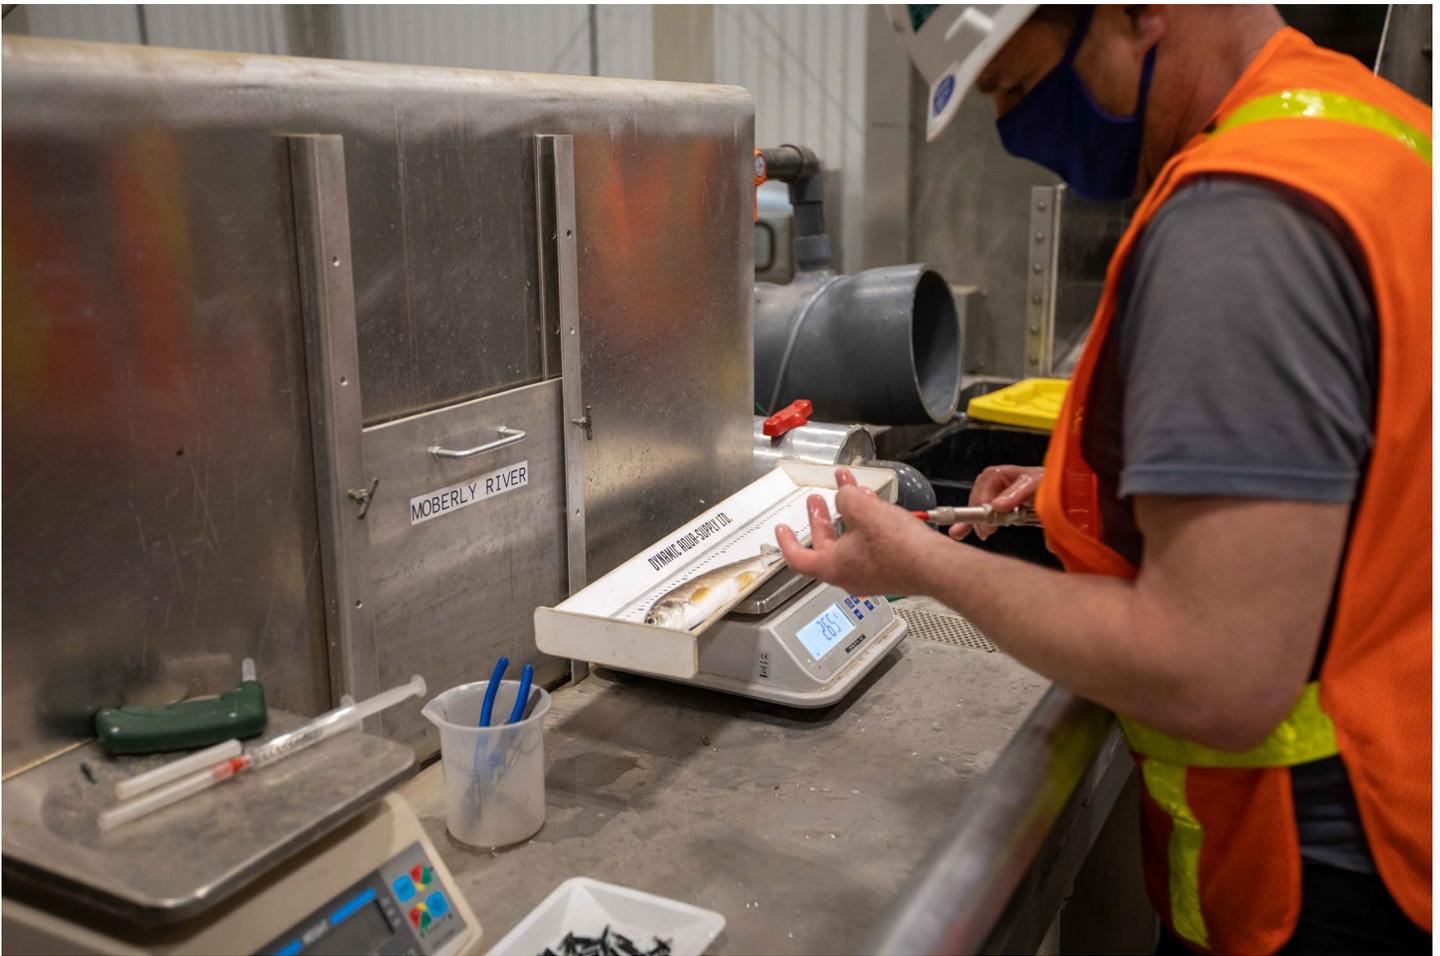
**Photo 3.** Facility operator samples and tags a Mountain Whitefish in the sorting facility (June 21, 2021).

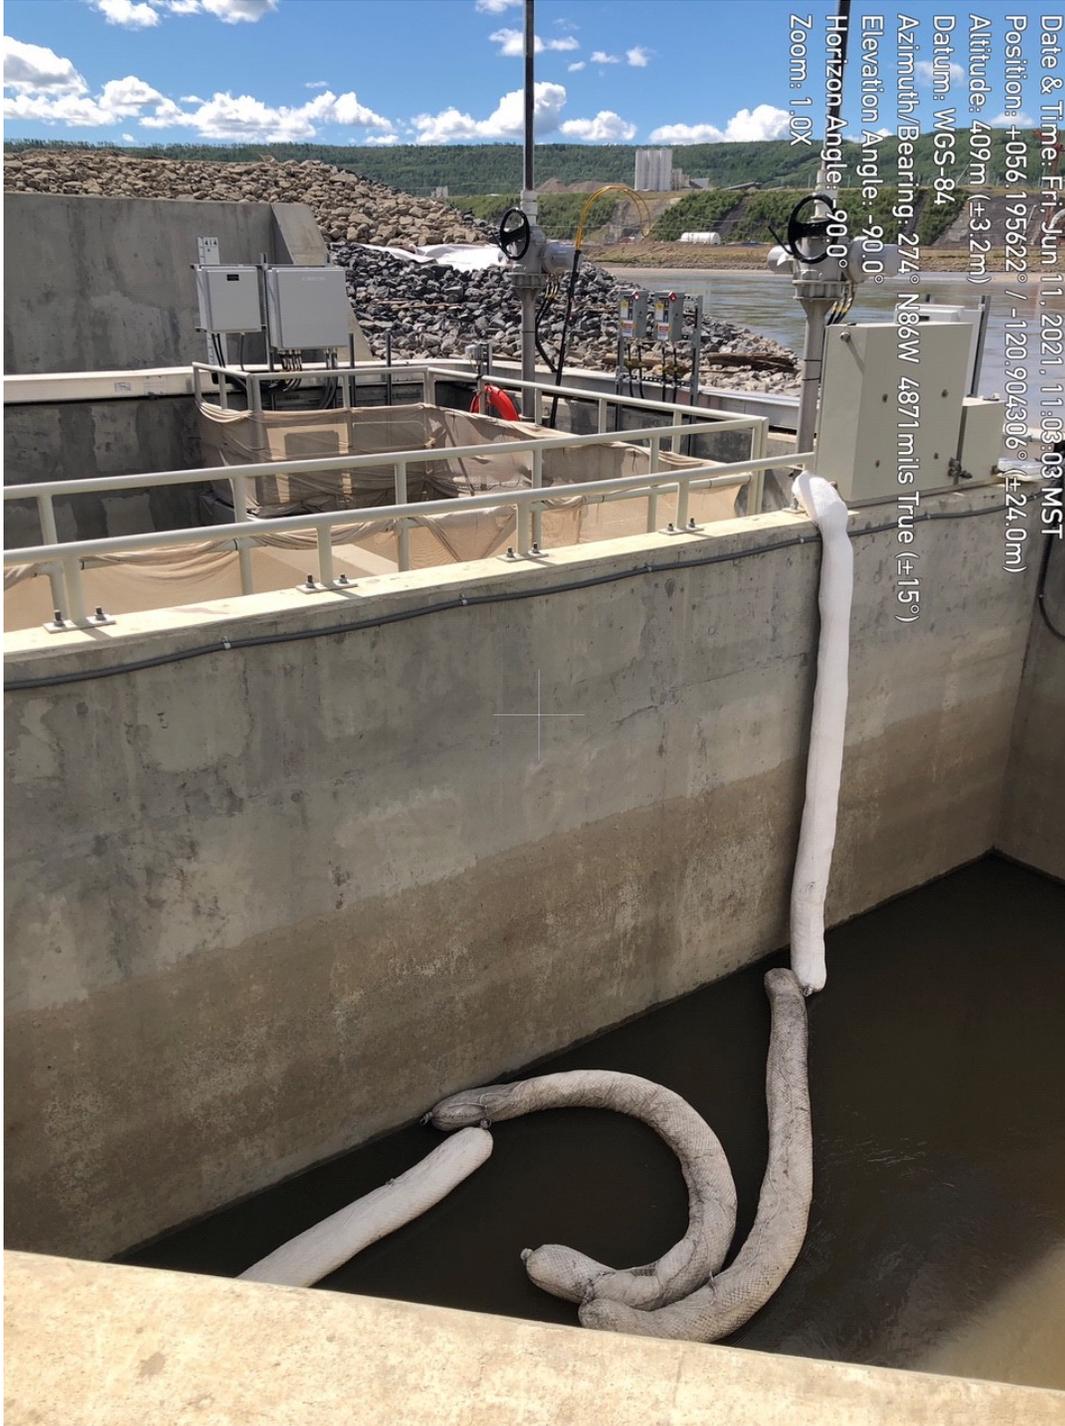
On June 11 and 29 the facility operator observed a sheen on the surface of the water in the West Auxillary Water Supply (AWS) Receiving Pool and immediately shut down the facility. Given that the sheen may have been oil, and to mitigate the risk of oil being released into the Peace River, the operator deployed an absorbent boom in the pool and closed the entrance gates (Photo 4). On both occasions, laboratory analysis of collected water samples confirmed that the sheen was not hydrocarbon-based and was instead of natural origin. Operations began shortly after receiving results from the laboratory.

**Photo 4.** An absorbent boom was deployed in the West AWS Receiving Pool and the entrance gates were closed to mitigate the risk of oil being released into the Peace River (June 11, 2021). Laboratory analysis of the water sample confirmed that the sheen was not hydrocarbon-based and was instead of natural origin.

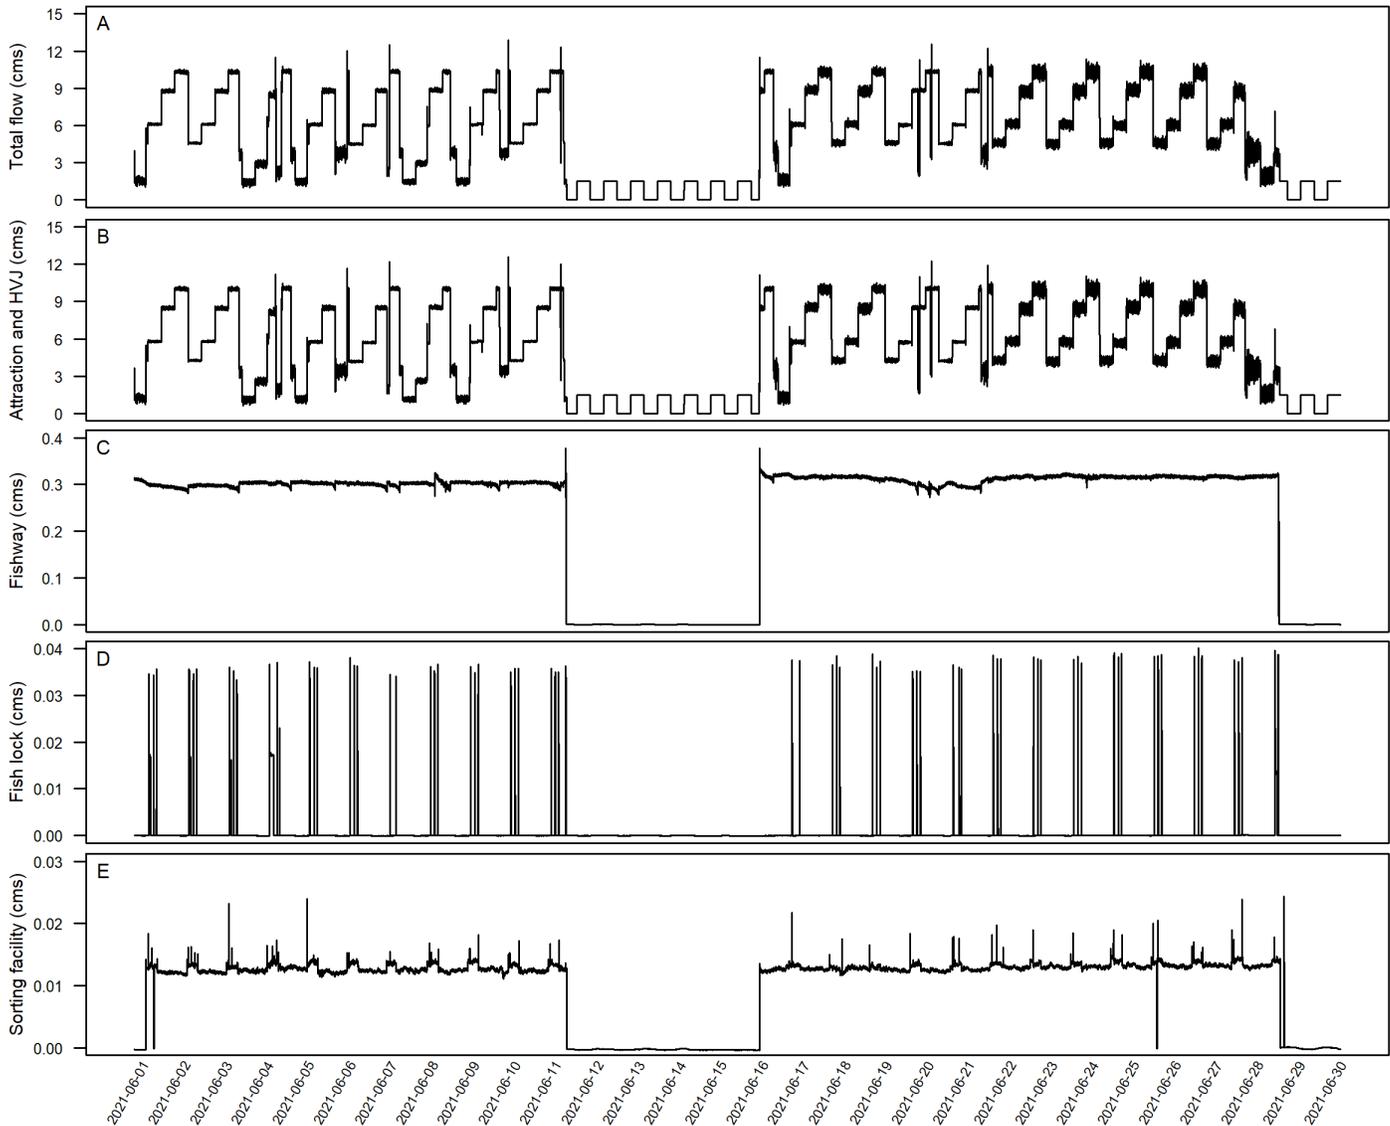
**Appendix II.** (A) Total flow (cms) diverted from the Peace River to operate the temporary facility during the reporting period. Total flow is a combination of flows used for the attraction flows and high velocity jet (B), fishway (C), fish lock (D), and sorting facility (E), as described in T023 Plan for Measurement of Flow. Under Conditional Water Licence 133987<sup>8</sup>, BC Hydro is authorized to divert up to 15 cms of flow from the Peace River to operate the temporary facility; this authorized quantity was not exceeded during the reporting period (A).
