Site C Clean Energy Project

Temporary Upstream Fish Passage Facility Operations Report

Reporting Period: September 1 to 15, 2024

Prepared by BC Hydro

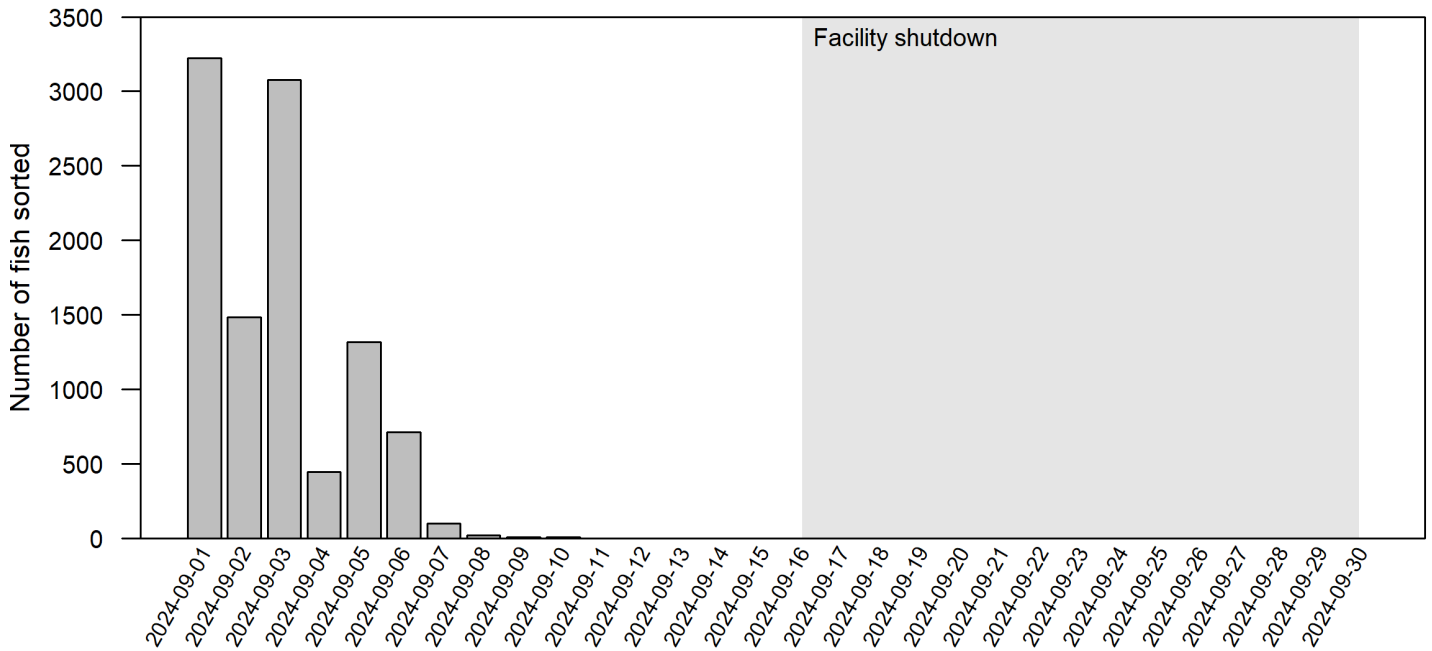
Between 2 and 3222 fish were sorted daily during the reporting period (Figure 1).

Figure 1. Daily number of fish sorted in the temporary facility during the reporting period.

In total, 10420 fish were sorted in the temporary facility during the reporting period (Table 1; Figure 1). Two mortalities were observed during the reporting period (0.4% of all fish sorted in 2024), which is in-line with the anticipated levels of mortality during operations³.

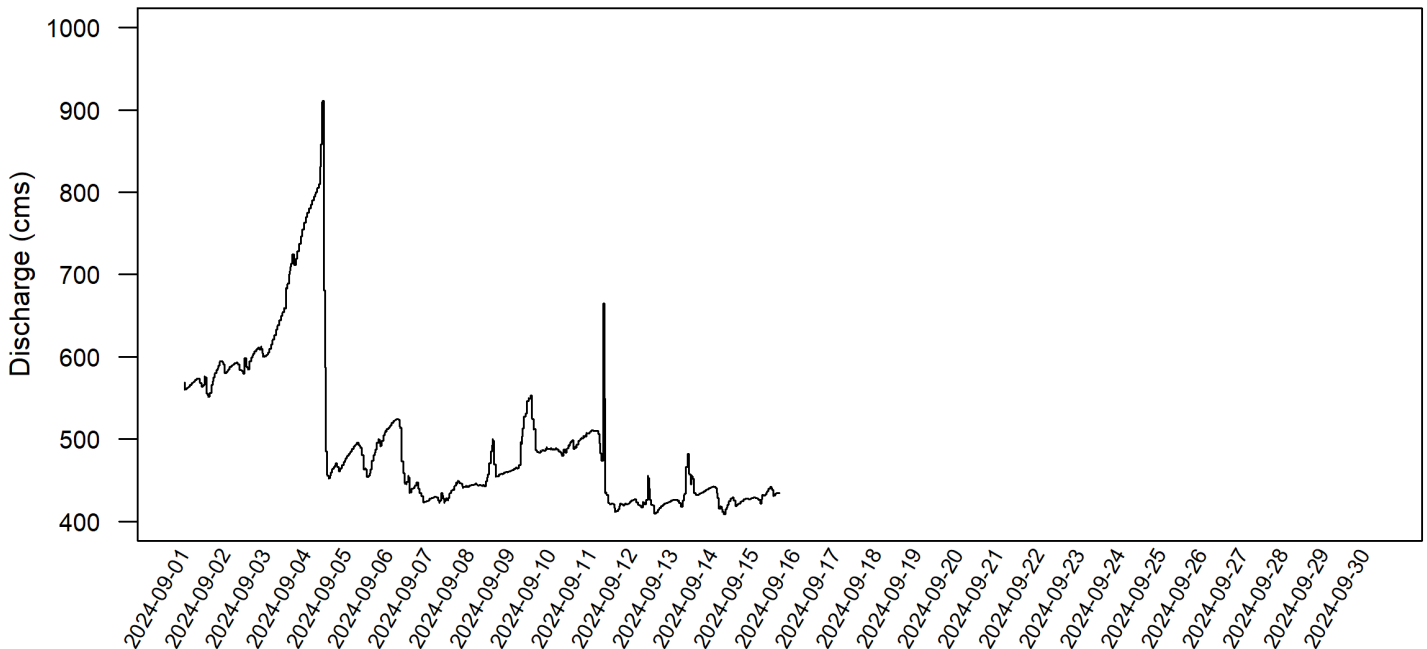
Discharge in the Peace River fluctuated during the reporting period from a low of 409 cms on September 14 to a high of 911 cms on September 4 (Figure 2). Flows were reduced on September 4 to allow the closure of Diversion Tunnel #2 and to facilitate filling the Site C Reservoir.

Figure 2. Discharge in the Peace River during the reporting period as measured at the Peace River above Pine River (07FA004) Water Survey of Canada (WSC) hydrometric station. Data were downloaded from the WSC on October 3; the downloaded data were provided at 5-minute intervals and were listed as provisional by the WSC.

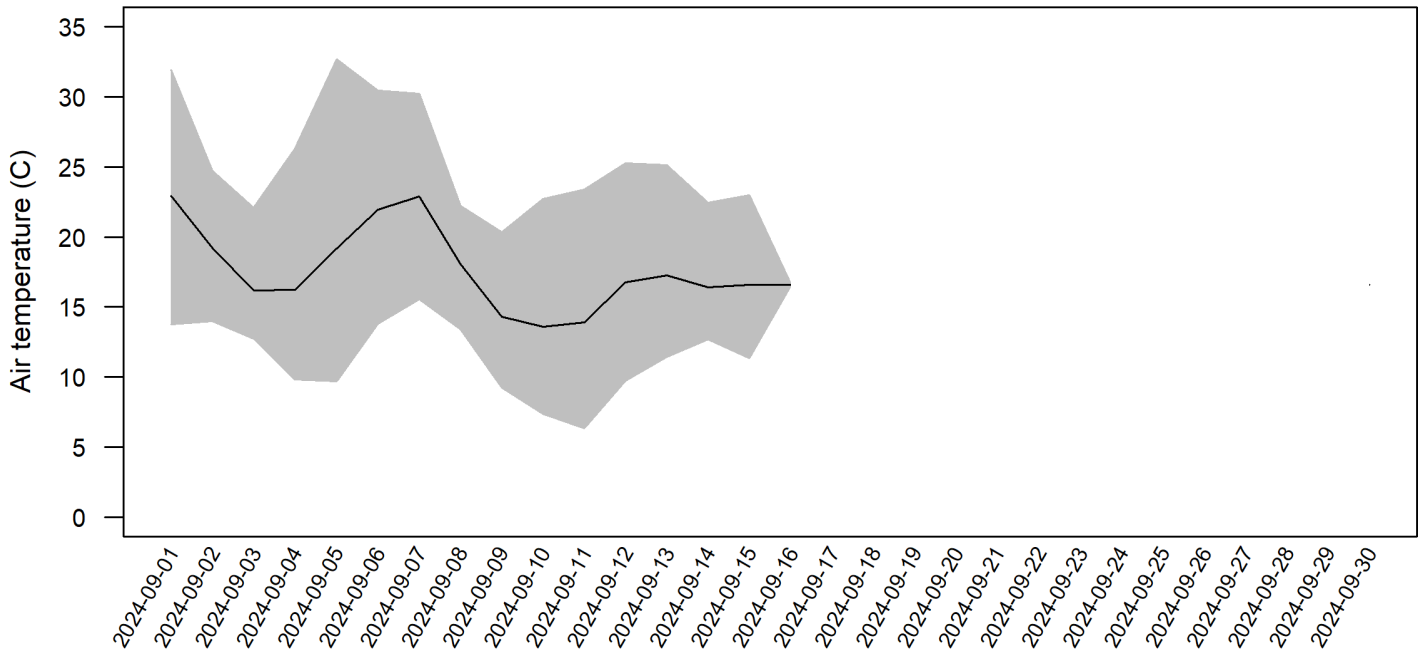
Air temperature fluctuated during the reporting period from a low of 6.4°C on September 11 to a high of 32.7°C on September 5 (Figure 3).

Figure 3. Mean daily air temperature (black line; °C) during the reporting period as measured by a temperature sensor at the temporary facility (TT-602). Shaded area represents the minimum and maximum daily air temperatures.

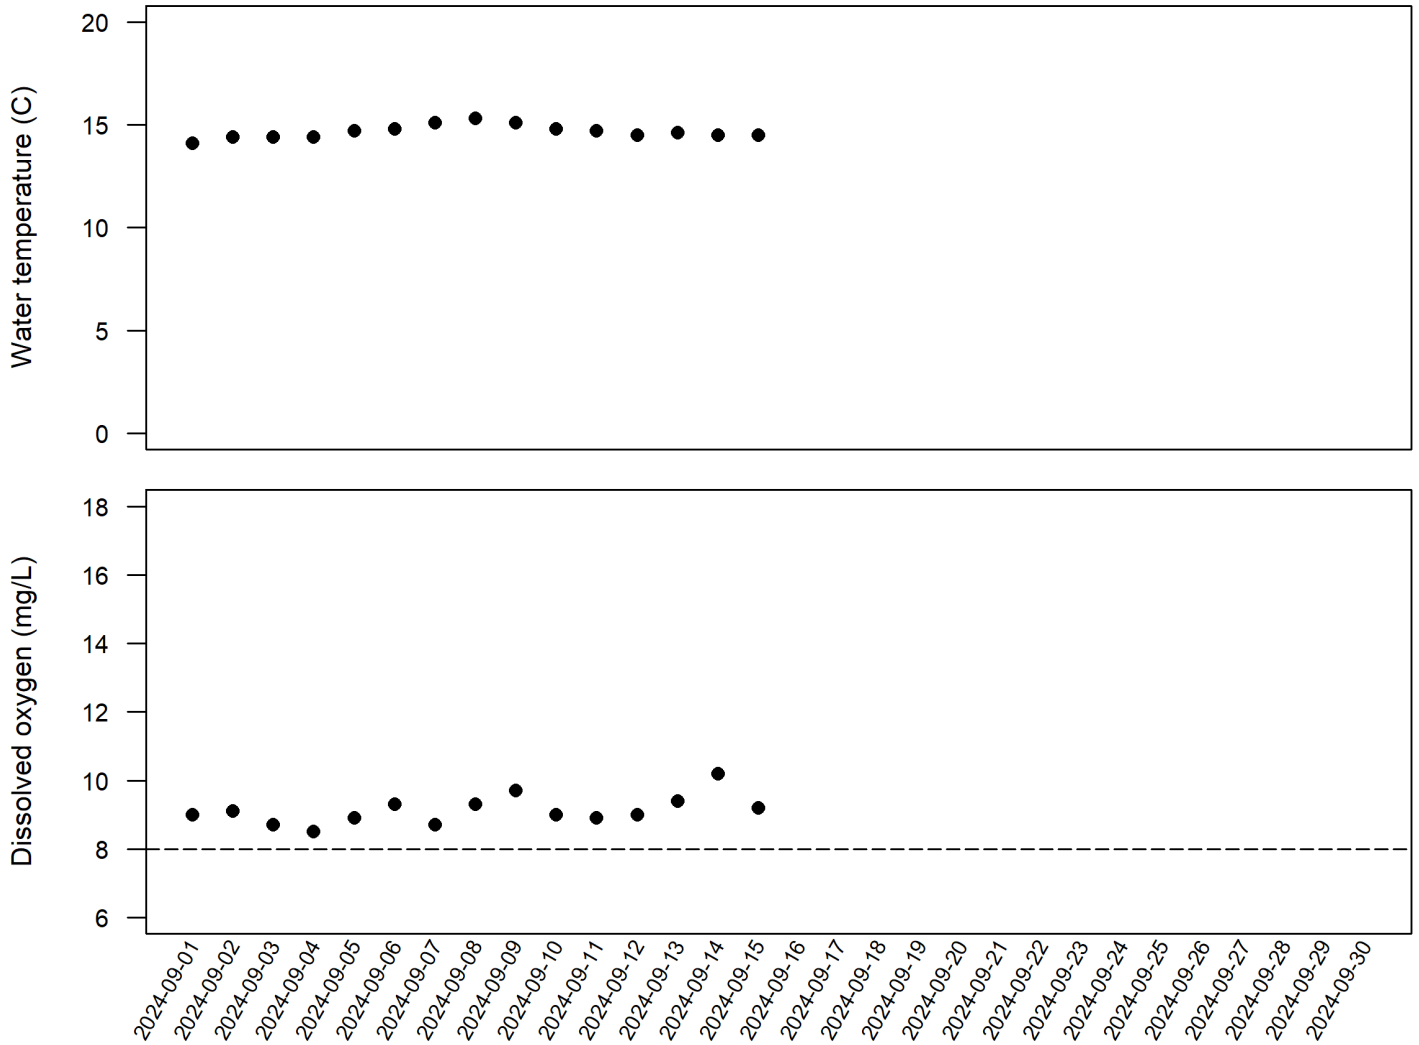
Water temperature remained stable during the reporting period (Figure 4). Dissolved oxygen remained above the minimum dissolved oxygen level (8.0 mg/L) described in the design report of the temporary facility.

Figure 4. Daily water temperature (°C) and dissolved oxygen (mg/L) during the reporting period as measured in Pool 25 of the temporary facility.

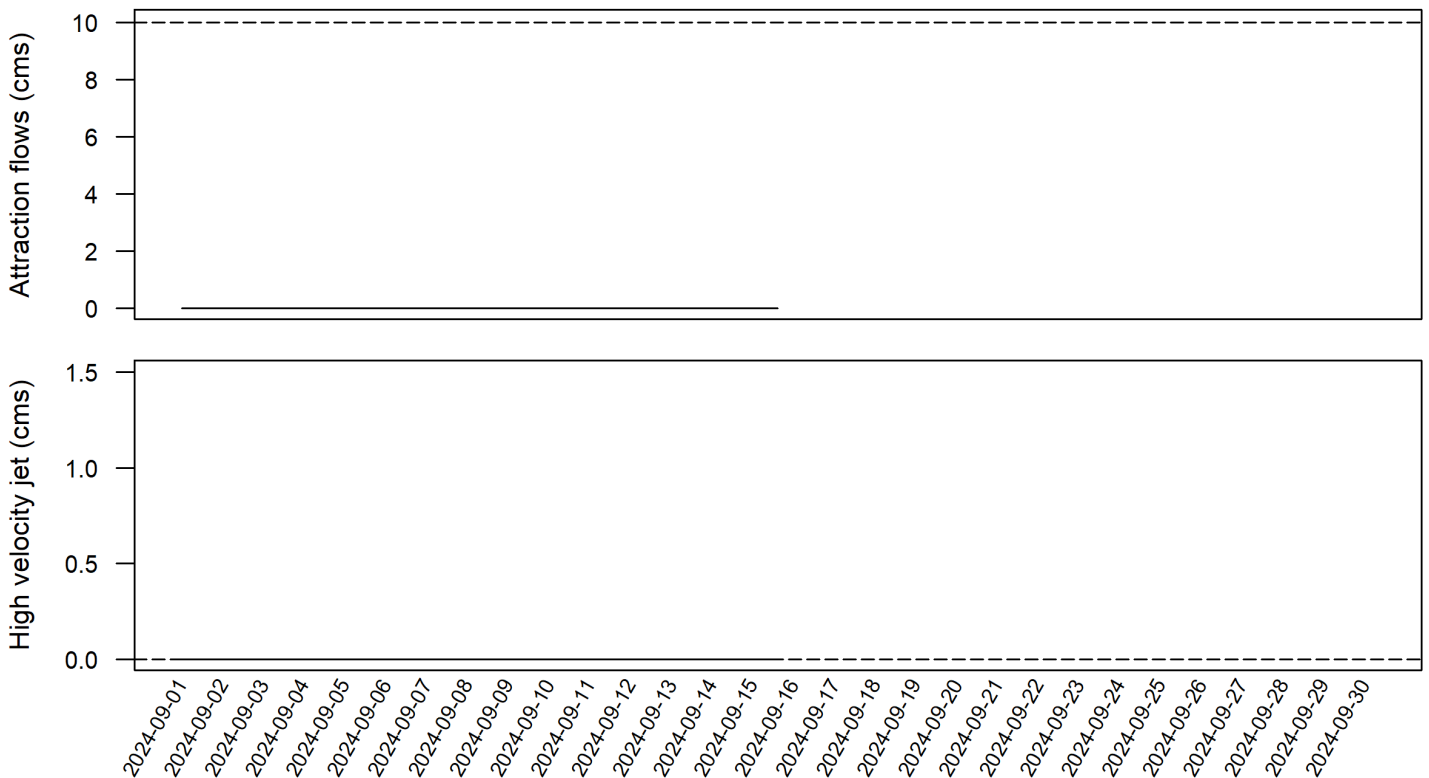
In 2024, BC Hydro intended to operate the attraction flows and high velocity jet at 10 cms and 0 cms, respectively (horizontal dashed lines in Figure 5). However, within the first week of operations, the attraction flows steadily declined and system alarms indicated electrical faults with the horizontal propeller pumps. BC Hydro 'turned off' the horizontal propeller pumps on April 5, 2024 and removed them from the pump station for a detailed inspection on April 15, 2024. As such, there were no attraction flows during the reporting period. BC Hydro turned off the high velocity jet on May 23 as water levels were not being maintained in the pump station to reliably operate the pump.

Figure 5. Operation of the attraction flows and high velocity jet during the reporting period.

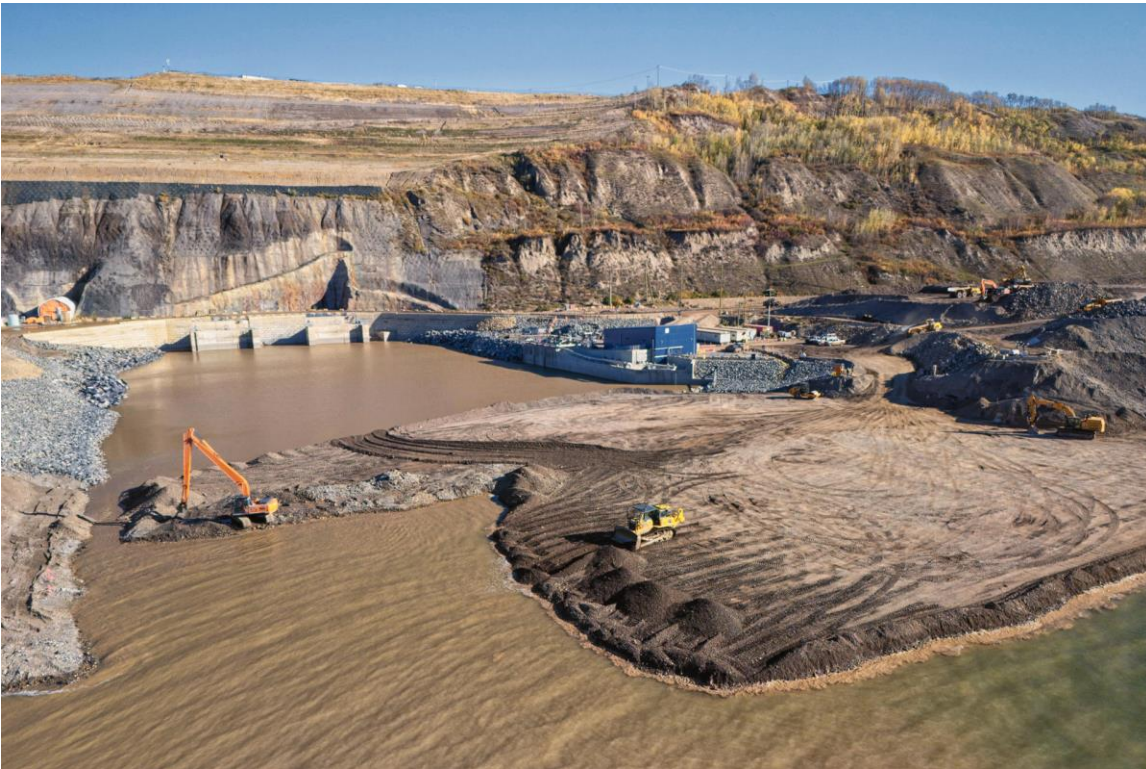
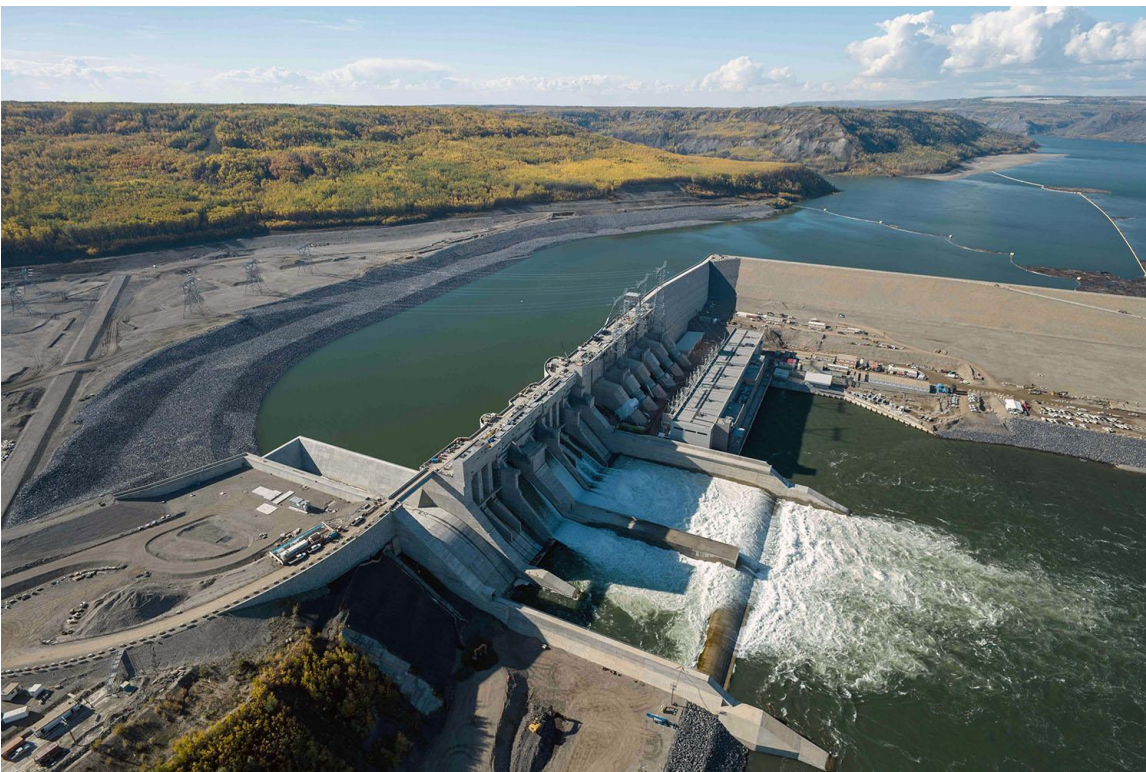
Photo 1. BC Hydro operated the temporary facility until the diversion tunnel outlet closure cofferdam work began on September 16 (top: September 27, 2024). Low level outlet gates and spillway operating gates were used to maintain flows in the Peace River downstream of the Project during the reporting period (bottom: September 29, 2024).

Following a single crowd on September 15, the facility was permanently shutdown in advance of the diversion tunnel outlet closure cofferdam work commencing on September 16 (Photo 1).

Date	Standby or shutdown	Rationale
2024-09-15 09:12	Shutdown	BC Hydro operated the temporary facility from September 1 to 15 and then shutdown the facility on September 15 at 09:12 (Photo 1).

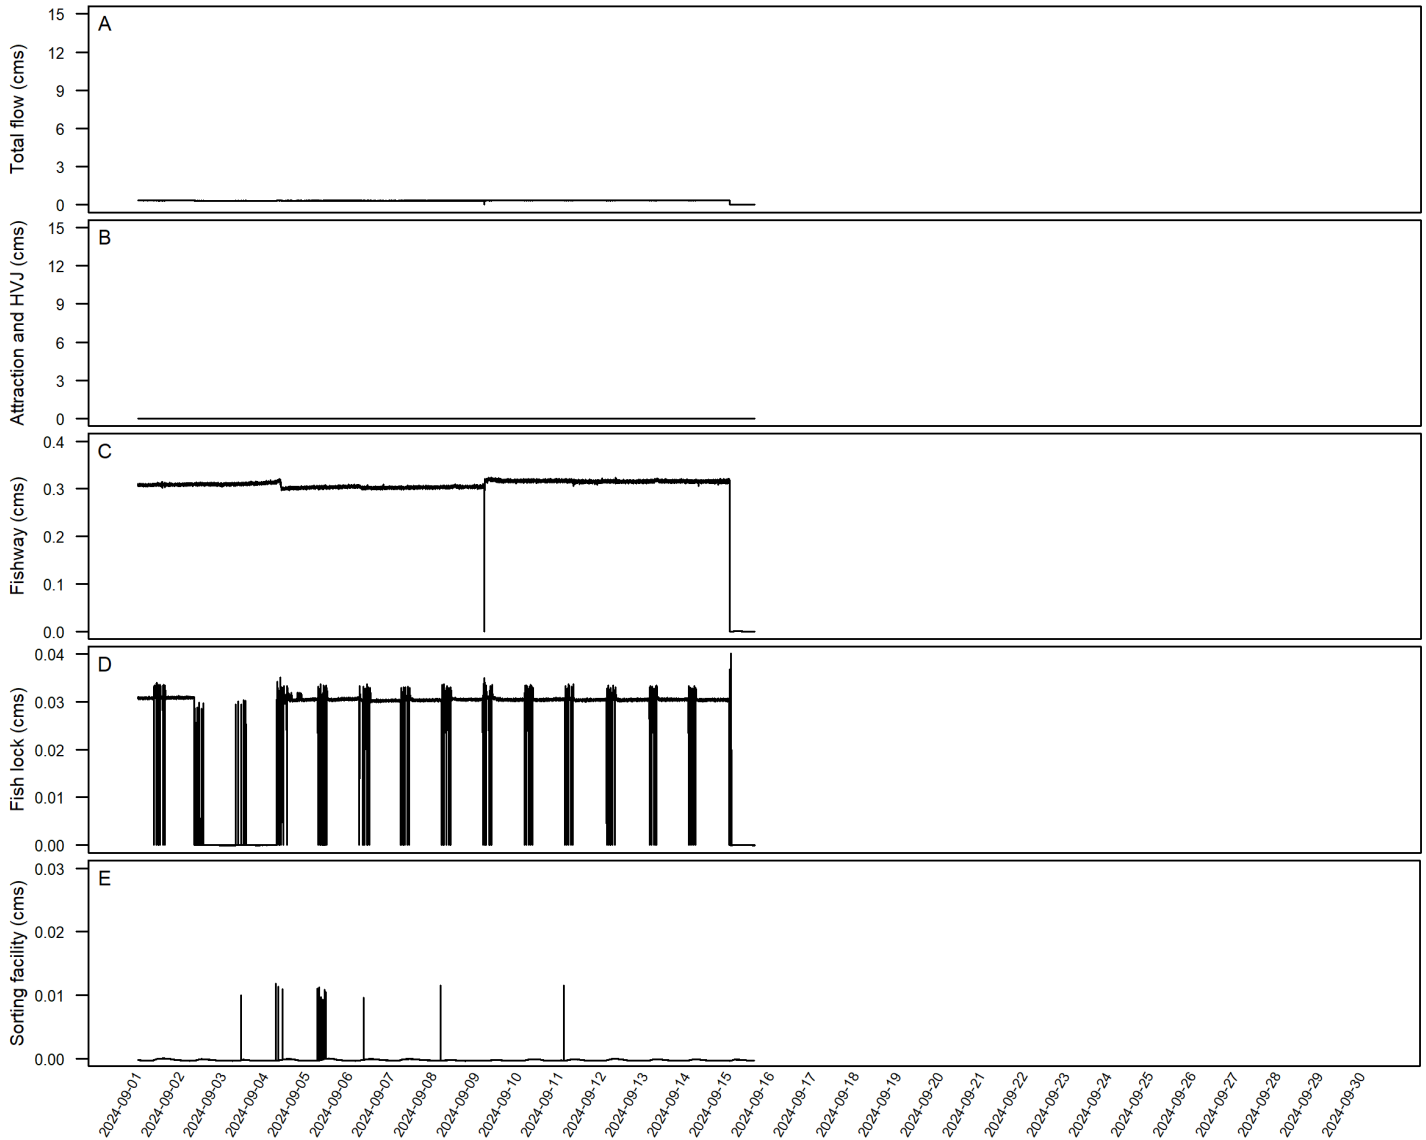
Appendix I. (A) Total flow (cms) diverted from the Peace River to operate the temporary facility during the reporting period. Total flow is a combination of flows used for the attraction flows and high velocity jet (B), fishway (C), fish lock (D), and sorting facility (E), as described in T023 Plan for Measurement of Flow. Under Conditional Water Licence 133987⁴, BC Hydro is authorized to divert up to 15 cms of flow from the Peace River to operate the temporary facility; this authorized quantity was not exceeded during the reporting period (A).

Appendix I summarizes the total flow diverted from the Peace River to operate the temporary facility during the reporting period.
