## **Site C Clean Energy Project**

### **Temporary Upstream Fish Passage Facility Operations Report**

**Reporting Period: June 1 to 30, 2022**

Prepared by BC Hydro

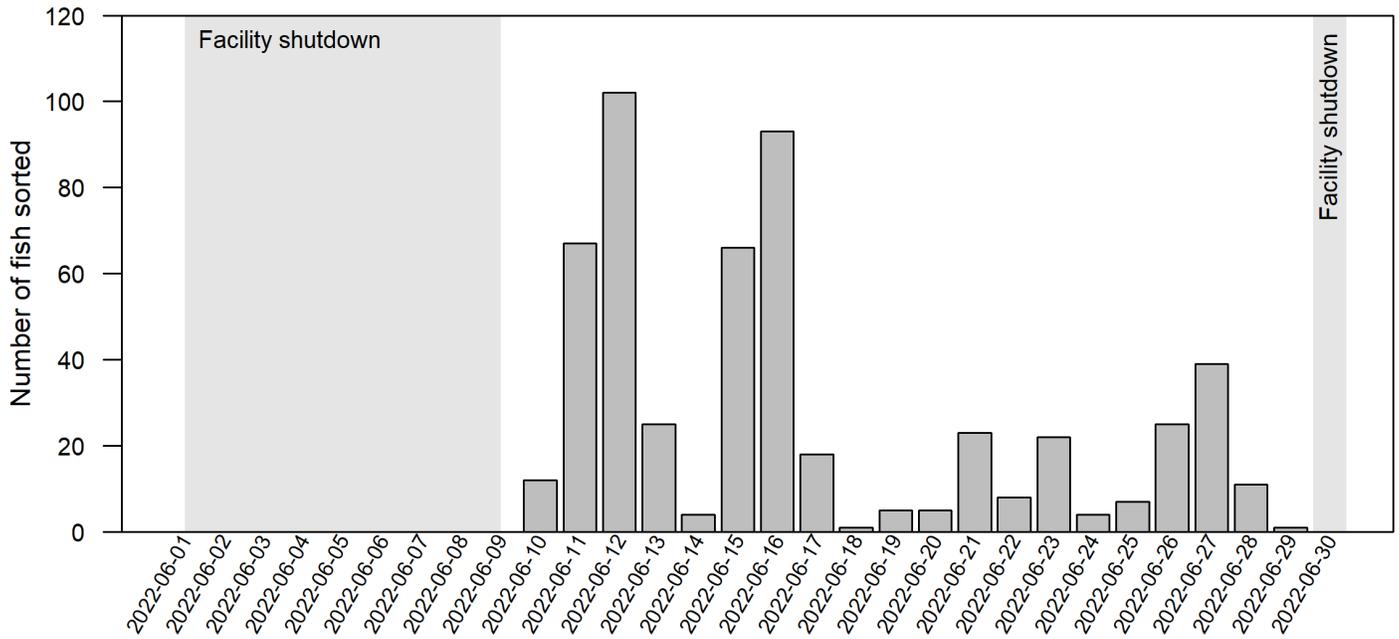
**Figure 1.** Daily number of fish sorted in the temporary facility during the reporting period.

Between zero and 102 fish were sorted daily during the reporting period (Figure 1). Similar rates of passage were observed in [June 2021](#), where 571 fish passed the facility and 392 fish were passed via contingent fish capture.

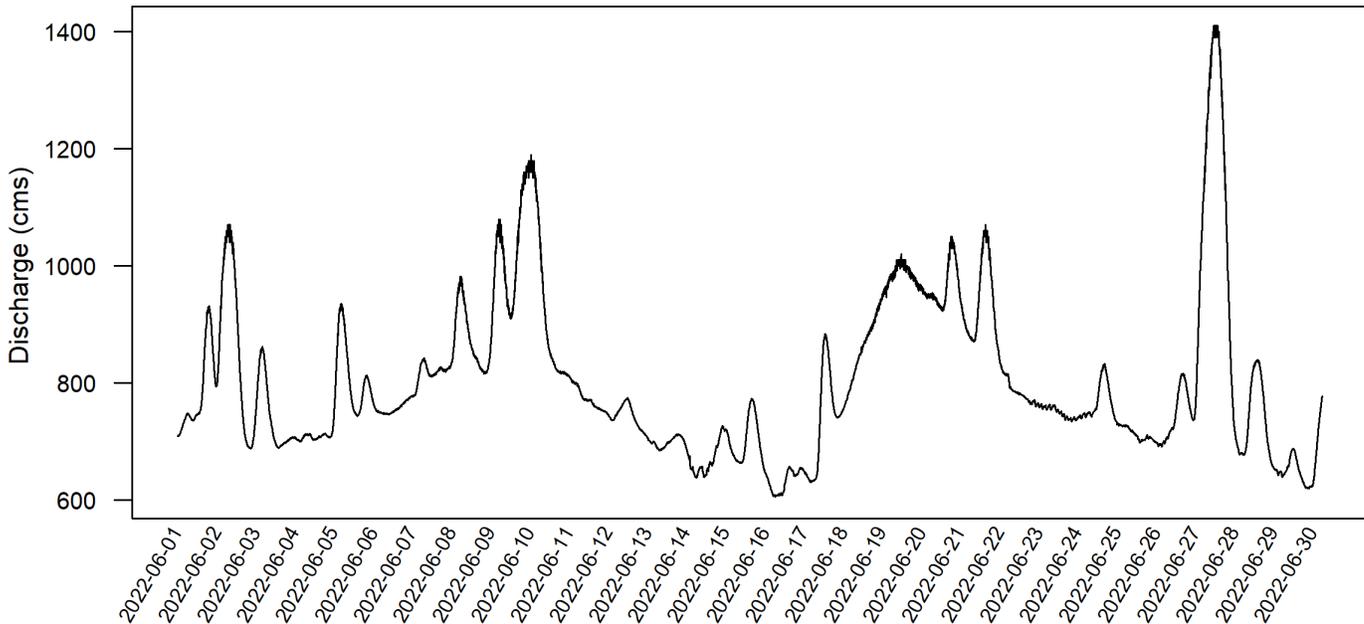
**Figure 2.** Discharge in the Peace River during the reporting period as measured at the Peace River above Pine River (07FA004) Water Survey of Canada (WSC) hydrometric station. Data were downloaded from the WSC on July 5; the downloaded data were provided at 5-minute intervals and were listed as provisional by the WSC.

Discharge in the Peace River fluctuated during the reporting period from a low of 605 cms on June 16 to a high of 1410 cms on June 28 (Figure 2).

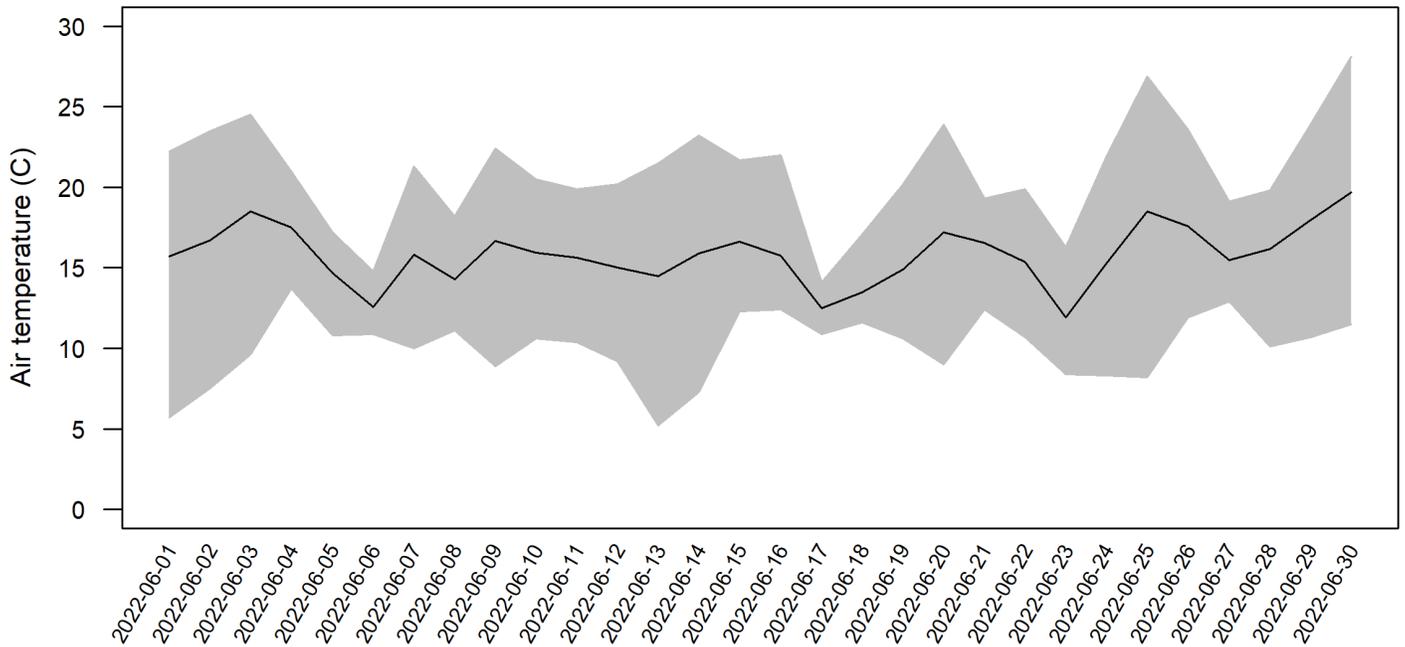
**Figure 3.** Mean daily air temperature (black line; °C) during the reporting period as measured by the provincial air monitoring station located on the dam site at the Site C Workers Accommodation<sup>7</sup> (E309527). Shaded area represents the minimum and maximum daily air temperatures.

Air temperature fluctuated during the reporting period from a low of 5.2°C on June 13 to a high of 28.1°C on June 30 (Figure 3).

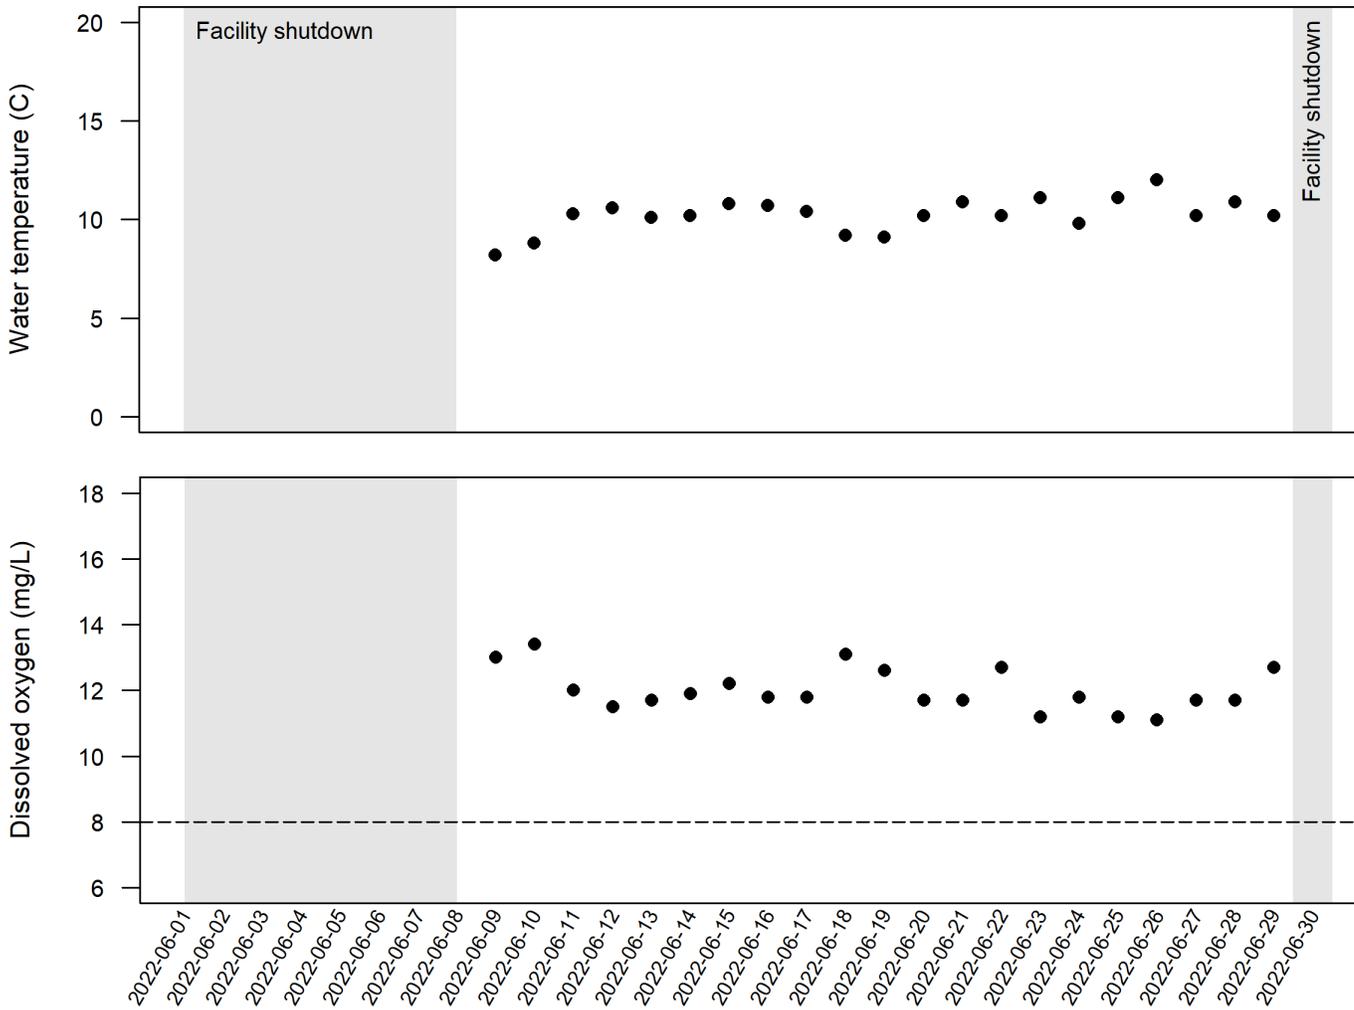
**Figure 4.** Daily water temperature (°C) and dissolved oxygen (mg/L) during the reporting period as measured in the pre-sort holding pool of the temporary facility.

Water temperature steadily increased during the reporting period from a low of 8.2°C on June 9 to a high of 12.0°C on June 26 (Figure 4). Dissolved oxygen remained above the minimum dissolved oxygen level (8.0 mg/L) described in the design report of the temporary facility.

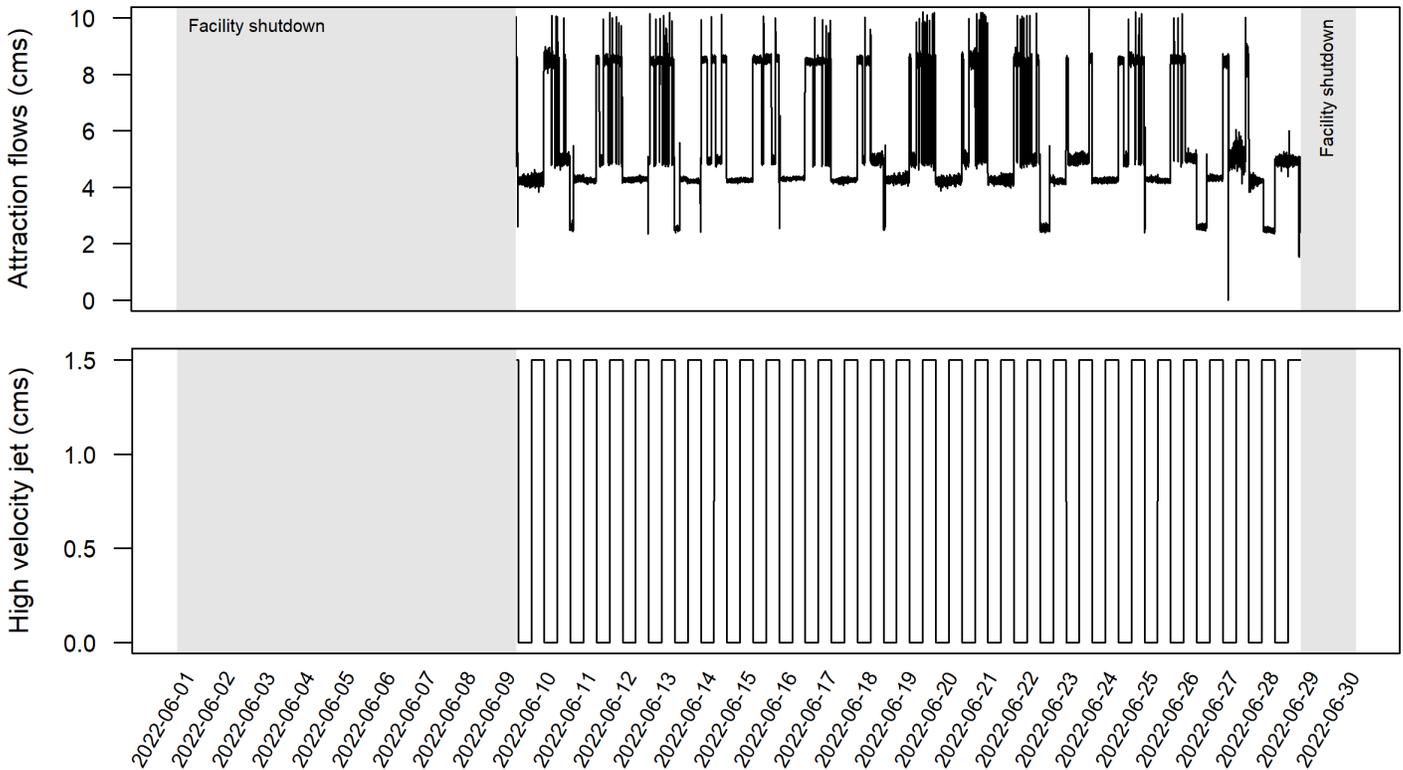
**Figure 5.** Operation of the attraction flows and high velocity jet during the reporting period.

BC Hydro operated the attraction flows and high velocity jet as described in Section 3.2.1.3 of the OPP, whereby conditions were changed every 8 hours during the reporting period (Figure 5), with the exception of June 1 to 9 and June 29 to 30 (Tables 3 and 4).

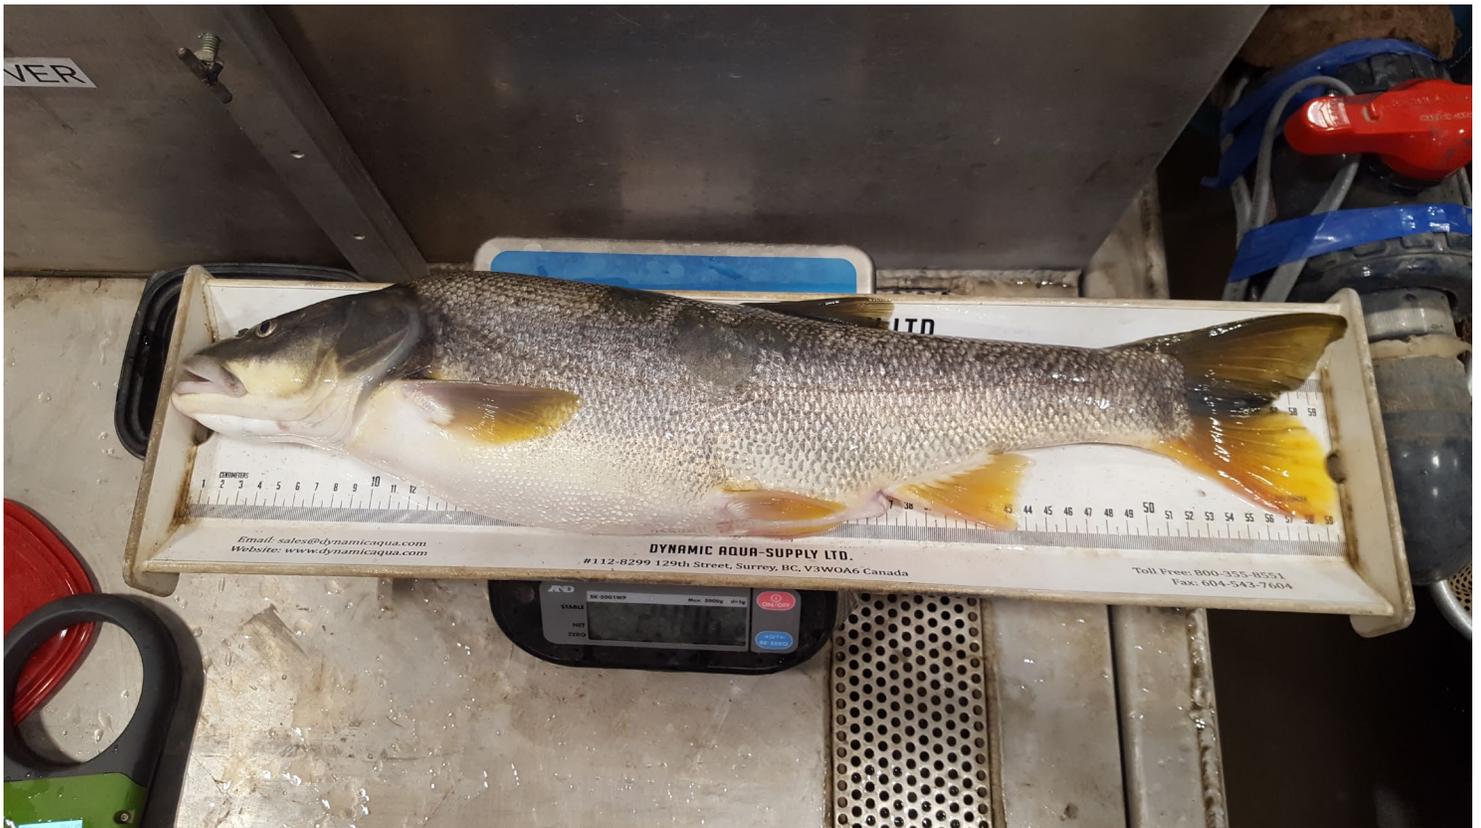
**Photo 1.** Biologists sample a Northern Pikeminnow in the sorting facility, where a distended belly showed signs of spawning (June 25, 2022).

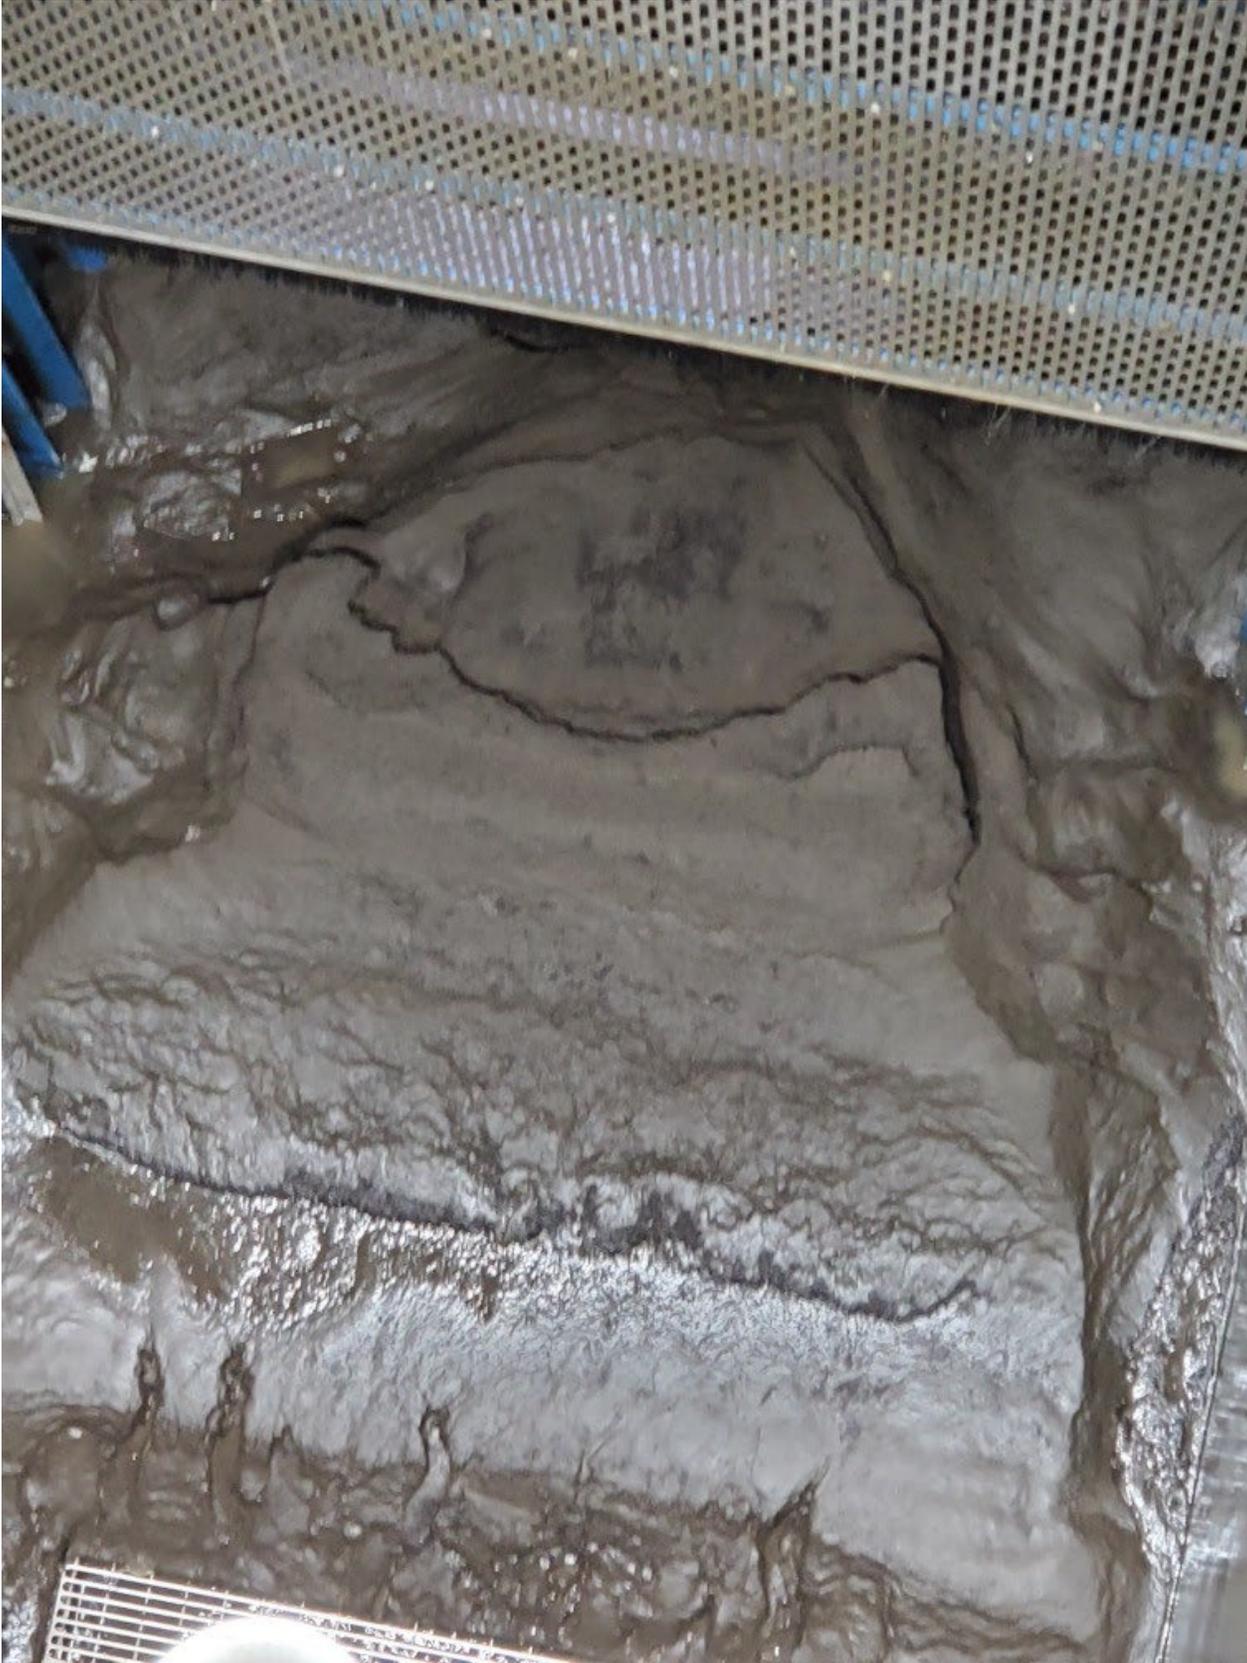
2022-06-29 09:57 to 2022-06-30 15:41	Shutdown	<p>Sediment continued to build up in the pre-sort holding pool (Photo 2), and the operator observed a significant differential between the diversion tunnel outlet and wetwell. BC Hydro kept the facility down to protect mechanical equipment (e.g., pumps) from damage and ensure fish health.</p> <p>BC Hydro conducted the following maintenance and adjustments during this shutdown: (1) clean out the sediment from the pre-sort holding pool, and (2) modify the finger weir and orifice panel and side panels of the vee-trap to strike a balance between increasing trapping efficiency and not causing sediment to build up in the pre-sort holding pool (Table 5).</p>

**Photo 2.** Build up of sediment in the pre-sort holding pool, which required clean out with a hydrovac at the beginning and end of the reporting period (June 29, 2022).

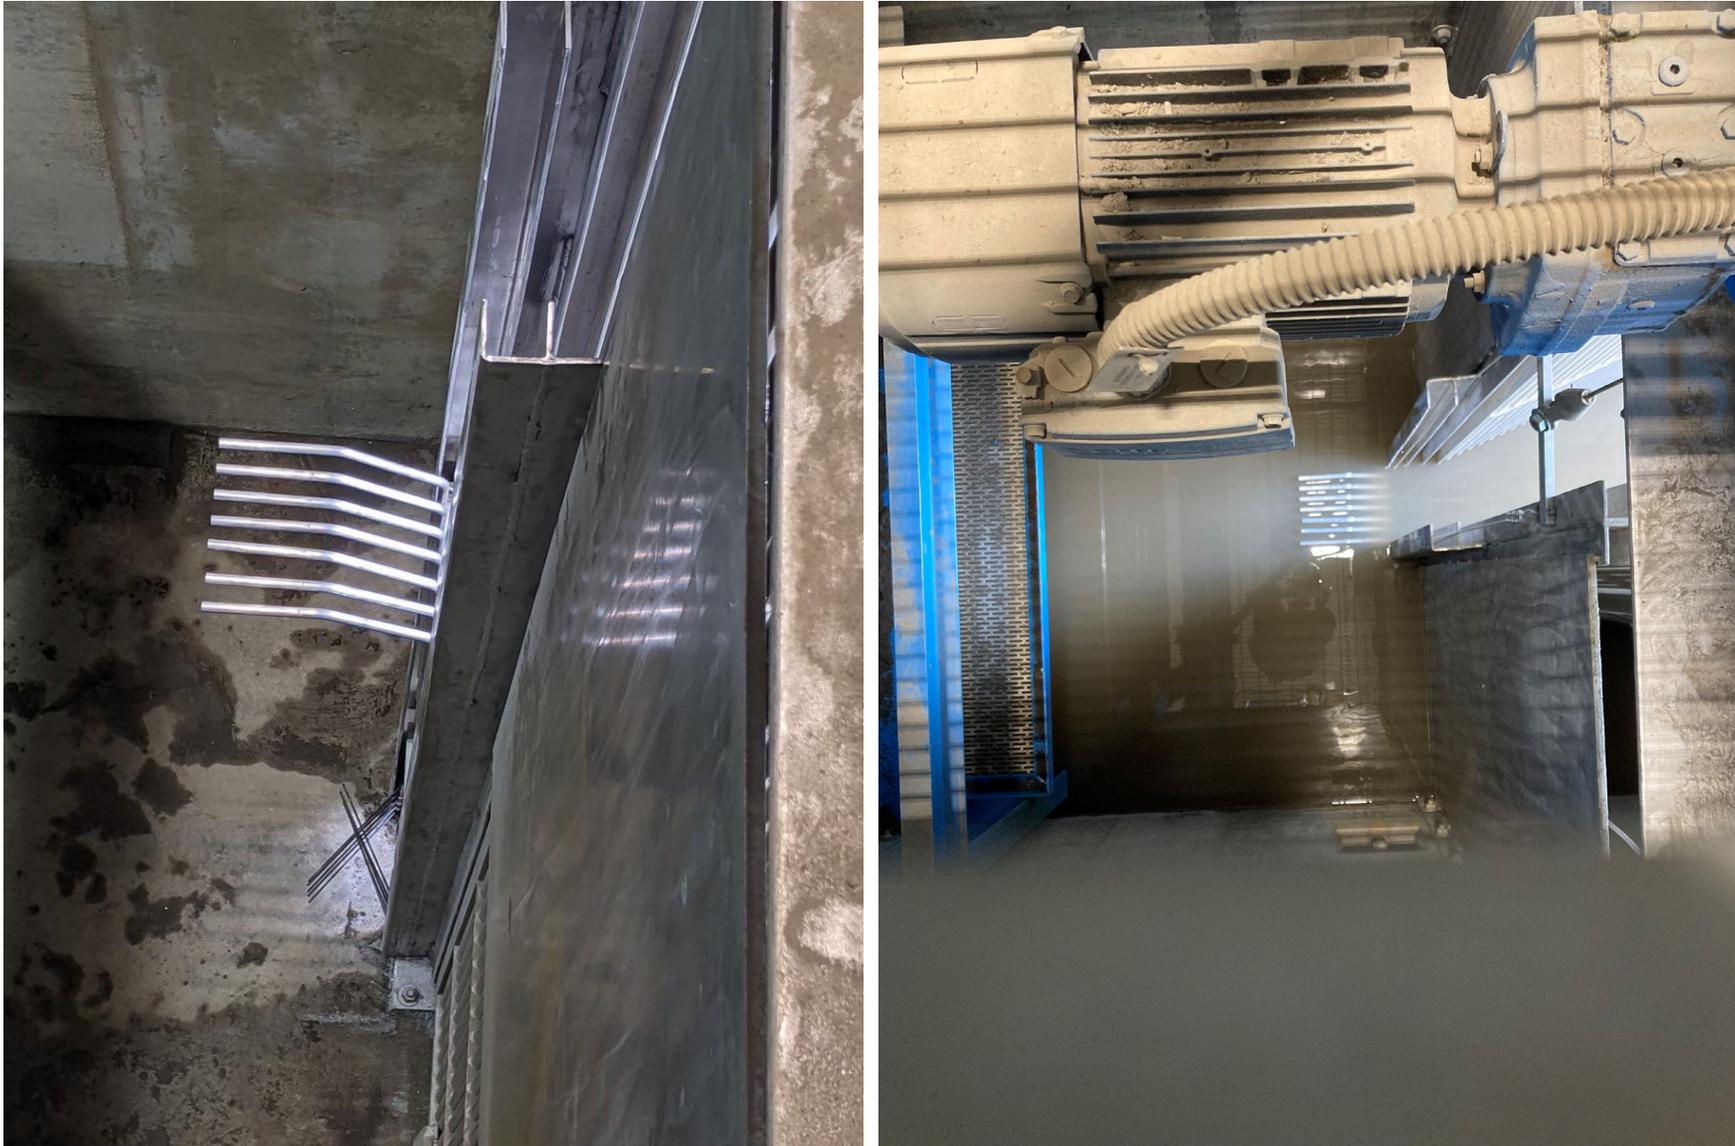
**Photo 3.** BC Hydro installed a finger weir and orifice panel in the vee-trap throat to improve trapping efficiency (left panel; June 9, 2022). Fish can now either swim over the finger weir or through the orifice and cod fingers to enter the pre-sort holding pool. BC Hydro set the finger weir at 23 cm below the water surface to match the existing hydraulic drop between fishway pools (right panel; June 13, 2022).

- On June 8 BC Hydro installed a finger weir and orifice panel in the vee-trap throat to improve trapping efficiency (Photo 3). Fish can now either swim over the finger weir or through the orifice and cod fingers to enter the pre-sort holding pool. BC Hydro set the finger weir at 23 cm below the water surface to match the existing hydraulic drop between fishway pools. Capture rates will be monitored to determine the effectiveness of the adjusted trapping mechanism.

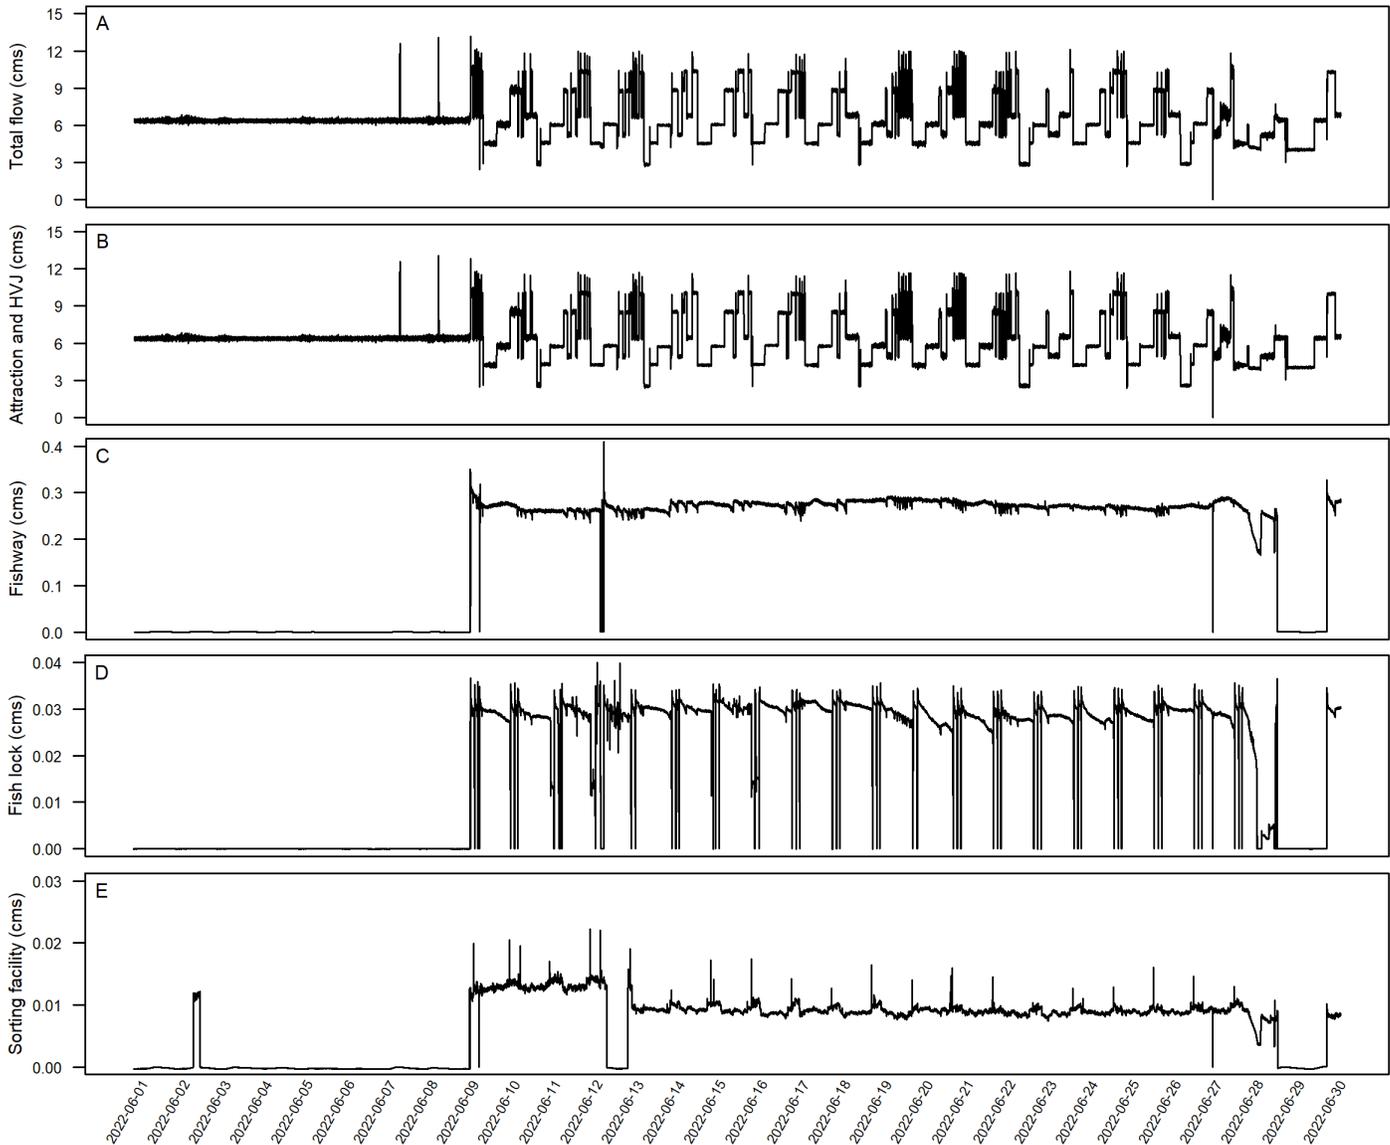
**Appendix II.** (A) Total flow (cms) diverted from the Peace River to operate the temporary facility during the reporting period. Total flow is a combination of flows used for the attraction flows and high velocity jet (B), fishway (C), fish lock (D), and sorting facility (E), as described in T023 Plan for Measurement of Flow. Under Conditional Water Licence 133987<sup>8</sup>, BC Hydro is authorized to divert up to 15 cms of flow from the Peace River to operate the temporary facility; this authorized quantity was not exceeded during the reporting period (A).

Appendix II summarizes the total flow diverted from the Peace River to operate the temporary facility during the reporting period.
