Site C Clean Energy Project

Temporary Upstream Fish Passage Facility Operations Report

Reporting Period: August 1 to 31, 2022

Prepared by BC Hydro

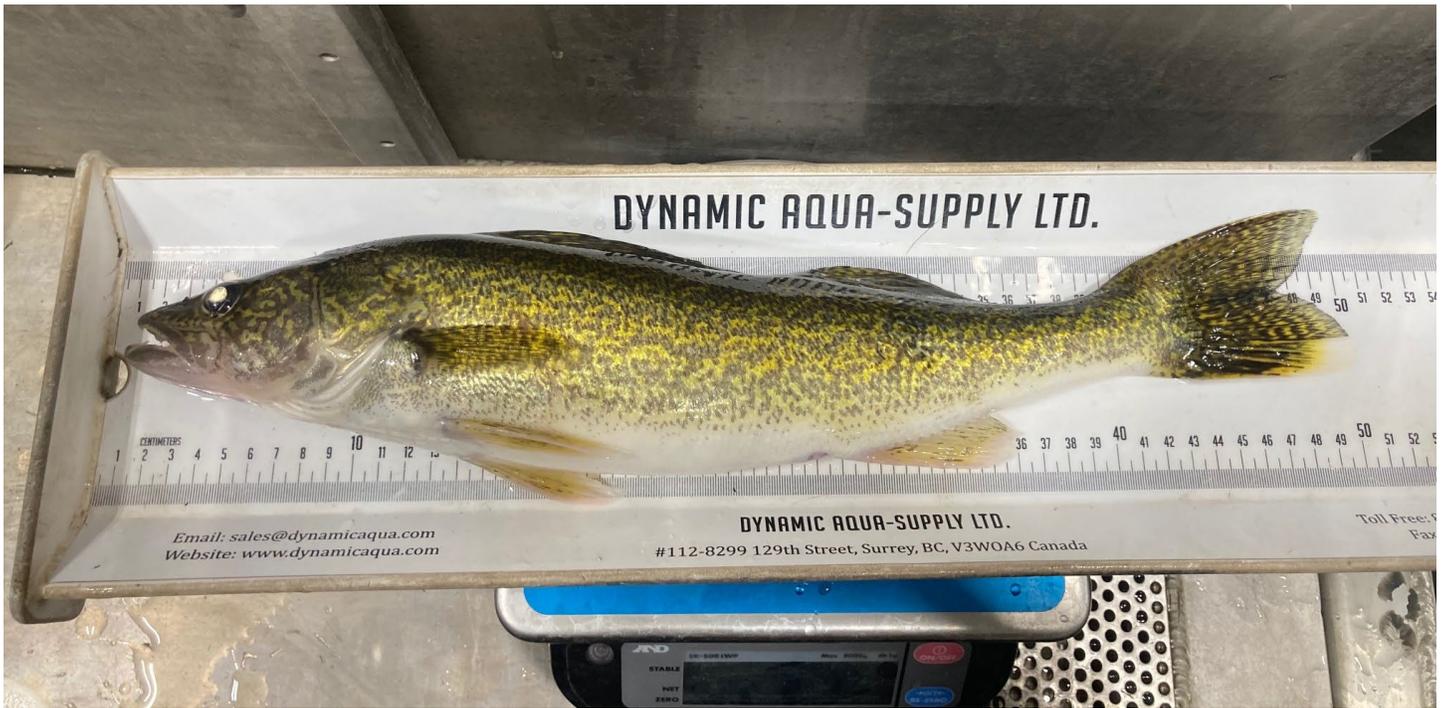
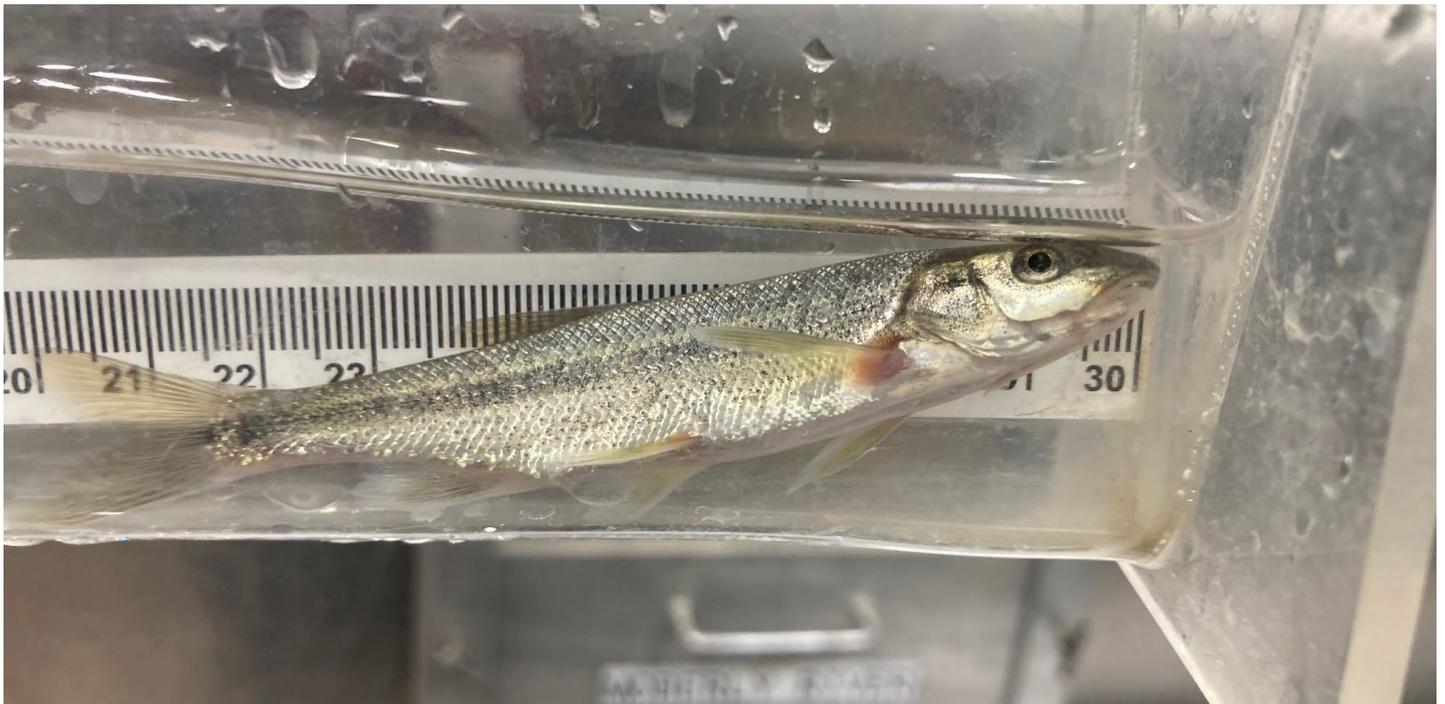
Photo 1. Biologists sample a Walleye (top; August 13, 2022) and Pearl Dace (bottom; August 20, 2022) in the sorting facility; the Walleye was released downstream of the Project as described in the OPP.

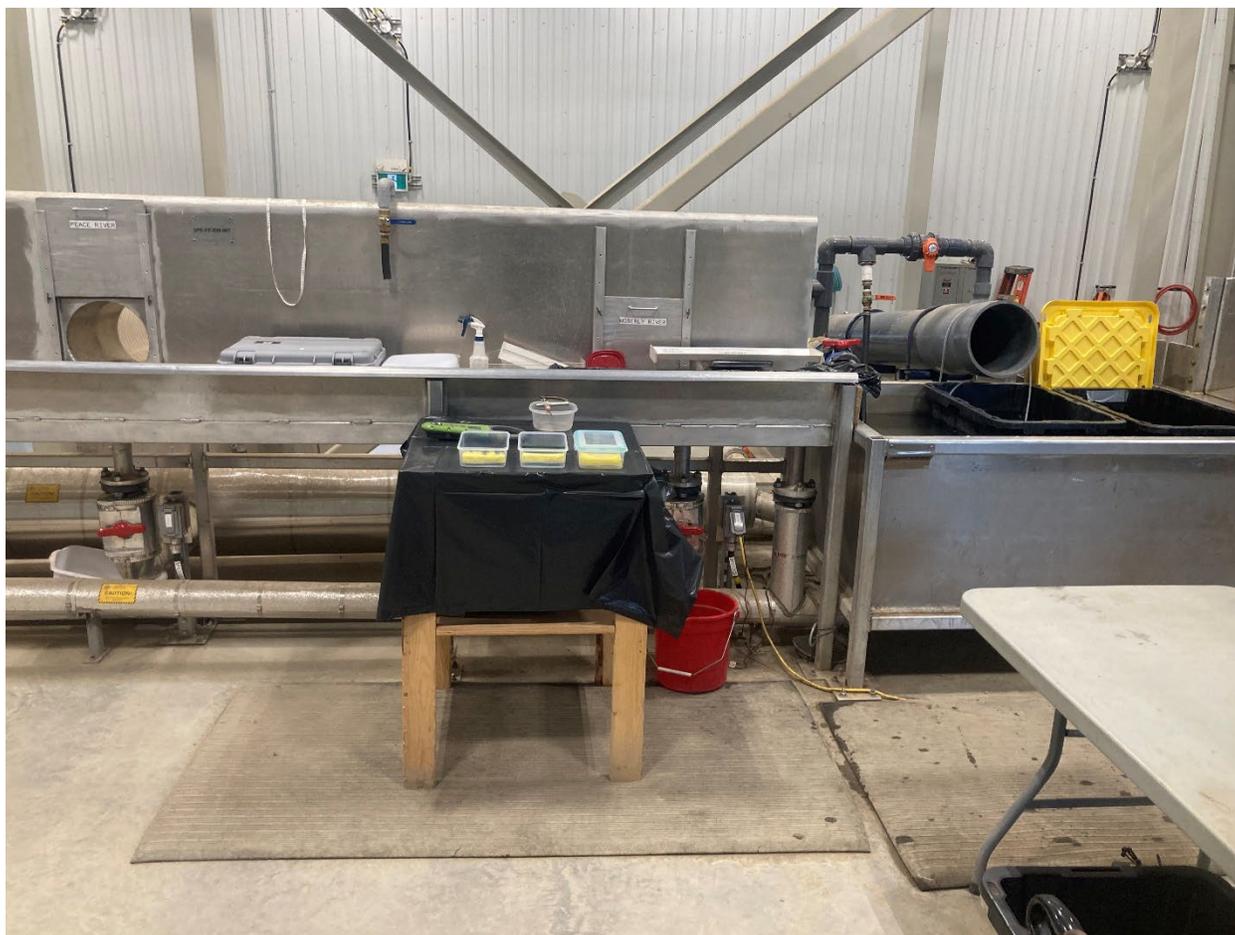
Photo 2. Changes were made to the physical setup of the sorting area to reduce the risk of injury to fish, improve ergonomics and the ability of the operators to communicate with each other, and allow for both individuals to be involved in the tagging and sampling of fish (August 24, 2022).

- Several adjustments were made to improve the efficiency of fish processing. Changes were made to the physical setup of the sorting area to reduce the risk of injury to fish, improve ergonomics and the ability of the operators to communicate with each other, and allow for both individuals to be involved in the tagging and sampling of fish (Photo 2). Changes were also made to the order in which measurements and samples were collected from fish to streamline the process.
