Site C Clean Energy Project

Temporary Upstream Fish Passage Facility Operations Report

Reporting Period: April 1 to 30, 2022

Prepared by BC Hydro

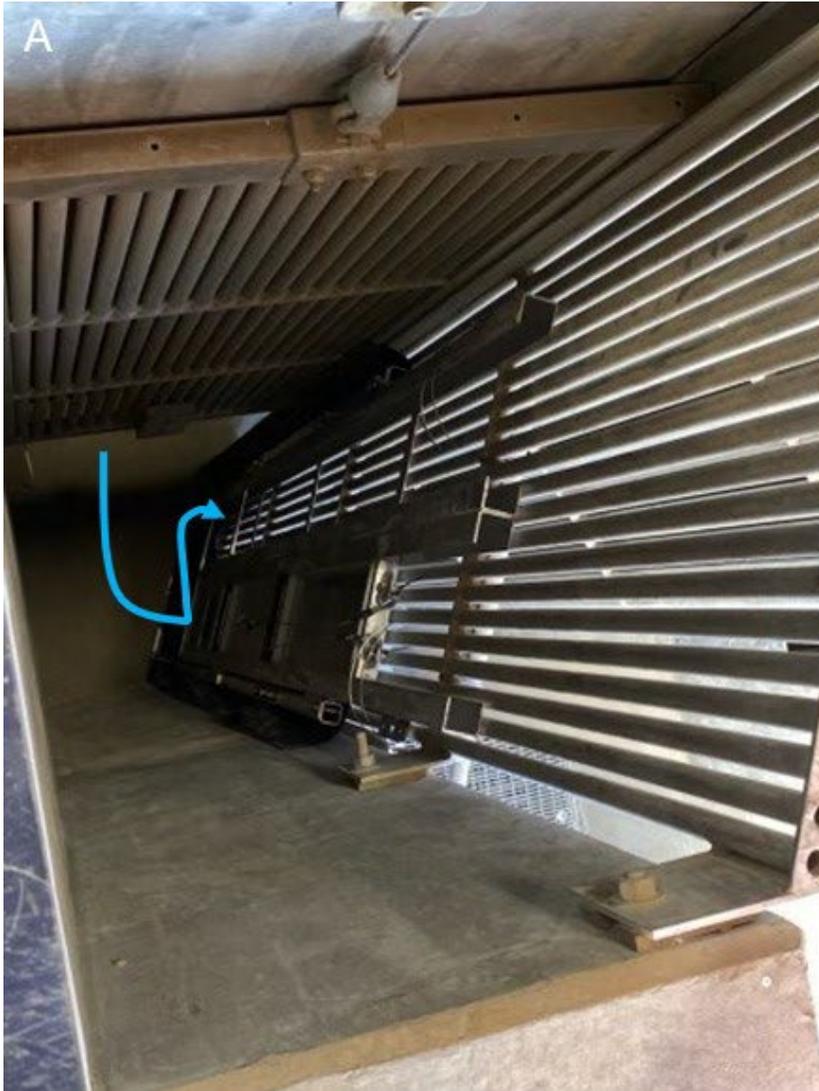
Photo 1. (A) Channels were bolted onto the side arms of the vee-trap and panels were lowered into place to concentrate the flow cue (light blue arrow) through the upstream half of the vee-trap (March 18, 2022). (B) Screenshot of IFC Construction Drawing 1020-M13-00419 showing the vee-trap and spatial context of (A).

Several adjustments to the top of the fishway in [August](#), [September](#) and [October 2021](#) were continued in April 2022 to improve the biological and mechanical operation of the temporary facility. BC Hydro also made some physical modifications to the trapping mechanism (vee-trap) in March 2022 to improve passage into the pre-sort holding pool. Channels were bolted onto the side arms of the vee-trap and panels were lowered into place to concentrate the flow cue through the upstream half of the vee-trap (Photo 1). Where appropriate, the adjustments summarized in Table 5 will be reflected in an updated revision of the OPP for operations in 2023.

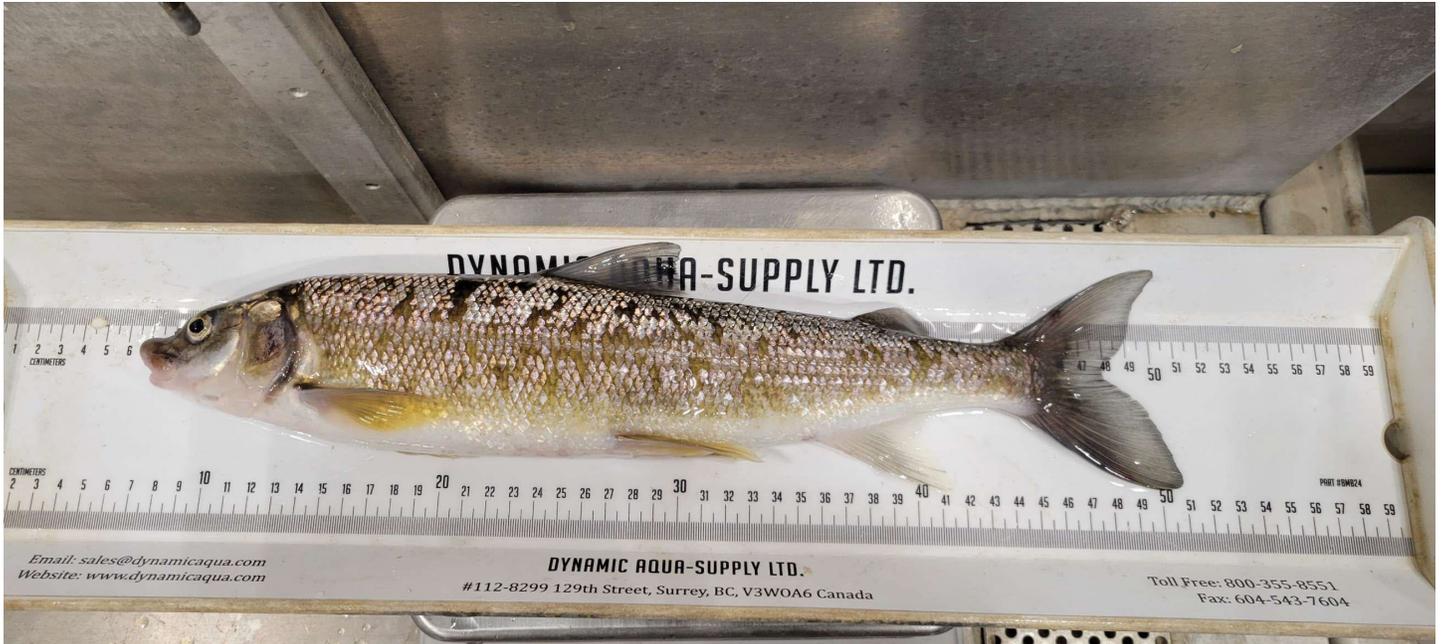
Photo 2. Biologists sample a mortality (Mountain Whitefish) to confirm sex and collect otoliths for microchemistry and ageing analysis (April 22, 2022).

In total, 4 fish were sorted in the temporary facility during the reporting period (Table 1; Figure 1). One mortality (Mountain Whitefish) was observed in the fish lock during the reporting period (25% of all fish sorted in 2022)⁶; this individual had sustained significant scale loss from the operculum to the dorsal fin (Photo 2). Cause of mortality is unknown.

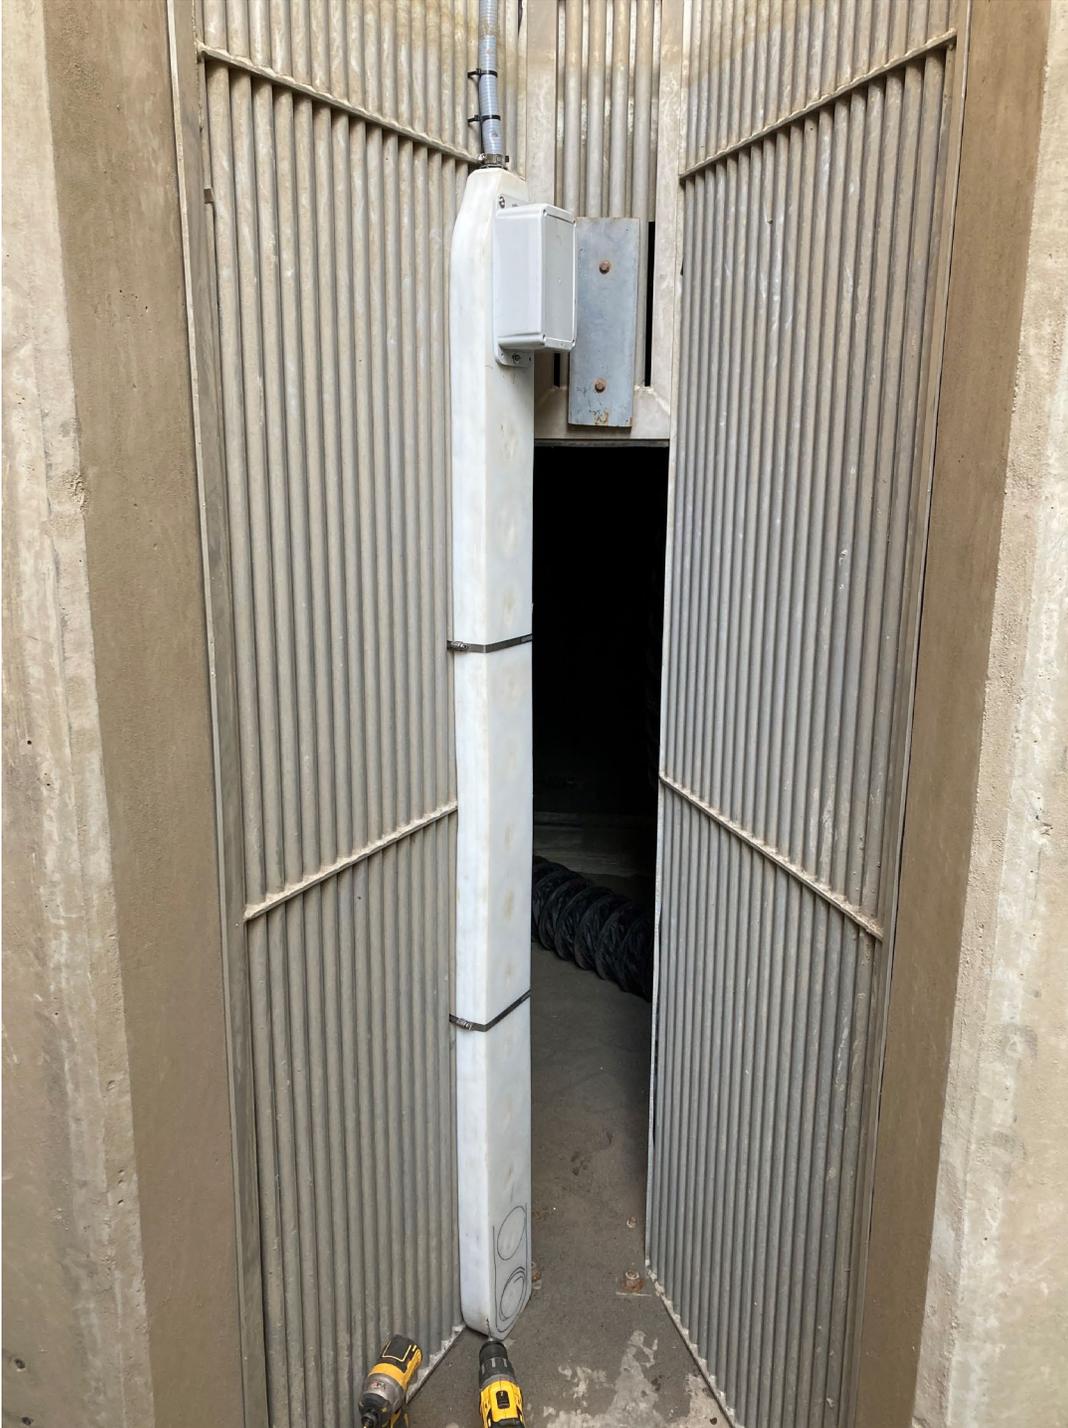
Photo 3. Crews install a passive integrated transponder (PIT) antenna onto the side of the vee-trap to detect tagged fish entering the pre-sort holding pool (March 18, 2022).
