Site C Clean Energy Project

Offset Effectiveness Monitoring for River Road Rock Spurs and Upper Site 109L – 2018

Peace River Fish Community Monitoring Program (Mon-2, Task 2d) Peace River Physical Habitat Monitoring Program (Mon-3, Task 2c)

Construction Year 4 (2018)

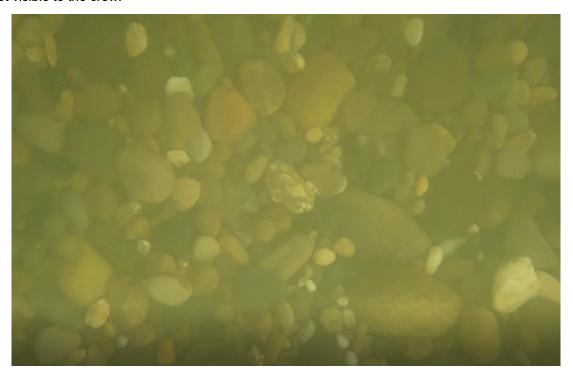
Plate 1 Riverbed substrate material image captured at the Video-01 site located upstream of substrate mat M05 (Appendix A, Figure A4), 19 December 2018.

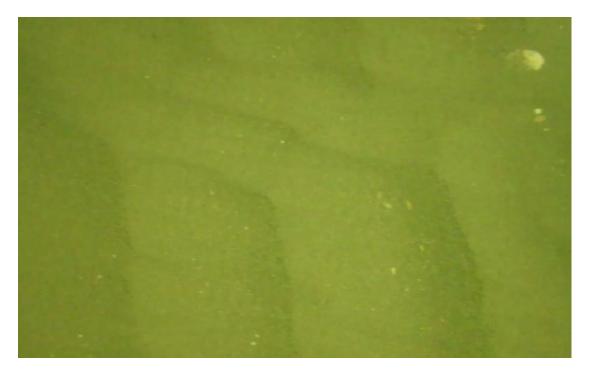
Plate 2 Riverbed substrate material image captured at the Video-03 site located between substrate mat M06 and M09 (Appendix A, Figure A4), 19 December 2018.

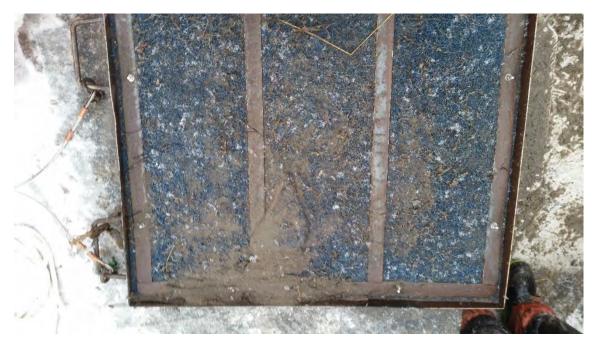
During the Mountain Whitefish spawning period (Section 3.3), field crews noted that substrate mats at M06 and M09 had substantial volumes of sand and small gravel embedded in the mat material (Plate 3). During one retrieval, the downstream anchor and chain of M06 were completely covered with sand and fine substrate and was not visible to the crew.

Plate 3 Sand and fines deposited onto substrate mat M09 on 4 January 2019.
