**Report Title:** Site C Reservoir Shoreline Stability Assessment

**Issuer:** Thurber Consultants Ltd.

**Date:** April 1978

**A report to  
B.C. HYDRO & POWER AUTHORITY**

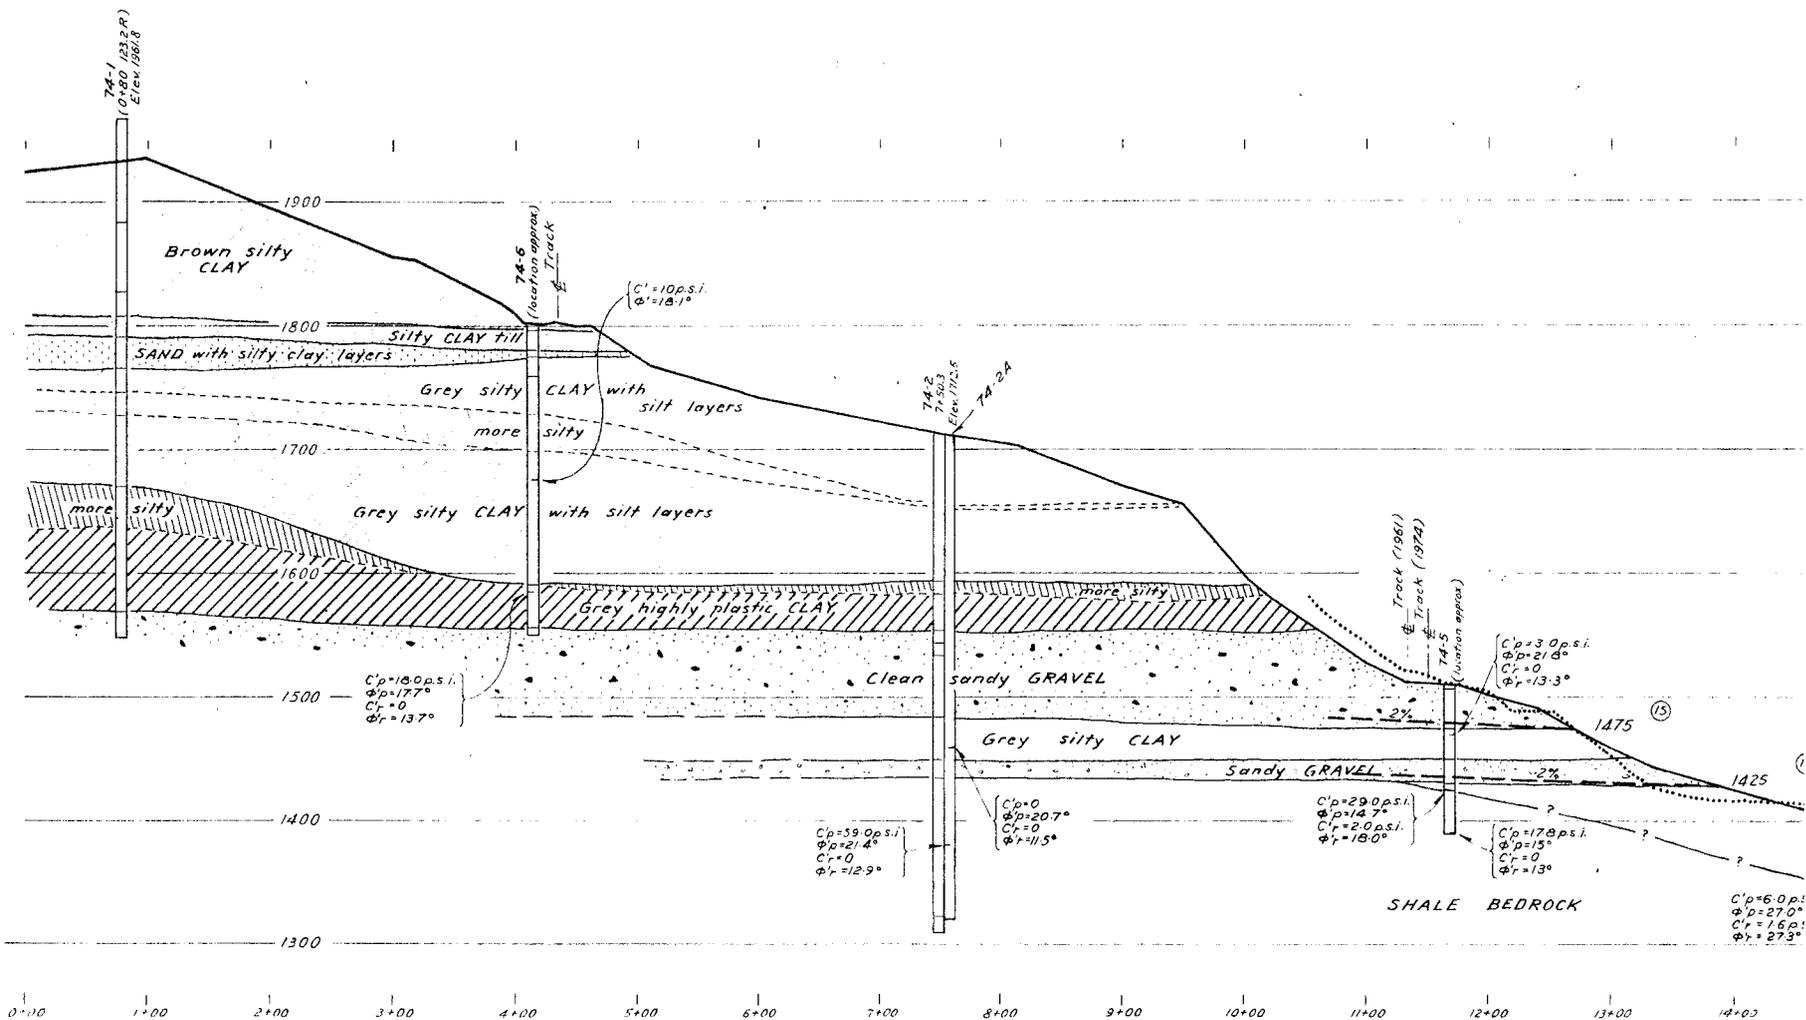
FIGURE 10

SECTION THROUGH PEACE HILL SLIDE AREA  
AT MILE 30 (NORTH BANK)

Figure 10 shows a typical sequence in the overburden. It was prepared from a detailed drilling investigation of the north bank of the Peace River at Mile 30, downstream of Site C.

The section from the B.C.R. investigation at Mile 31 shown on Fig.10 also shows the results of several direct shear tests on 2-inch square specimens parallel to the bedding. The range of values is tabulated below:

The failure plane is well exposed at the head of a spring on the downstream side of the toe of the slide at el.1646, approximately 215 feet above present river level. It is a sharply defined knife edge plane located in a brittle plastic clay 12 to 17 inches above the basal gravel which is 60 feet thick at this point. The failure plane was not clearly determined in DH 63-1, but it appears to be located approximately 14 feet above the gravel. The peak shear strength properties of the clay beneath the failure plane have been measured. A minimum  $\phi'_p$  value of  $23^\circ$  was recorded for failure parallel to the varves ( $c'_p = 12$  psi). This is comparable to the average peak value  $\phi'_p = 22^\circ$  obtained from direct shear testing of clays from the slide area at Mile 30. Failure across the varves resulted in an average  $\phi'_p = 28^\circ$ . Residual values would be appreciably less; a minimum  $\phi' = 11.5^\circ$  was recorded at Mile 30 (figure 10).

- c) Slides involving bedrock (shales) have occurred infrequently relative to slides in overburden. However, the largest slide to have occurred in the reservoir area (i.e. the Cache Creek Slide) developed in the shale bedrock. The requisites for the development of a large slide in shale are believed to be the presence of pre-existing shear planes in a critical location paralleling the bedding of the shales and sufficiently adverse groundwater conditions. The shearing resistance along these planes can approach residual values. Residual  $\phi$ -values as low as  $13^\circ$  and averaging  $14^\circ$  have been obtained from a detailed investigation at Mile 31 (p.13 and Fig.10).

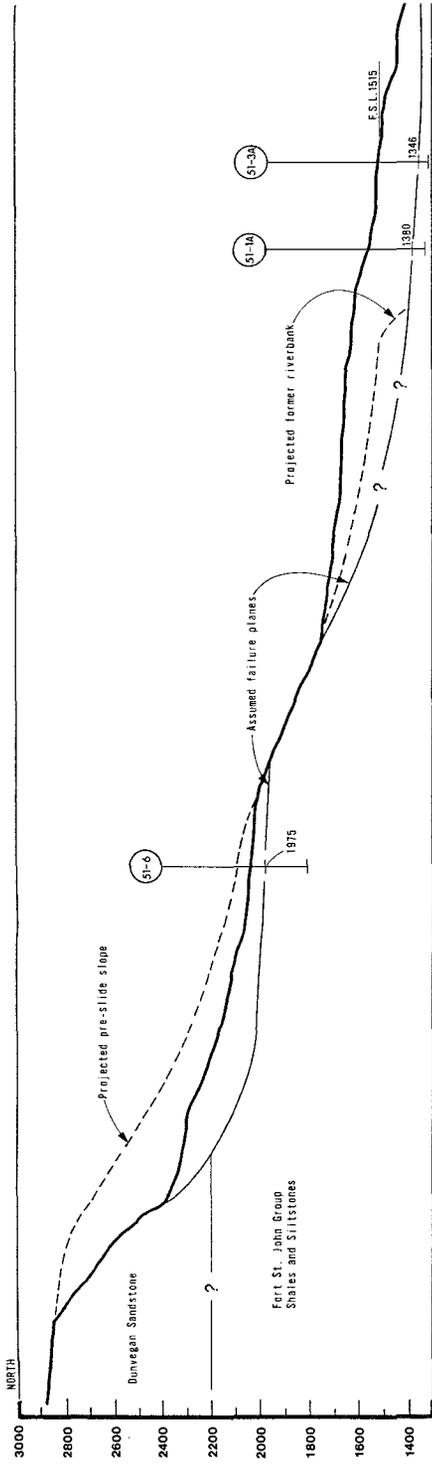
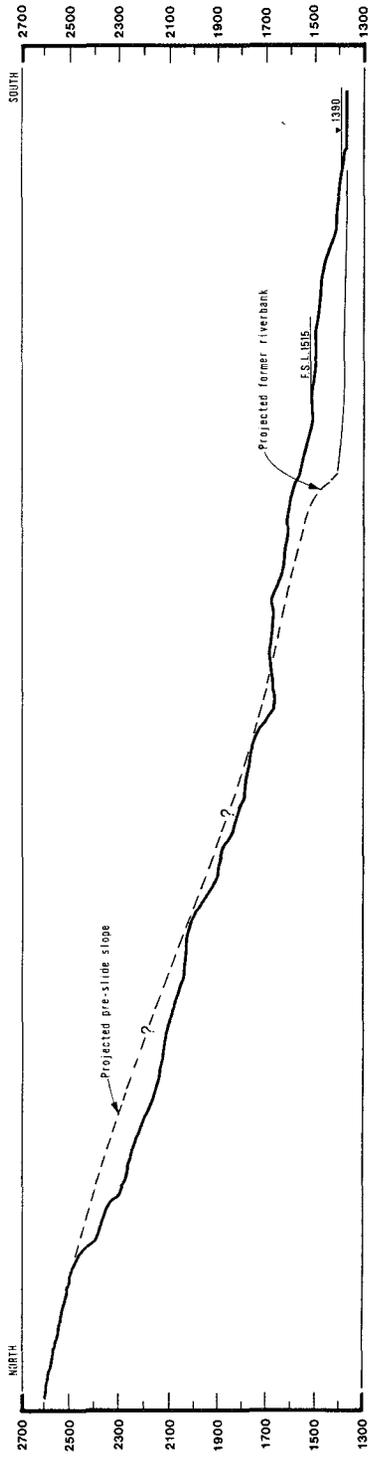
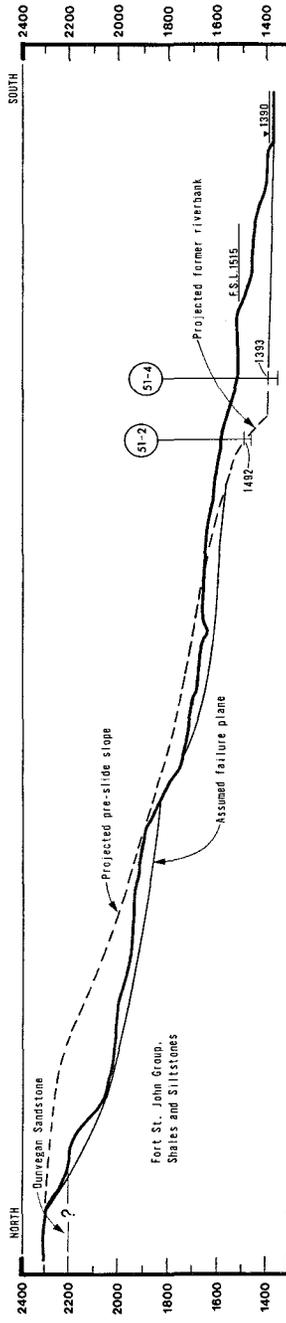
British Columbia Hydro and Power Authority	DRAWN G. M.
	CACHE CREEK SLIDE AREA	TRACED K. R. C. - D.
	Site C Reservoir Shoreline Assessment	DATE Nov. 1977
	<b>THURBER CONSULTANTS LTD., Geotechnical Engineers</b>	APPROVED G. C. M.
		SCALE Shown
		DRAWING NO 15-2-62-10

The profile of the river bank prior to failure has been estimated and plotted on Dwg. 10. Section C shows holes 51-2 and 51-4 straddling the bank which, like the existing one downstream, was a 100 feet or so high. The pre-slide profiles have been prepared by projecting the surface contours from each side of the slide and by comparing areas of slide debris at the toe with material removed from the top. The results are tabulated on the following page.
