INFORMATION SHEET

BC HYDRO MANAGES TWO ENVIRONMENTAL EVENTS AT SITE C

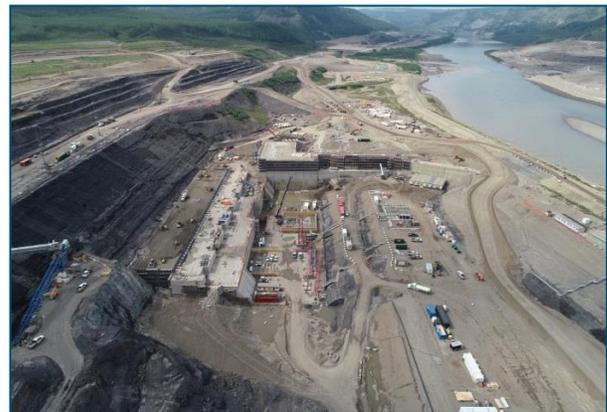
The work on the south bank is in close proximity to the Peace River
