Site C Clean Energy Project

Temporary Upstream Fish Passage Facility Operations Report

Reporting Period: June 1 to 30, 2023

Prepared by BC Hydro July 12, 2023

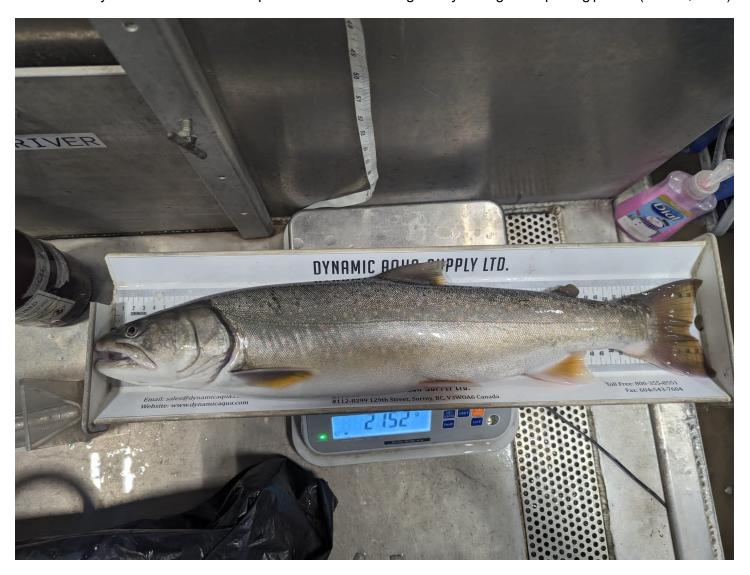
Photo 2. Fifty-seven Bull Trout were processed in the sorting facility during the reporting period (June 6, 2023).
