Map 22 of 26 – KM 130-139
Preliminary Impact Lines, Highway 29 Realignments and Agriculture Assessment March 2013

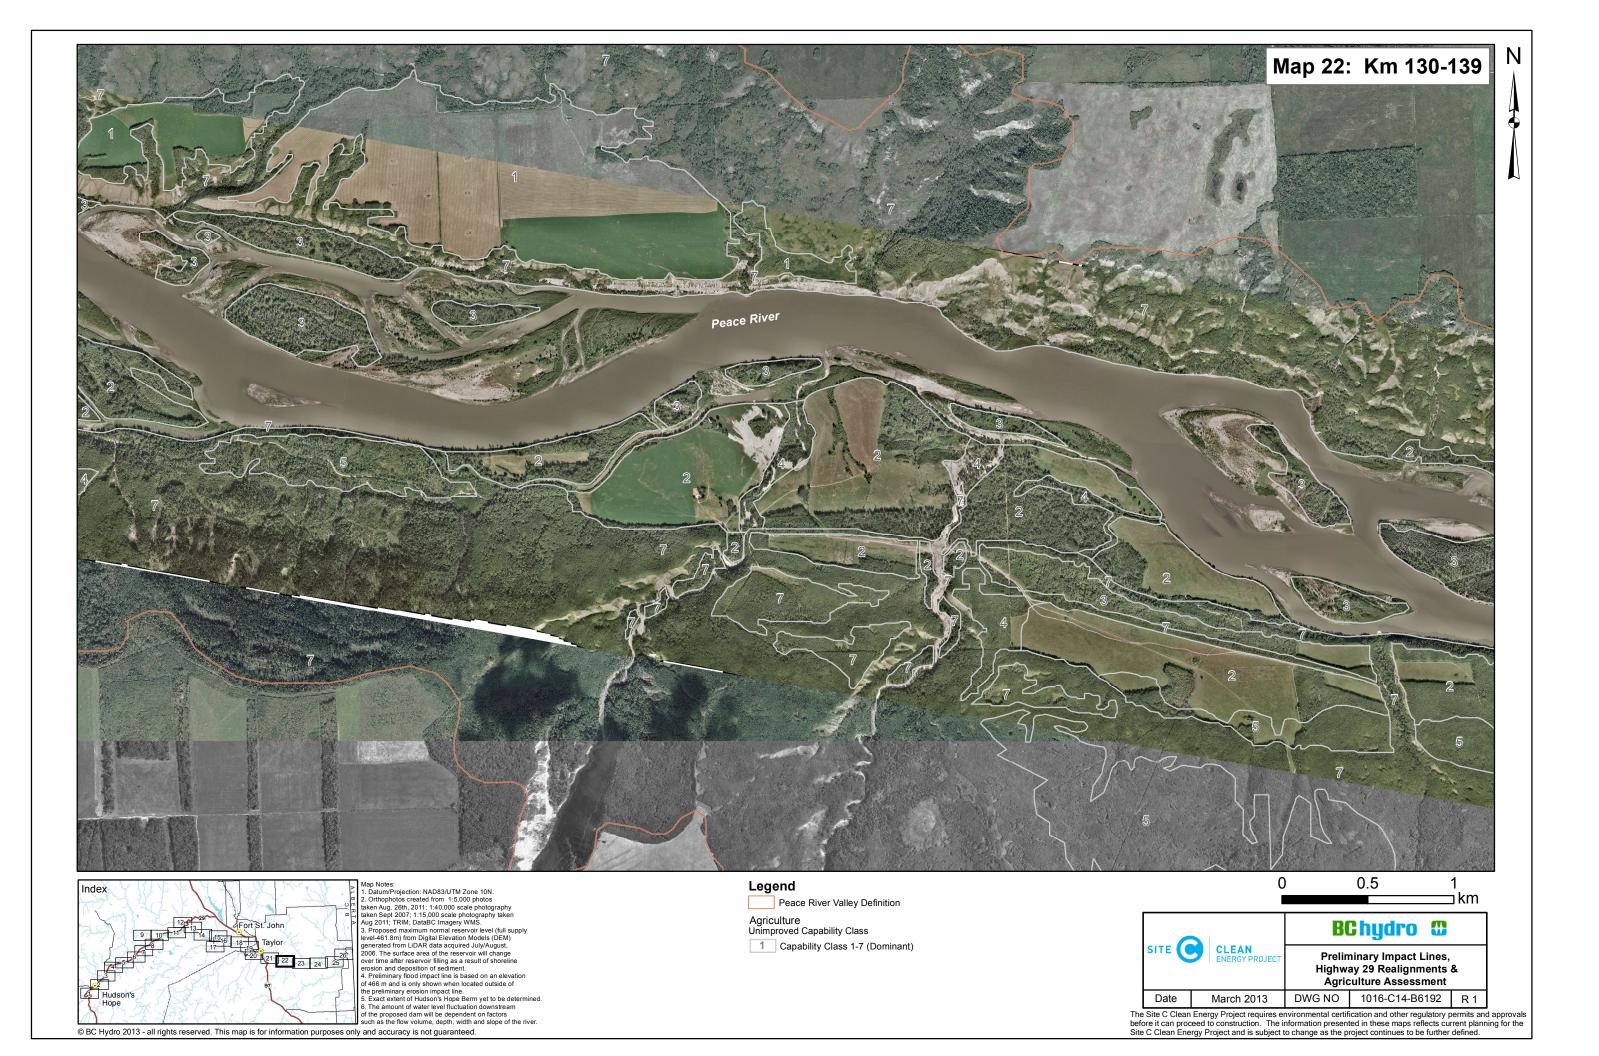
Kilometre 130-139	Agriculture Assessment Improved (irrigated and/or drained) agricultural land capability ratings are provided for the Site C project component areas where additional soil survey work has been undertaken as part of the Agriculture Assessment.
	For remaining lands outside the Site C project component areas, including the Peace River valley downstream of the Site C dam, unimproved agricultural land capability ratings are provided. The unimproved ratings reflect published agricultural capability maps from the 1970s, based on an assumed low climatic moisture deficit (CMD) during the growing season in the range of 34 mm. However, subsequent climate studies have confirmed much drier conditions in the Peace River valley, with a CMD in the range of 148 mm, which results in a Class 3 unimproved climatic capability rating. With irrigation, it is likely that Peace River valley soils downstream of the Site C dam historically rated as Class 2 or Class 3 with aridity or soil water holding capacity limitations, which would now be rated as unimproved Class 3 due to climatic limitations, would improve to Class 2 or Class 1 with irrigation.

Peace River Valley Definition BC Hydro defined the Peace River Valley as a spatial area, reflecting the Peace River mainstem from the Peace Canyon Dam to the B.C.–Alberta border. The upper edge of the Peace River Valley is defined as the crest of the top of high bank slopes, typically between El. 620 and 850m. The purpose of spatially defining the valley was to provide a consistent area for use where relevant in the Environmental Impact Statement.
